Roof Inspection Report

Mr. Greg Boettger
Bellevue Schools
&
Mr. Ralph Gladbach
GP Architecture, LLC.

Roofing Solutions, Inc.
6728 W. 153rd Street
Overland Park, KS 66223

Belleaire Elementary
1200 W. Mission Avenue
Bellevue, NE 68005

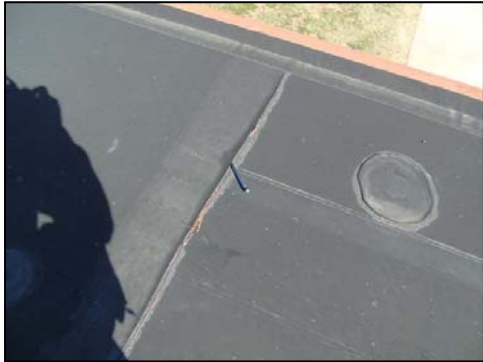
Defect Code:	3	Quantity:	Widespread	Priority:	Monitor
Description: Open lap in field membrane.					
Repair: Clean lap of all dirt and close seam. Overlay edge of affected seam with strip-in of new membrane of like material. Extend a minimum of 4" in all directions past seam edges and repair areas.

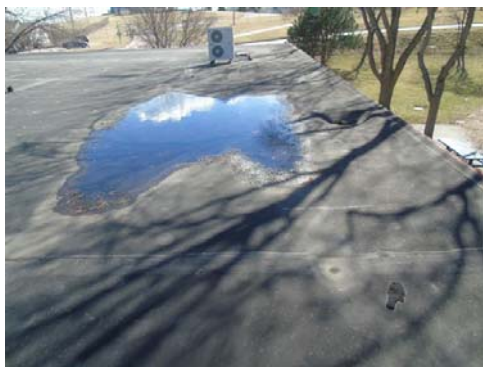
Defect Code:	15	Quantity:	Random	Priority:	Monitor
Description: Ponding of water.					
Repair: Monitor areas for severe or chronic ponding. Provide sacrificial membrane ply in ponded areas where existing membrane is deteriorated. Install additional drain or scupper including collectors and drain piping where ponding conditions are severe and chronic.

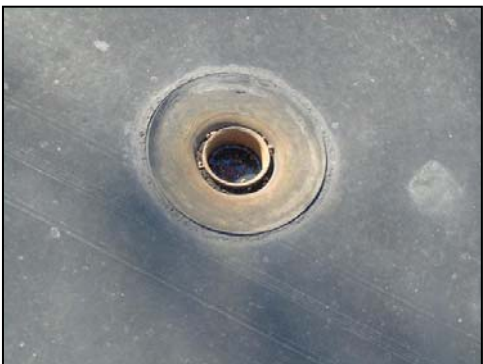
Defect Code:	16	Quantity:	1	Priority:	First Year
Description: Blocked drain, scupper, or downspout.					
Repair: Remove all debris from drainage system and ensure drain or scupper is free flowing without restrictions at strainer or piping.

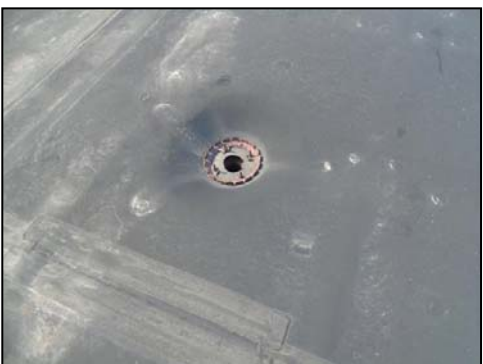
Defect Code:	17	Quantity:	1	Priority:	Monitor
Description: Missing or damaged drain/scupper strainer					
Repair: Replace damaged or missing strainer with a new cast iron strainer sized to fit the drain assembly or scupper opening. Lock in place to prevent loss.

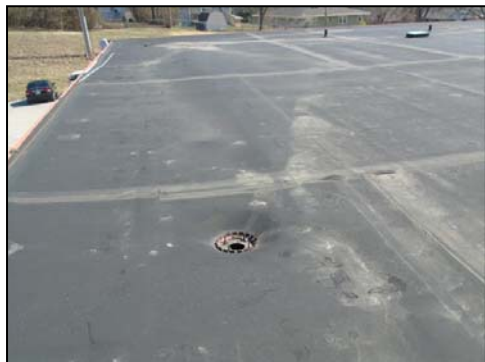
Defect Code:	18	Quantity:	Widespread	Priority:	Urgent
Description: Unadhered membrane or inadequate membrane attachment.					
Repair: At unadhered areas, cut open membrane and readhere to substrate with manufacturer's approved adhesive. At areas with missing securement, provide securement in the form of screws and plates installed a maximum of 12" O.C. Overlay repaired areas with new membrane of similar gauge, type, and plies and extend repairs a minimum of 4" past cut areas or edges of plates.

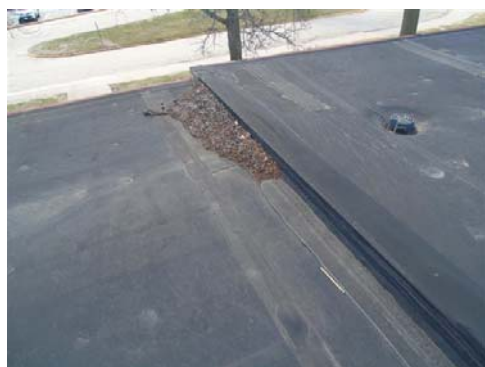
Defect Code:	22	Quantity:	Random	Priority:	Monitor
Description: Debris, trash, construction materials, HVAC equipment, filters, motors, etc. on roof surface.					
Repair: Remove all trash and debris from roof. Clean and inspect surfaces and repair any damages to the membrane or flashings.

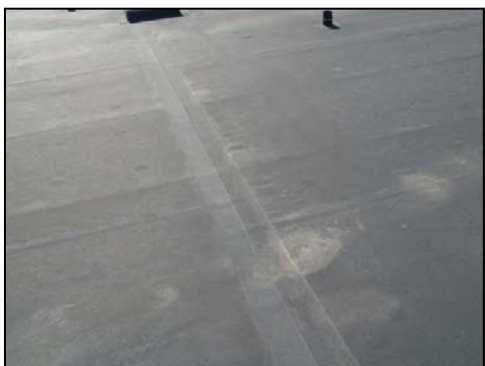
Defect Code:	24	Quantity:	Widespread	Priority:	Monitor
Description: Evidence of past problem and previous repair.					
Repair: Investigate for chronic leak problems and repair any areas that are suspect.

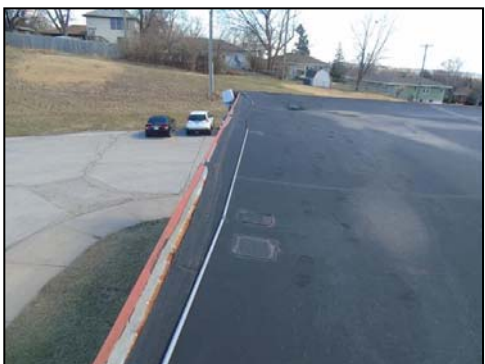
Defect Code:	26	Quantity:	Widespread	Priority:	Urgent
Description: Membrane shrinkage					
Repair: Investigate and repair cause of shrinkage. Cut away affected areas and prepare to receive new membrane. Install new membrane and secure at base flashings. Adhere to walls and substrates and reinstall metal copings, counterflashings, and termination bars to complete the repair. On ballasted systems redistribute ballast evenly.

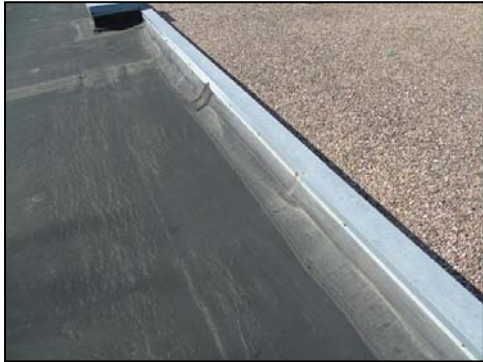
Defect Code:	44	Quantity:	Widespread	Priority:	Monitor
Description: Bridged flashing					
Cut out all bridged flashings. Clean area thoroughly and apply new flashings. Apply corner flashings and overlay all T-laps, flashings laps, and splice intersections.

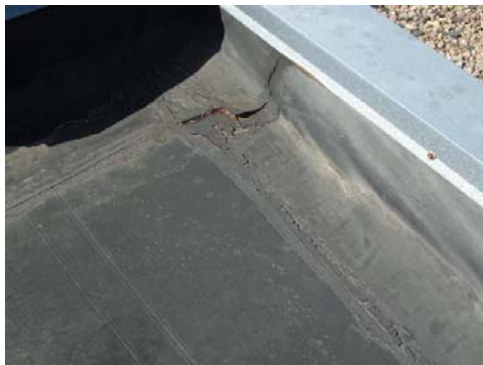
Defect Code:	45	Quantity:	Widespread	Priority:	Monitor
Description: Open flashing lap					
Repair: Open loose lap area and clean thoroughly. Prime and reseam or reweld lap per the manufacturer's requirements. Strip-in defective lap with minimum 6" wide membrane on single ply systems or 6" wide fabric and mastic three-course application on asphalt systems. Regranulate or coat flashing repairs.

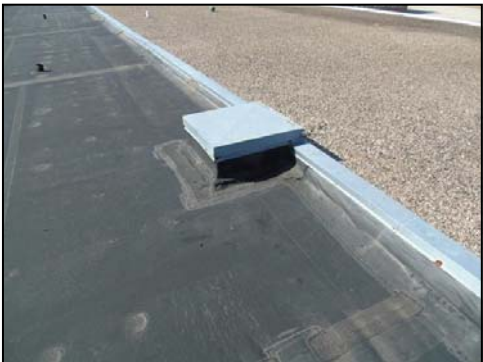
Defect Code:	56	Quantity:	6	Priority:	Monitor
Description: Abandoned and obsolete equipment.					
Repair: Monitor for leaks. Check systems are abandoned and disconnected and will not be used in the future. Remove abandoned equipment and repair deck at scheduled roof replacement.

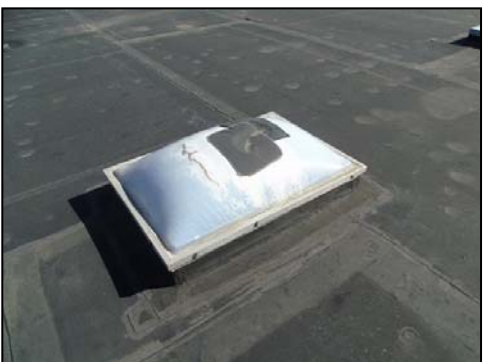
Defect Code:	88	Quantity:	Random	Priority:	First Year
Description: Skylight defect/cracked/deteriorated					
Repair: Remove and replace affected components.

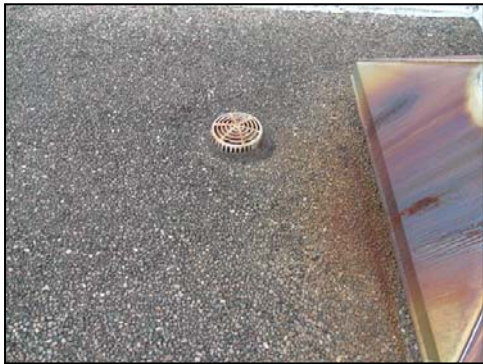
Defect Code:	22	Quantity:	Random	Priority:	Monitor
Description: Debris, trash, construction materials, HVAC equipment, filters, motors, etc. on roof surface.					
Repair: Remove all trash and debris from roof. Clean and inspect surfaces and repair any damages to the membrane or flashings.

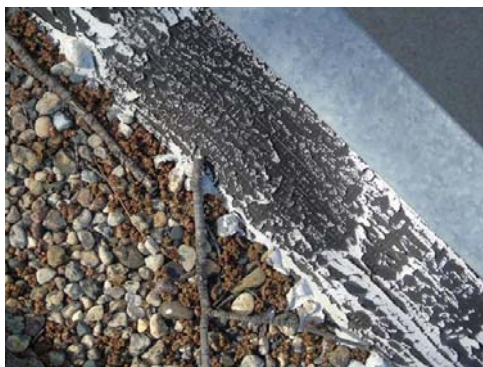
Defect Code:	43	Quantity:	Widespread	Priority:	Monitor
Description: Weathered and deteriorated flashing					
Repair: Clean and prepare surfaces by removing loose granules, dirt, and other debris. Apply two coats of elastomeric coating compatible with the flashing materials.

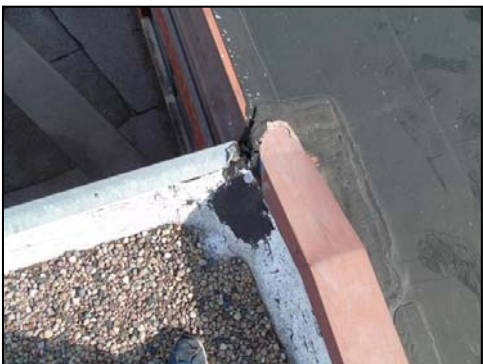
Defect Code:	46	Quantity:	Under 10 LF	Priority:	First Year
Description: Split in flashing					
Repair: Cut away loose flashing and clean and prime repair area. Apply strip in of like material centered over split extending a minimum of 4" in all directions past prepared area.

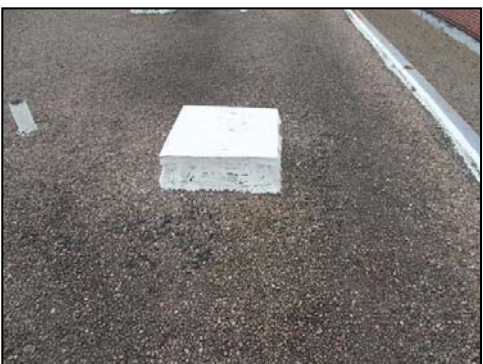
Defect Code:	56	Quantity:	1	Priority:	Monitor
Description: Abandoned and obsolete equipment.					
Repair: Monitor for leaks. Check systems are abandoned and disconnected and will not be used in the future. Remove abandoned equipment and repair deck at scheduled roof replacement.

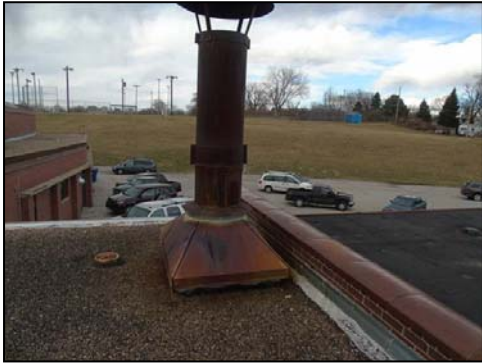
Defect Code:	86	Quantity:	Random	Priority:	Monitor
Description: Corrosion or rust					
Repair: Remove rusted components and replace with similar metal fabricated and installed per SMACNA requirements.

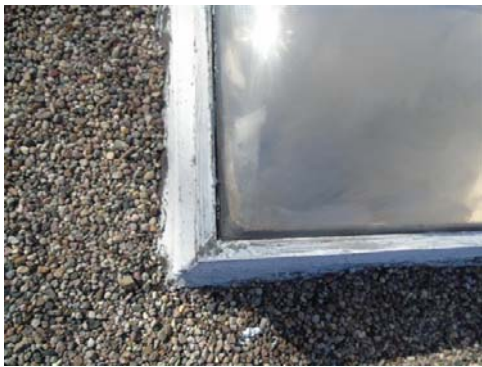
Defect Code:	88	Quantity:	2	Priority:	First Year
Description: Skylight defect/cracked/deteriorated					
Repair: Remove and replace affected components.

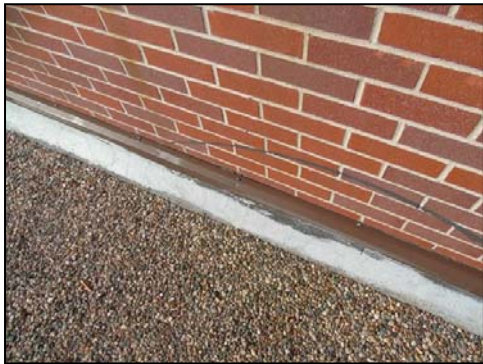
Defect Code:	1	Quantity:	Widespread	Priority:	First Year
Description: Deteriorated or missing sealant at counterflashing, termination bar, sealant lip, metal flashing, expansion joint, etc.					
Repair: Clean loose sealant and dirt from all surfaces. Apply new polyurethane sealant and tool to shed water.

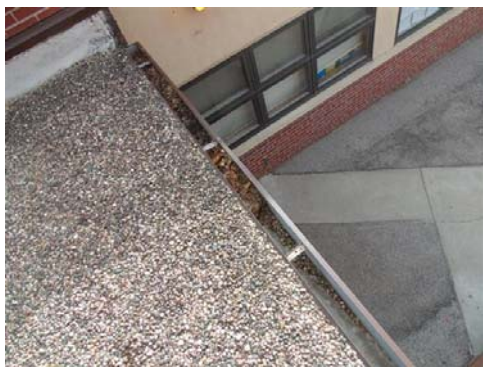
Defect Code:	22	Quantity:	Random	Priority:	Monitor
Description: Debris, trash, construction materials, HVAC equipment, filters, motors, etc. on roof surface.					
Repair: Remove all trash and debris from roof. Clean and inspect surfaces and repair any damages to the membrane or flashings.

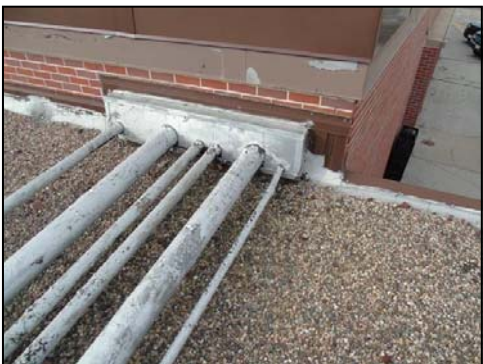
Defect Code:	40	Quantity:	Random	Priority:	Monitor
Description: Low flashing height.					
Repair: Raise flashing height to a minimum of 8" above finished roof surface. Provide appropriate termination of flashings with metal copings or counterflashings. Provide a compression bar termination of flashings to concrete or block surface if flashings cannot be maintained at 8" minimum height.

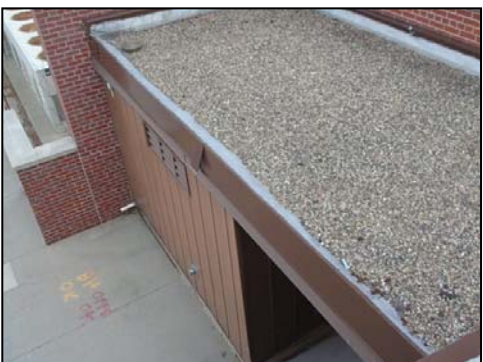
Defect Code:	71	Quantity:	1	Priority:	First Year
Description: Open or missing joint cover.					
Repair: Replace joint covers that are open or missing with matching joint covers and sealant.

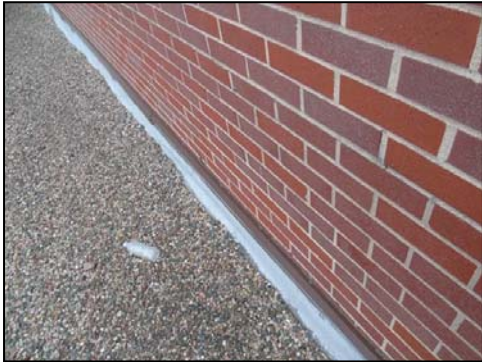
Defect Code:	1	Quantity:	Widespread	Priority:	First Year
Description: Deteriorated or missing sealant at counterflashing, termination bar, sealant lip, metal flashing, expansion joint, etc.					
Repair: Clean loose sealant and dirt from all surfaces. Apply new polyurethane sealant and tool to shed water.

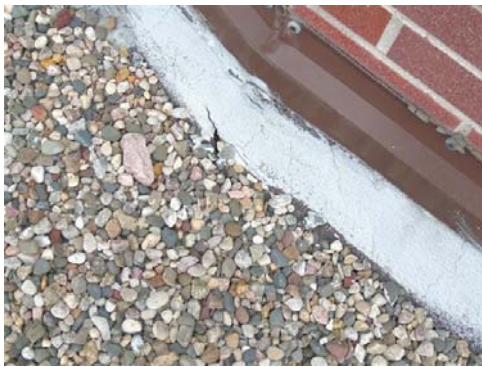
Defect Code:	46	Quantity:	Under 10 LF	Priority:	First Year
Description: Split in flashing					
Repair: Cut away loose flashing and clean and prime repair area. Apply strip in of like material centered over split extending a minimum of 4" in all directions past prepared area.

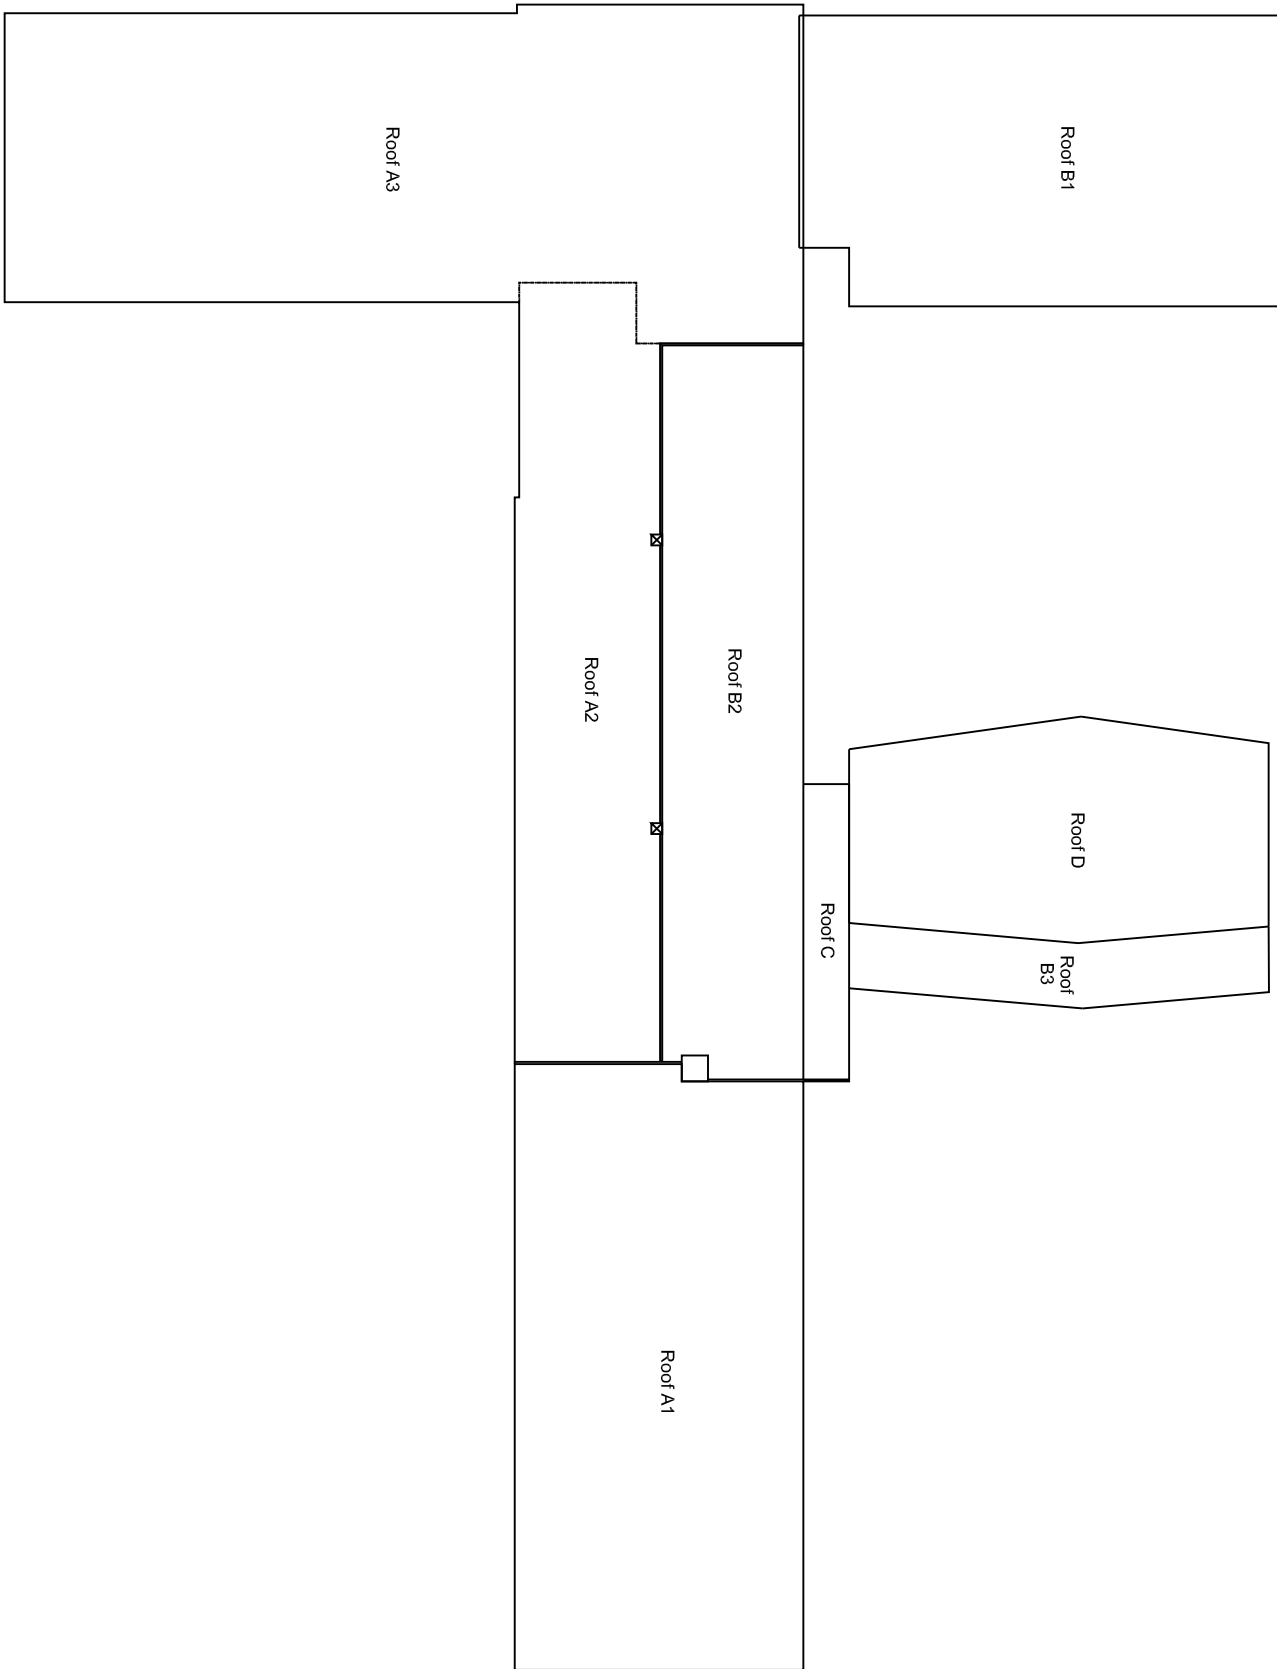
Typical defects for the B roof areas:
 (43) The BUR flashing's are weathered with areas of deterioration.

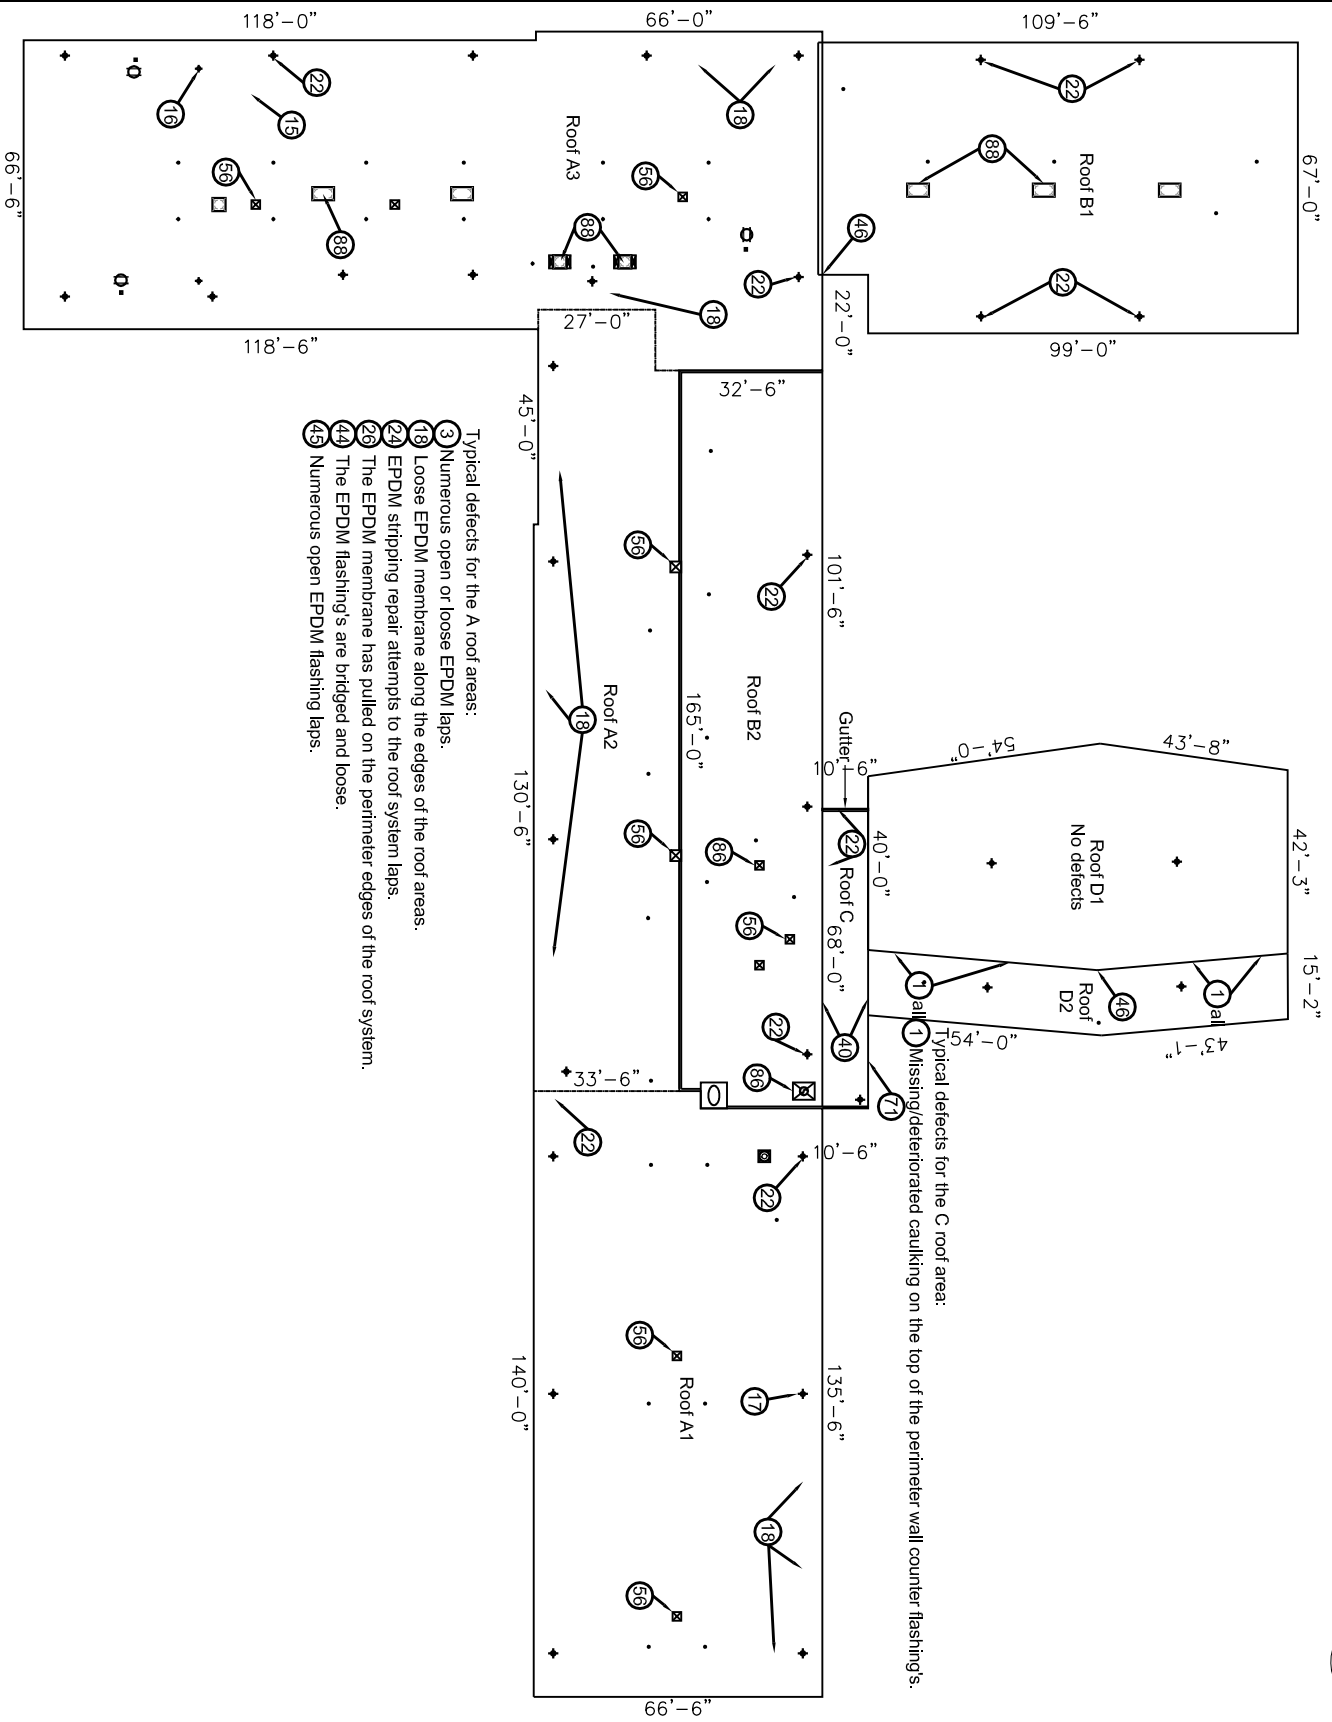
Typical defects for the C roof area:
 (1) Missing/deteriorated caulking on the top of the perimeter wall counter flashings.

- Typical defects for the A roof areas:
- (3) Numerous open or loose EPDM laps.
 - (19) Loose EPDM membrane along the edges of the roof areas.
 - (29) EPDM stripping repair attempts to the roof system laps.
 - (28) The EPDM membrane has pulled on the perimeter edges of the roof system.
 - (44) The EPDM flashing's are bridged and loose.
 - (45) Numerous open EPDM flashing laps.
