# Roof Inspection Report

Betz Elementary  
605 W. 27<sup>th</sup> Avenue  
Bellevue, NE 68005

**Date of Last Inspection:** Mar 08, 2017

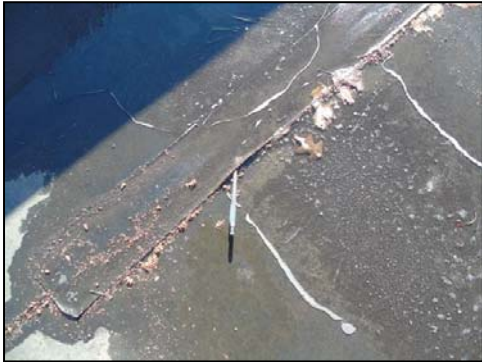
<b>Defect Code:</b>	<b>3</b>	<b>Quantity:</b>	<b>Widespread</b>	<b>Priority:</b>	<b>Monitor</b>
Description: Open lap in field membrane.					
Repair: Clean lap of all dirt and close seam. Overlay edge of affected seam with strip-in of new membrane of like material. Extend a minimum of 4" in all directions past seam edges and repair areas.

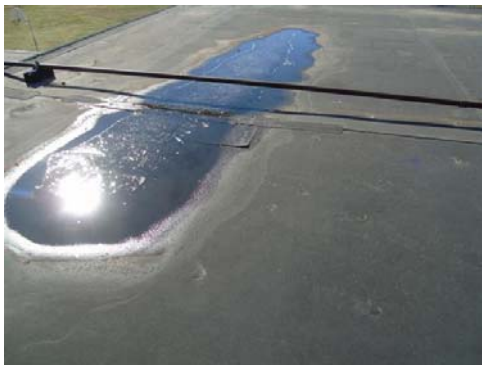
<b>Defect Code:</b>	<b>15</b>	<b>Quantity:</b>	<b>Random</b>	<b>Priority:</b>	<b>Monitor</b>
Description: Ponding of water.					
Repair: Monitor areas for severe or chronic ponding. Provide sacrificial membrane ply in ponded areas where existing membrane is deteriorated. Install additional drain or scupper including collectors and drain piping where ponding conditions are severe and chronic.

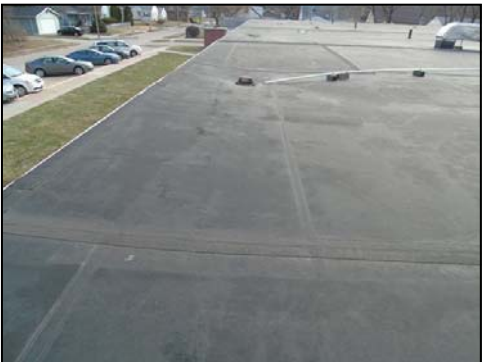
<b>Defect Code:</b>	<b>18</b>	<b>Quantity:</b>	<b>Widespread</b>	<b>Priority:</b>	<b>Urgent</b>
Description: Unadhered membrane or inadequate membrane attachment.					
Repair: At unadhered areas, cut open membrane and readhere to substrate with manufacturer's approved adhesive. At areas with missing securement, provide securement in the form of screws and plates installed a maximum of 12" O.C. Overlay repaired areas with new membrane of similar gauge, type, and plies and extend repairs a minimum of 4" past cut areas or edges of plates.

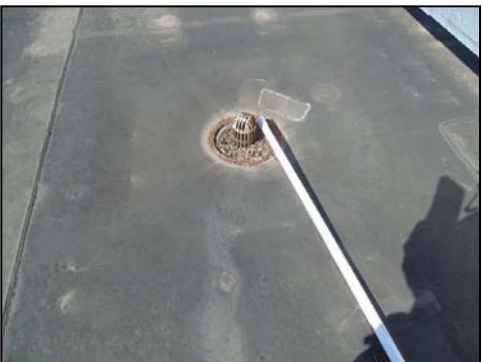
<b>Defect Code:</b>	<b>22</b>	<b>Quantity:</b>	<b>Random</b>	<b>Priority:</b>	<b>Monitor</b>
Description: Debris, trash, construction materials, HVAC equipment, filters, motors, etc. on roof surface.					
Repair: Remove all trash and debris from roof. Clean and inspect surfaces and repair any damages to the membrane or flashings.

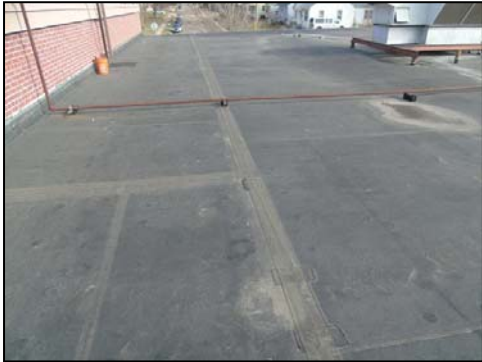
Defect Code:	24	Quantity:	Random	Priority:	Monitor
Description: Evidence of past problem and previous repair.					
Repair: Investigate for chronic leak problems and repair any areas that are suspect.

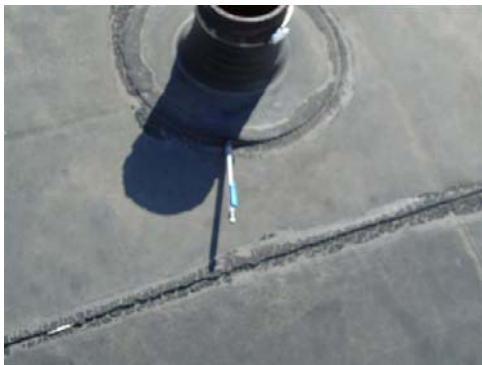
Defect Code:	45	Quantity:	Widespread	Priority:	Monitor
Description: Open flashing lap					
Repair: Open loose lap area and clean thoroughly. Prime and reseam or reweld lap per the manufacturer's requirements. Strip-in defective lap with mimum 6" wide membrane on single ply systems or 6" wide fabric and mastic three-course application on asphalt systems. Regranulate or coat flashing repairs.

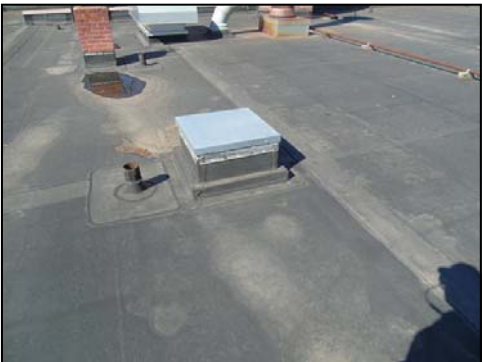
Defect Code:	56	Quantity:	2	Priority:	Monitor
Description: Abandoned and obsolete equipment.					
Repair: Monitor for leaks. Check systems are abandoned and disconnected and will not be used in the future. Remove abandoned equipment and repair deck at scheduled roof replacement.

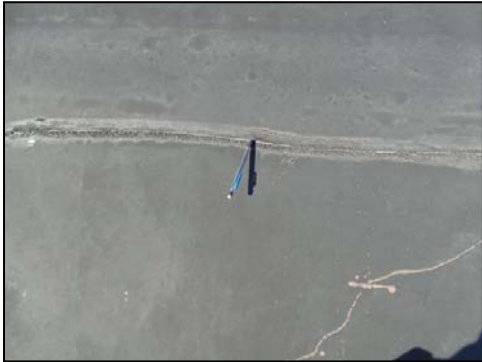
<b>Defect Code:</b>	<b>3</b>	<b>Quantity:</b>	<b>20 LF</b>	<b>Priority:</b>	<b>First Year</b>
Description: Open lap in field membrane.					
Repair: Clean lap of all dirt and close seam. Overlay edge of affected seam with strip-in of new membrane of like material. Extend a minimum of 4" in all directions past seam edges and repair areas.

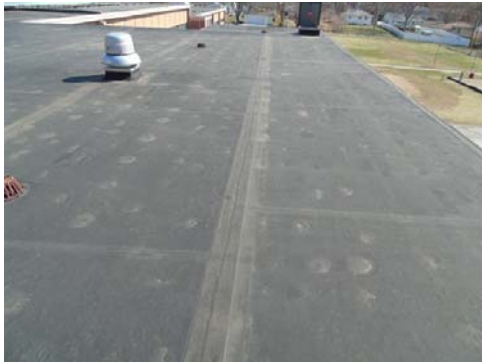
<b>Defect Code:</b>	<b>24</b>	<b>Quantity:</b>	<b>Widespread</b>	<b>Priority:</b>	<b>Monitor</b>
Description: Evidence of past problem and previous repair.					
Repair: Investigate for chronic leak problems and repair any areas that are suspect.

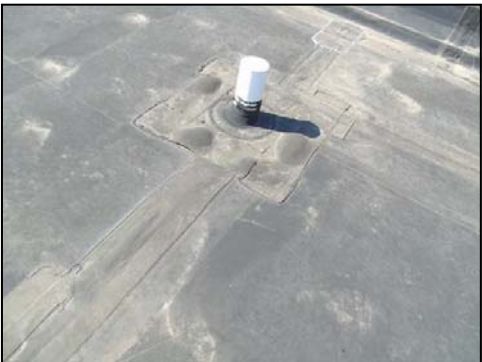
<b>Defect Code:</b>	<b>45</b>	<b>Quantity:</b>	<b>Random</b>	<b>Priority:</b>	<b>First Year</b>
Description: Open flashing lap					
Repair: Open loose lap area and clean thoroughly. Prime and reseam or reweld lap per the manufacturer's requirements. Strip-in defective lap with mimum 6" wide membrane on single ply systems or 6" wide fabric and mastic three-course application on asphalt systems. Regranulate or coat flashing repairs.

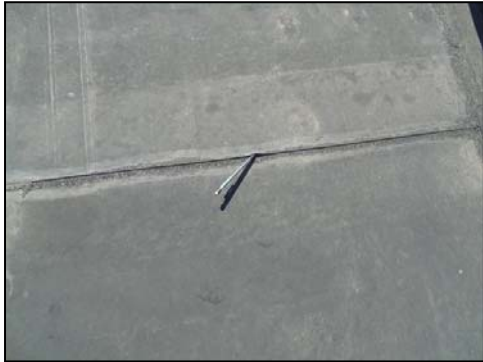
<b>Defect Code:</b>	<b>3</b>	<b>Quantity:</b>	<b>Widespread</b>	<b>Priority:</b>	<b>Monitor</b>
Description: Open lap in field membrane.					
Repair: Clean lap of all dirt and close seam. Overlay edge of affected seam with strip-in of new membrane of like material. Extend a minimum of 4" in all directions past seam edges and repair areas.

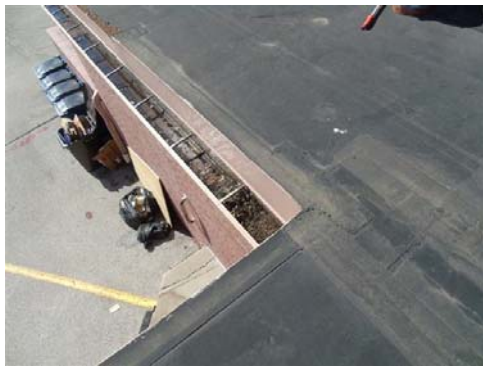
<b>Defect Code:</b>	<b>22</b>	<b>Quantity:</b>	<b>Random</b>	<b>Priority:</b>	<b>Monitor</b>
Description: Debris, trash, construction materials, HVAC equipment, filters, motors, etc. on roof surface.					
Repair: Remove all trash and debris from roof. Clean and inspect surfaces and repair any damages to the membrane or flashings.

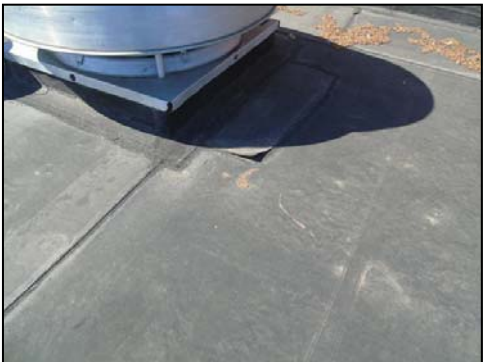
<b>Defect Code:</b>	<b>45</b>	<b>Quantity:</b>	<b>Random</b>	<b>Priority:</b>	<b>First Year</b>
Description: Open flashing lap					
Repair: Open loose lap area and clean thoroughly. Prime and reseam or reweld lap per the manufacturer's requirements. Strip-in defective lap with mimum 6" wide membrane on single ply systems or 6" wide fabric and mastic three-course application on asphalt systems. Regranulate or coat flashing repairs.

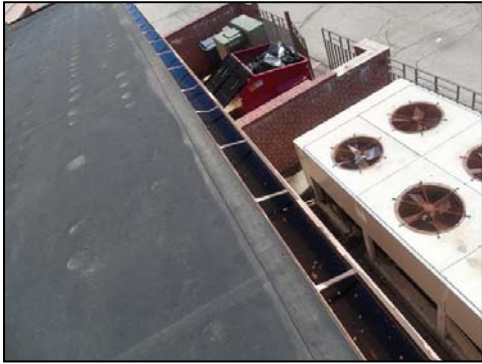
<b>Defect Code:</b>	<b>16</b>	<b>Quantity:</b>	<b>Widespread</b>	<b>Priority:</b>	<b>First Year</b>
Description: Blocked drain, scupper, or downspout.					
Repair: Remove all debris from drainage system and ensure drain or scupper is free flowing without restrictions at strainer or piping.

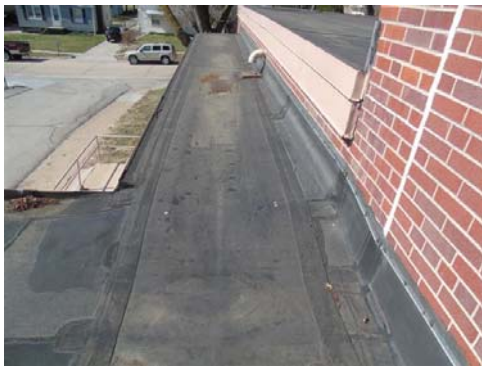
<b>Defect Code:</b>	<b>18</b>	<b>Quantity:</b>	<b>150 SF</b>	<b>Priority:</b>	<b>Urgent</b>
Description: Unadhered membrane or inadequate membrane attachment.					
Repair: At unadhered areas, cut open membrane and readhere to substrate with manufacturer's approved adhesive. At areas with missing securement, provide securement in the form of screws and plates installed a maximum of 12" O.C. Overlay repaired areas with new membrane of similar gauge, type, and plies and extend repairs a minimum of 4" past cut areas or edges of plates.

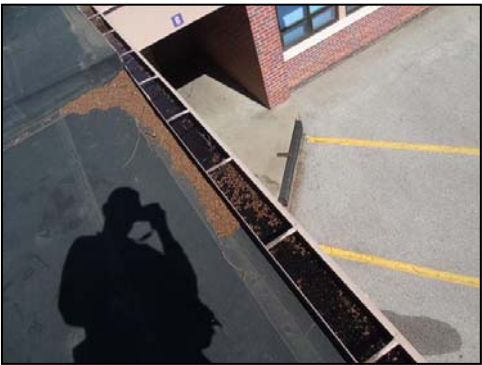
<b>Defect Code:</b>	<b>22</b>	<b>Quantity:</b>	<b>Widespread</b>	<b>Priority:</b>	<b>First Year</b>
Description: Debris, trash, construction materials, HVAC equipment, filters, motors, etc. on roof surface.					
Repair: Remove all trash and debris from roof. Clean and inspect surfaces and repair any damages to the membrane or flashings.

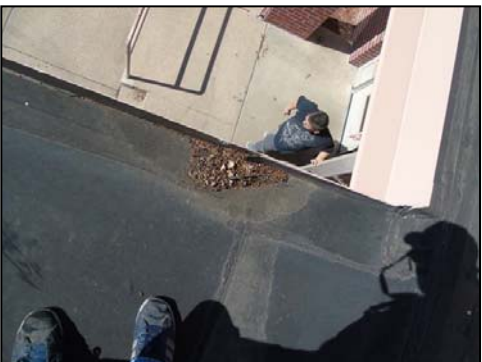
<b>Defect Code:</b>	<b>45</b>	<b>Quantity:</b>	<b>Random</b>	<b>Priority:</b>	<b>Monitor</b>
Description: Open flashing lap					
Repair: Open loose lap area and clean thoroughly. Prime and reseam or reweld lap per the manufacturer's requirements. Strip-in defective lap with mimum 6" wide membrane on single ply systems or 6" wide fabric and mastic three-course application on asphalt systems. Regranulate or coat flashing repairs.

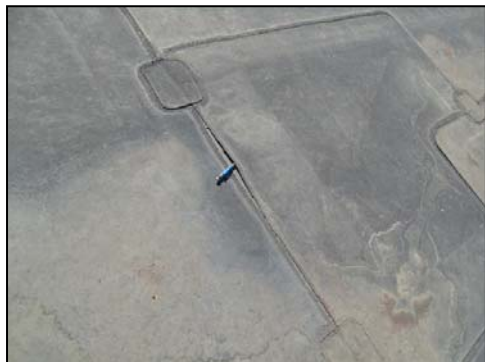
<b>Defect Code:</b>	<b>3</b>	<b>Quantity:</b>	<b>Widespread</b>	<b>Priority:</b>	<b>Monitor</b>
Description: Open lap in field membrane.					
Repair: Clean lap of all dirt and close seam. Overlay edge of affected seam with strip-in of new membrane of like material. Extend a minimum of 4" in all directions past seam edges and repair areas.

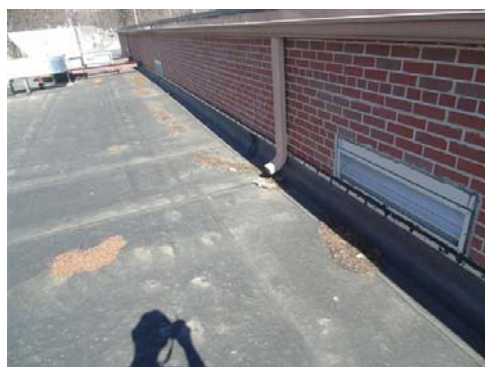
<b>Defect Code:</b>	<b>22</b>	<b>Quantity:</b>	<b>Random</b>	<b>Priority:</b>	<b>Monitor</b>
Description: Debris, trash, construction materials, HVAC equipment, filters, motors, etc. on roof surface.					
Repair: Remove all trash and debris from roof. Clean and inspect surfaces and repair any damages to the membrane or flashings.

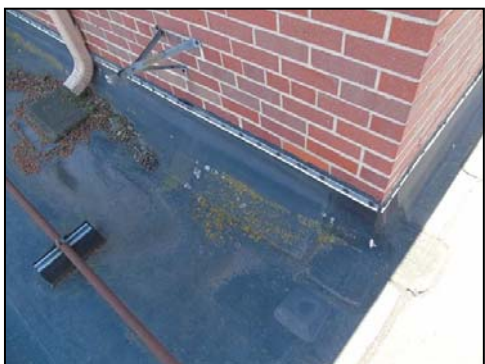
<b>Defect Code:</b>	<b>44</b>	<b>Quantity:</b>	<b>Widespread</b>	<b>Priority:</b>	<b>Monitor</b>
Description: Bridged flashing					
Repair: Cut out all bridged flashings. Clean area thoroughly and apply new flashings. Apply corner flashings and overlay all T-laps, flashings laps, and splice intersections.

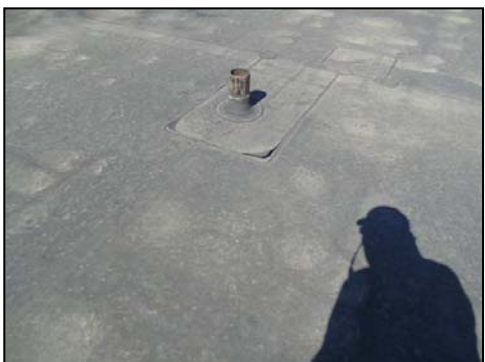
<b>Defect Code:</b>	<b>45</b>	<b>Quantity:</b>	<b>Widespread</b>	<b>Priority:</b>	<b>Monitor</b>
Description: Open flashing lap					
Repair: Open loose lap area and clean thoroughly. Prime and reseam or reweld lap per the manufacturer's requirements. Strip-in defective lap with mimum 6" wide membrane on single ply systems or 6" wide fabric and mastic three-course application on asphalt systems. Regranulate or coat flashing repairs.

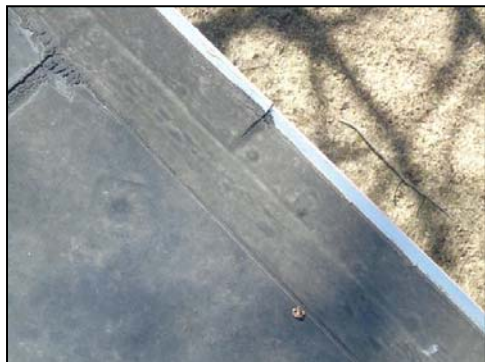
Defect Code:	46	Quantity:	Under 10 LF	Priority:	Monitor
Description: Split in flashing					
Repair: Cut away loose flashing and clean and prime repair area. Apply strip in of like material centered over split extending a minimum of 4" in all directions past prepared area.

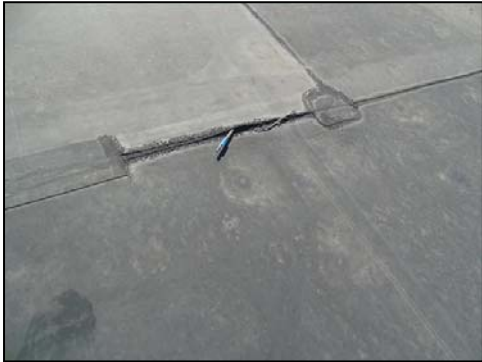
Defect Code:	3	Quantity:	Widespread	Priority:	Monitor
Description: Open lap in field membrane.					
Repair: Clean lap of all dirt and close seam. Overlay edge of affected seam with strip-in of new membrane of like material. Extend a minimum of 4" in all directions past seam edges and repair areas.

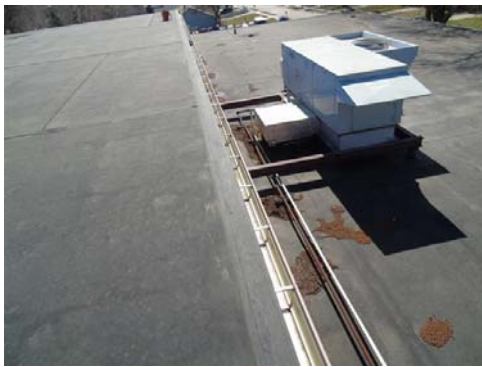
Defect Code:	24	Quantity:	Widespread	Priority:	Monitor
Description: Evidence of past problem and previous repair.					
Repair: Investigate for chronic leak problems and repair any areas that are suspect.

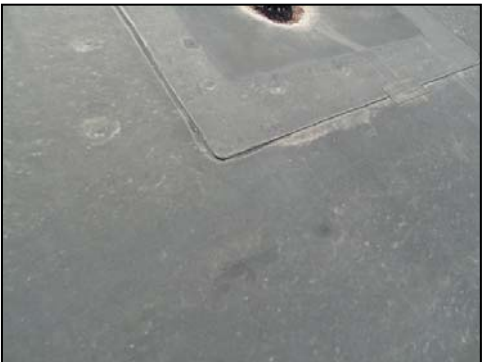
Defect Code:	45	Quantity:	Random	Priority:	Monitor
Description: Open flashing lap					
Repair: Open loose lap area and clean thoroughly. Prime and reseam or reweld lap per the manufacturer's requirements. Strip-in defective lap with mimum 6" wide membrane on single ply systems or 6" wide fabric and mastic three-course application on asphalt systems. Regranulate or coat flashing repairs.

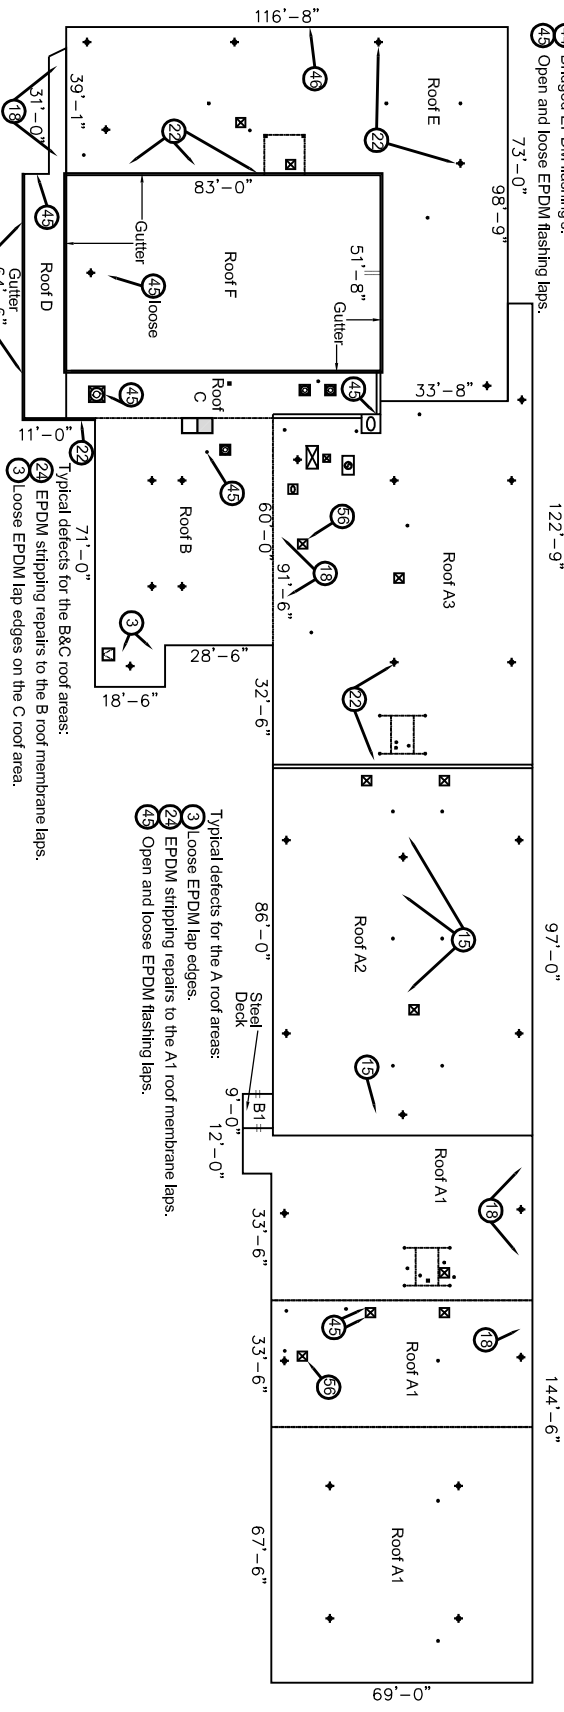
Typical defects for the E roof area:  
 3 Loose EPDM lap edges.  
 49 Open and loose EPDM flashing laps.

Typical defects for the F roof area:  
 3 Loose EPDM lap edges.  
 24 EPDM stripping repairs to the gutter edge detail seams.  
 122'-9"
