# Roof Inspection Report

Central Elementary School  
510 W. 22<sup>nd</sup> Avenue  
Bellevue, NE 68005

Date	Inspection Type	Inspecting Company	Inspector
Mar 22, 2017	Phase 1 Roof Inspection	Roofing Solutions, Inc.	Garry Hendrickson

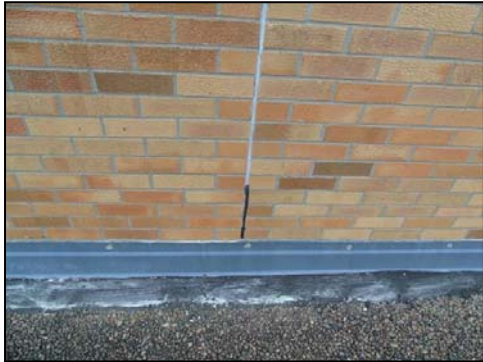
<b>Defect Code:</b>	<b>1</b>	<b>Quantity:</b>	<b>Random</b>	<b>Priority:</b>	<b>First Year</b>
Description: Deteriorated or missing sealant at counterflashing, termination bar, sealant lip, metal flashing, expansion joint, etc.					
Repair: Clean loose sealant and dirt from all surfaces. Apply new polyurethane sealant and tool to shed water.

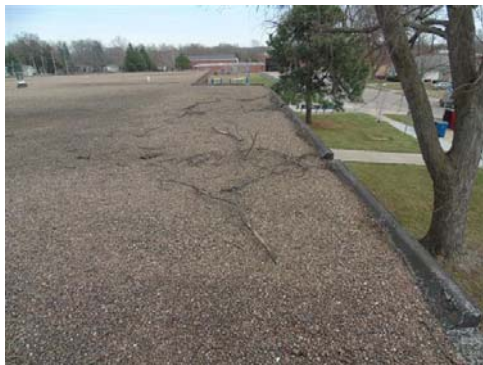
<b>Defect Code:</b>	<b>22</b>	<b>Quantity:</b>	<b>Random</b>	<b>Priority:</b>	<b>First Year</b>
Description: Debris, trash, construction materials, HVAC equipment, filters, motors, etc. on roof surface.					
Repair: Remove all trash and debris from roof. Clean and inspect surfaces and repair any damages to the membrane or flashings.

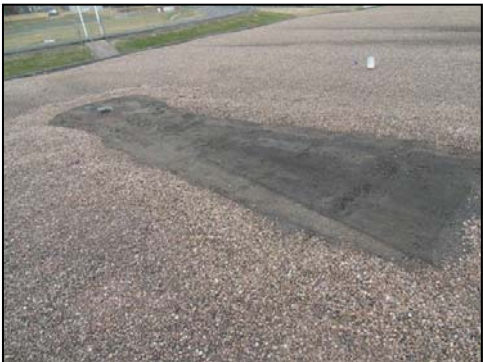
<b>Defect Code:</b>	<b>24</b>	<b>Quantity:</b>	<b>Numerous</b>	<b>Priority:</b>	<b>Monitor</b>
Description: Evidence of past problem and previous repair.					
Repair: Investigate for chronic leak problems and repair any areas that are suspect.

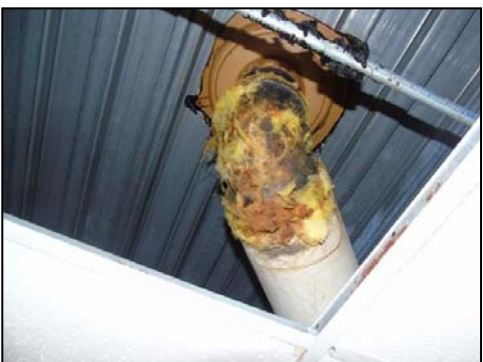
Facility personnel reported an ongoing leak issue around a roof drain on the A-1 roof area.

<b>Defect Code:</b>	<b>28</b>	<b>Quantity:</b>	<b>1</b>	<b>Priority:</b>	<b>First Year</b>
Description: Reported leak location					
Repair: Investigate leak and determine source. Repair areas with like materials of appropriate gauge and plies.

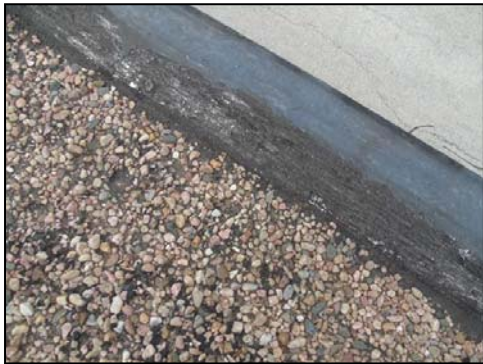
<b>Defect Code:</b>	<b>43</b>	<b>Quantity:</b>	<b>Widespread</b>	<b>Priority:</b>	<b>First Year</b>
Description: Weathered and deteriorated flashing					
Repair: Clean and prepare surfaces by removing loose granules, dirt, and other debris. Apply two coats of elastomeric coating compatible with the flashing materials.

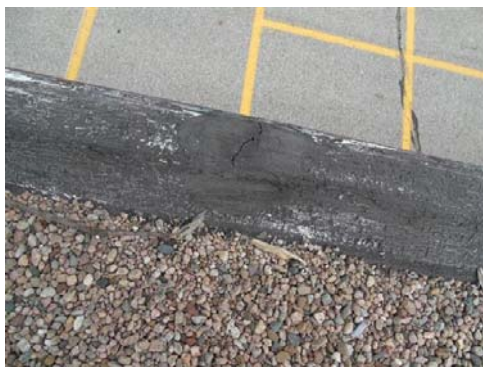
<b>Defect Code:</b>	<b>46</b>	<b>Quantity:</b>	<b>Widespread</b>	<b>Priority:</b>	<b>First Year</b>
Description: Split in flashing					
Repair: Cut away loose flashing and clean and prime repair area. Apply strip in of like material centered over split extending a minimum of 4" in all directions past prepared area.

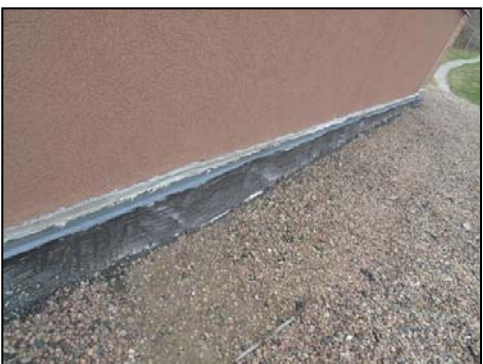
<b>Defect Code:</b>	<b>58</b>	<b>Quantity:</b>	<b>Random</b>	<b>Priority:</b>	<b>Monitor</b>
Description: Inadequate, incomplete, nonconforming membrane flashings or flashing details.					
Repair: Complete membrane flashing repairs in accordance with NRCA recommendations and good roofing practices. Follow manufacturer requirements on warranted systems.

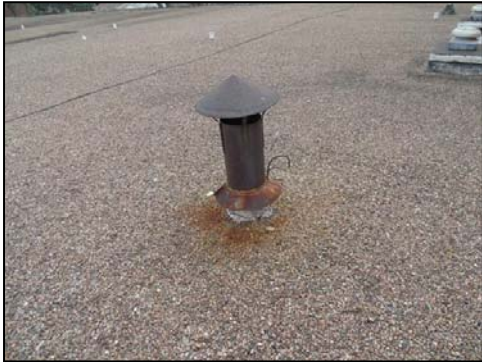
<b>Defect Code:</b>	<b>86</b>	<b>Quantity:</b>	<b>1</b>	<b>Priority:</b>	<b>Monitor</b>
Description: Corrosion or rust					
Repair: Remove rusted components and replace with similar metal fabricated and installed per SMACNA requirements.

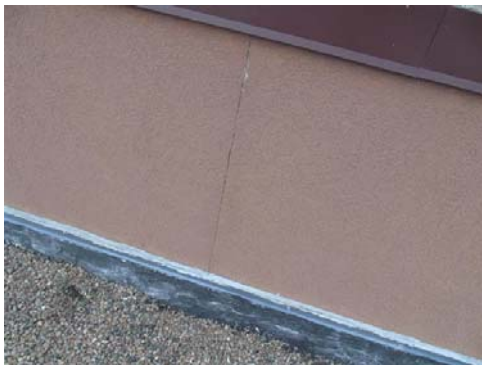
<b>Defect Code:</b>	<b>89</b>	<b>Quantity:</b>	<b>Under 10 LF</b>	<b>Priority:</b>	<b>First Year</b>
Description: Missing wall covering/cladding.					
Repair: Replace cladding/wall covering with matching materials and methods. Reattach and reseal all joints, seams, laps, etc.

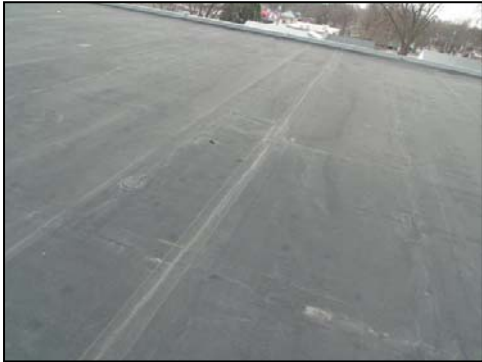
Defect Code:	24	Quantity:	Widespread	Priority:	Monitor
Description: Evidence of past problem and previous repair.					
Repair: Investigate for chronic leak problems and repair any areas that are suspect.

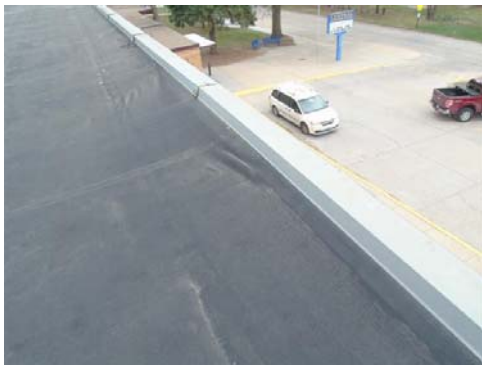
Defect Code:	41	Quantity:	Random	Priority:	Monitor
Description: Missing or inadequate flashing attachment.					
Repair: Mechanically attach flashings a maximum of 6" O.C using screws and plates or 1" cap nails. Terminate with metal flashings or compression bar.

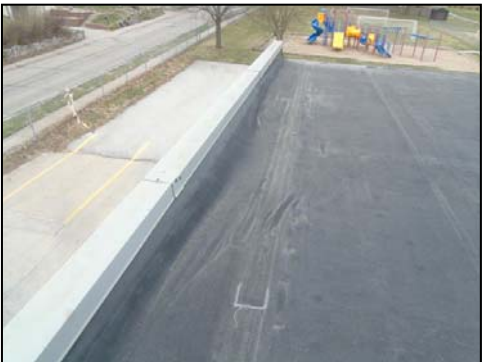
Defect Code:	44	Quantity:	Widespread	Priority:	Monitor
Description: Bridged flashing					
Repair: Cut out all bridged flashings. Clean area thoroughly and apply new flashings. Apply corner flashings and overlay all T-laps, flashings laps, and splice intersections.

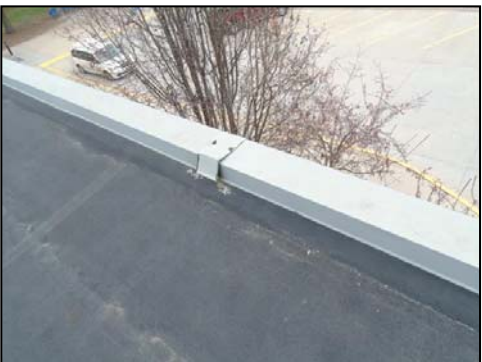
Defect Code:	71	Quantity:	Widespread	Priority:	Monitor
Description: Open or missing joint cover.					
Repair: Replace joint covers that are open or missing with matching joint covers and sealant.

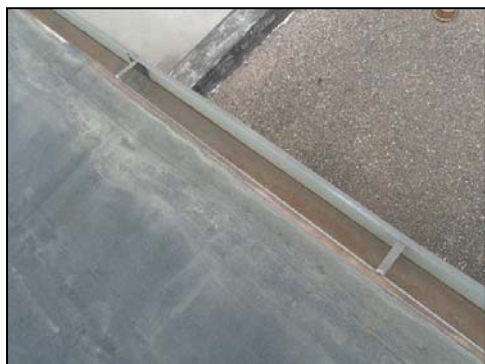
Defect Code:	86	Quantity:	Widespread	Priority:	Monitor
Description: Corrosion or rust					
Repair: Remove rusted components and replace with similar metal fabricated and installed per SMACNA requirements.

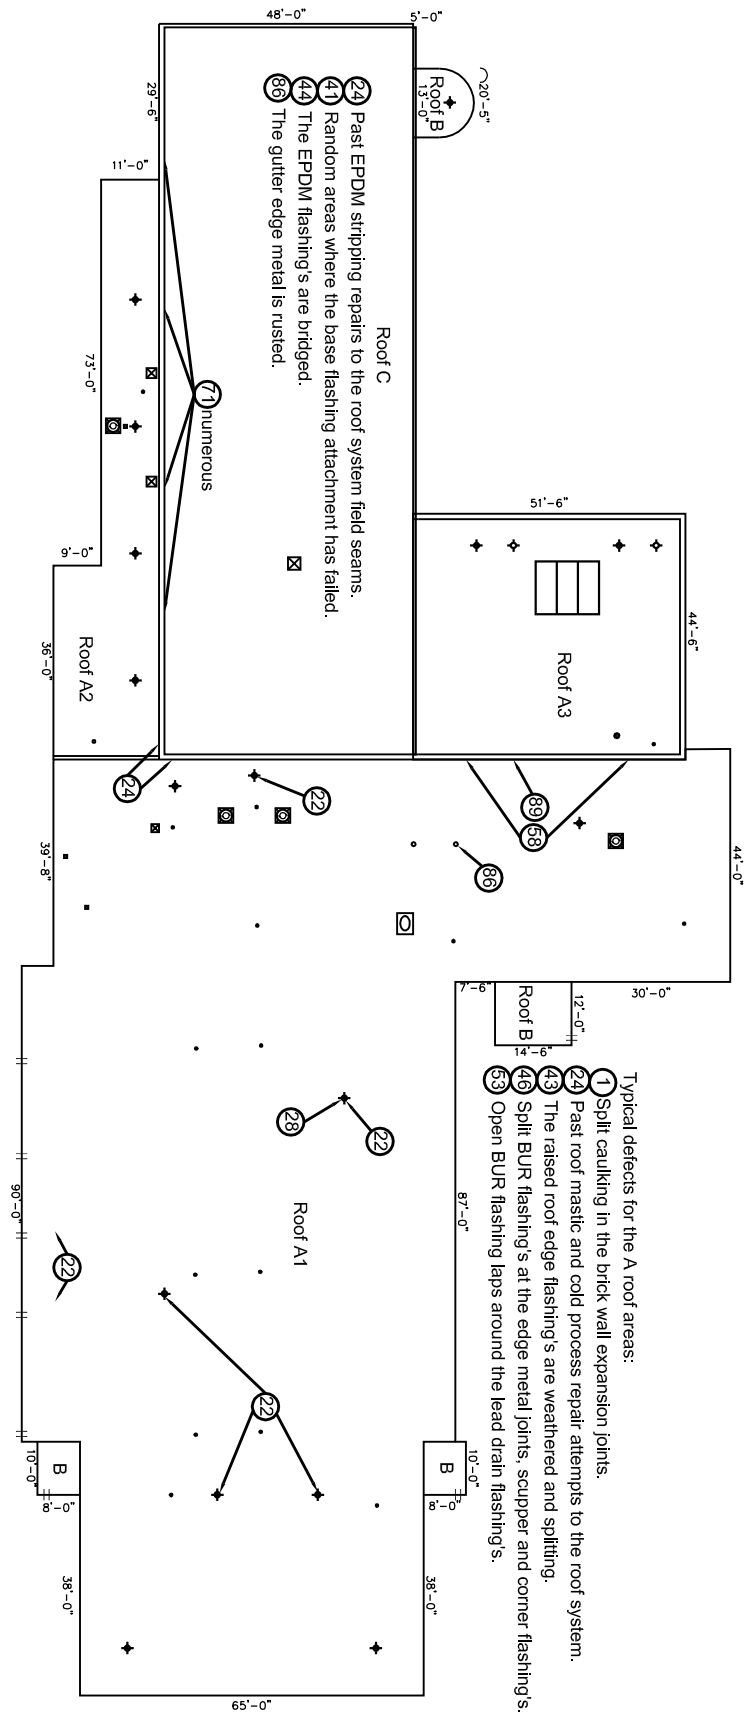
**Sheet Title:**  
**A,B&C-Roof Plan**

Typical defects for the A roof areas:

- (1) Split caulking in the brick wall expansion joints.
- (24) Past roof mastic and cold process repair attempts to the roof system.
- (43) The raised roof edge flashings are weathered and splitting.
- (49) Split BUR flashings at the edge metal joints, scupper and corner flashings.
- (53) Open BUR flashing laps around the lead drain flashings.

Roof C

- (24) Past EPDM stripping repairs to the roof system field seams.
- (41) Random areas where the base flashing attachment has failed.
- (44) The EPDM flashings are bridged.
- (86) The gutter edge metal is rusted.

(71) numerous
