Roof Inspection Report

Chap Elementary
1201 Gregg Road
Bellevue, NE 68005

Date	Inspection Type	Inspecting Company	Inspector
Mar 23, 2017	Phase 1 Roof Inspection	Roofing Solutions, Inc.	Garry Hendrickson

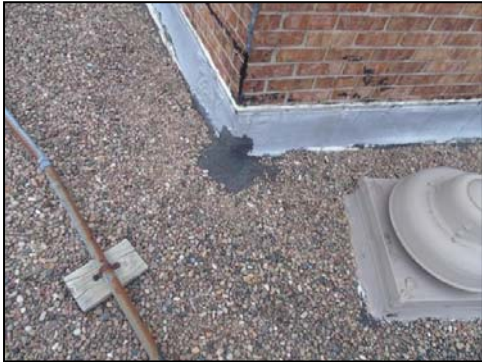
Defect Code:	24	Quantity:	Random	Priority:	Monitor
Description: Evidence of past problem and previous repair.					
Repair: Investigate for chronic leak problems and repair any areas that are suspect.

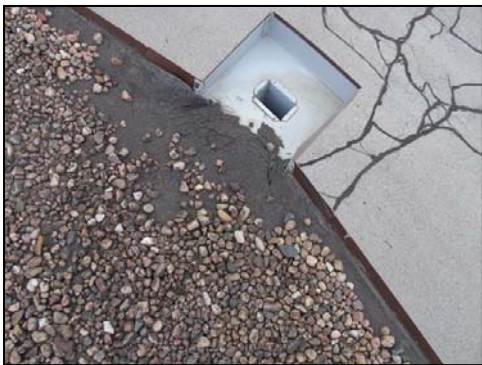
Defect Code:	46	Quantity:	Numerous	Priority:	First Year
Description: Split in flashing					
Repair: Cut away loose flashing and clean and prime repair area. Apply strip in of like material centered over split extending a minimum of 4" in all directions past prepared area.

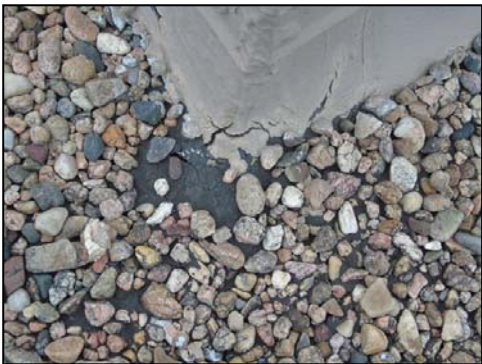
Defect Code:	46	Quantity:	Numerous	Priority:	Monitor
Description: Split in flashing					
Repair: Cut away loose flashing and clean and prime repair area. Apply strip in of like material centered over split extending a minimum of 4" in all directions past prepared area.

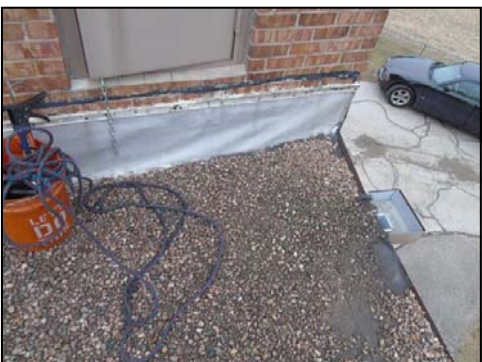
Defect Code:	47	Quantity:	Random	Priority:	Monitor
Description: Racked flashings					
Repair: Monitor flashings and repair when identified as deteriorated.

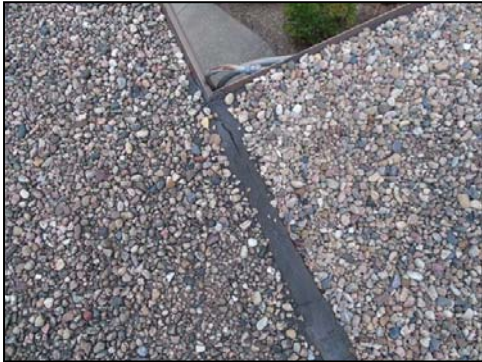
Defect Code:	57	Quantity:	Widespread	Priority:	Monitor
Description: Expansion joint deficiencies.					
Repair: Repair defects in rubber expansion joint or joint covers with two layers of flashing with the second layer being 3" larger in all directions than the first. Install flashing with manufacturer's recommended cleaners and primers.

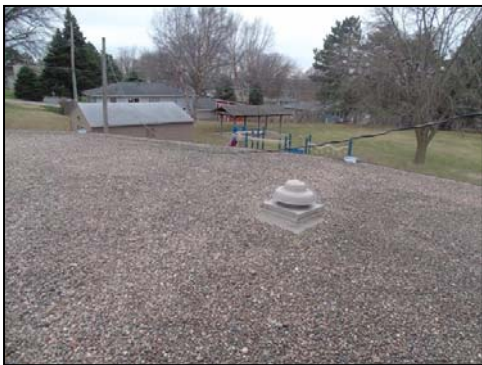
Defect Code:	87	Quantity:	1	Priority:	First Year
Description: Mechanical defect					
Repair: Repair mechanical defect. Replace or reinstall missing access doors and panels. Reseal rooftop unit, pans, ducts, curbs, etc.
