Roof Inspection Report

East High School
1401 High School Drive
Bellevue, NE 68005

Date of Last Inspection: Apr 03, 2017

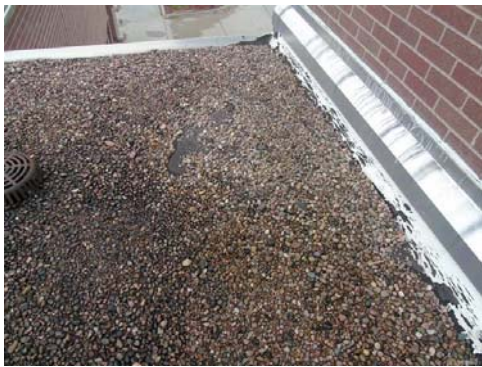
Defect Code:	11	Quantity:	Random	Priority:	Monitor
Description: Blister in field membrane or flashing.					
Repair: Monitor blisters that are not broken. Repair any broken blisters or blisters in traffic areas or those applying stress to seams or flashings. Cut out blistered membrane and remove wet materials. Apply new membrane and extend a minimum of 6" on

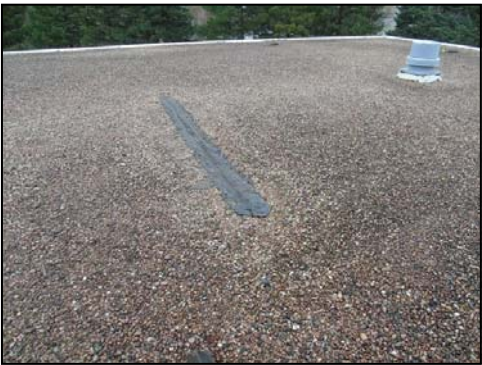
Defect Code:	24	Quantity:	Random	Priority:	Monitor
Description: Evidence of past problem and previous repair.					
Repair: Investigate for chronic leak problems and repair any areas that are suspect.

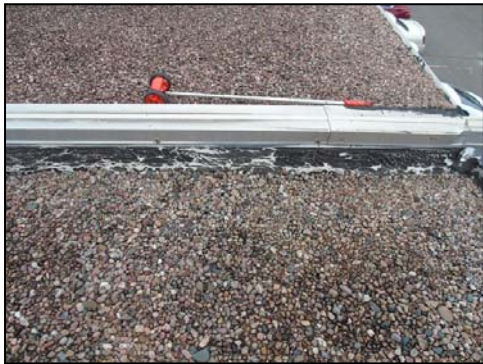
Defect Code:	75	Quantity:	Widespread	Priority:	First Year
Description: Inadequate attachment of metal flashings.					
Repair: Reattach metal flashings a maximum of two EPDM washered fasteners per side of curb or attach a maximum of 12" O.C for flashings more than 24 " in length.

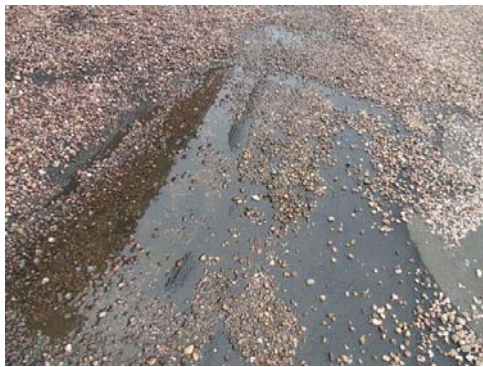
Defect Code:	5	Quantity:	Random	Priority:	Monitor
Description: Buckling or ridging of membrane.					
Repair: Cut out deteriorated buckles and ridges and repair membrane with similar membrane material. Extend repair material a minimum of 6" in all directions past repair areas.

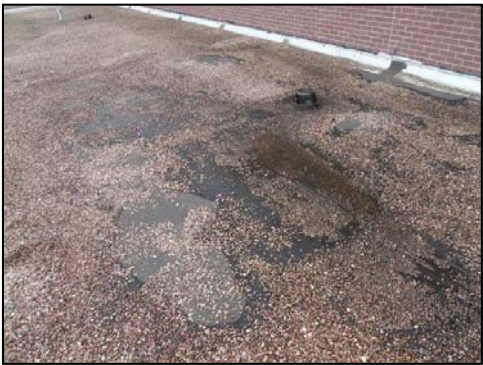
Defect Code:	8	Quantity:	Widespread	Priority:	Monitor
Description: Surface erosion.					
Repair: Prepare membrane surface by thoroughly cleaning and priming. Apply new surfacing of like materials to eroded areas. On gravel surfaced systems apply gravel in hot asphalt or recommended cold adhesive. Apply granulated fiberglass cap sheet or modified bitumen membrane on like systems. Apply coating system on smooth asphalt

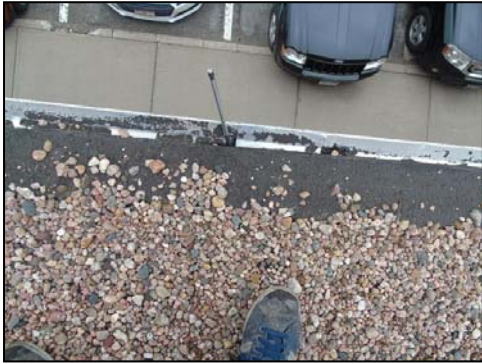
Defect Code:	45	Quantity:	Widespread	Priority:	First Year
Description: Open flashing lap					
Repair: Open loose lap area and clean thoroughly. Prime and reseam or reweld lap per the manufacturer's requirements. Strip-in defective lap with mimum 6" wide membrane on single ply systems or 6" wide fabric and mastic three-course application on asphalt systems. Regranulate or coat flashing repairs.

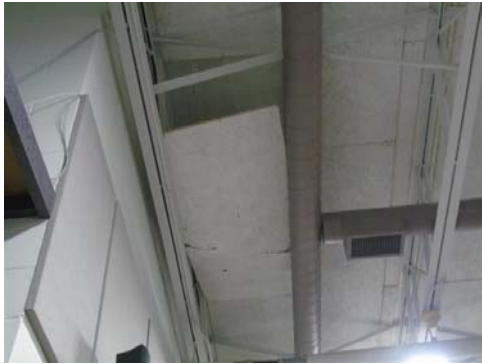
Defect Code:	84	Quantity:	1	Priority:	Urgent
Description: Deck deflection					
Repair: Significant deck deflection creating localized, moderate to severe ponding shall be investigated to determine the cause and severity of deflection.

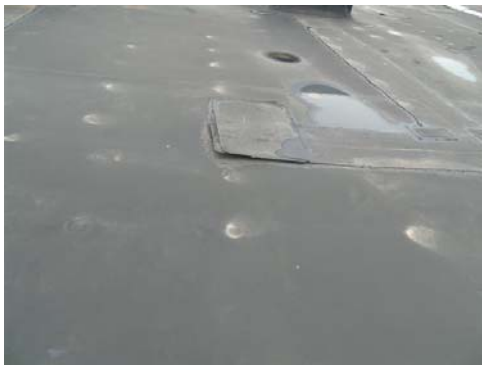
Defect Code:	3	Quantity:	Widespread	Priority:	Monitor
Description: Open lap in field membrane.					
Repair: Clean lap of all dirt and close seam. Overlay edge of affected seam with strip-in of new membrane of like material. Extend a minimum of 4" in all directions past seam edges and repair areas.

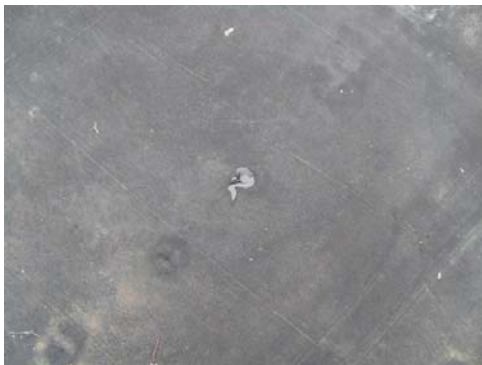
Defect Code:	23	Quantity:	Under 10 SF	Priority:	Monitor
Description: Physical damage to membrane including cuts, holes, tears, scrapes, scuffs, or abrasions.					
Repair: Apply repair membrane over damaged area, extending repair material a minimum 6" past damage.

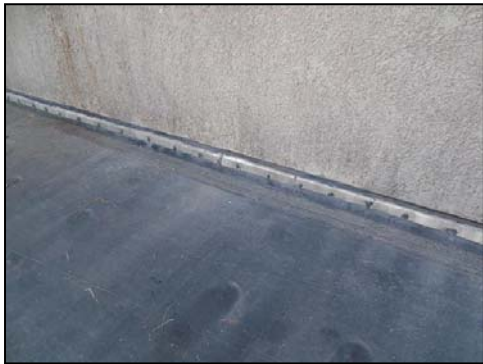
Defect Code:	40	Quantity:	20 LF	Priority:	Monitor
Description: Low flashing height.					
Repair: Raise flashing height to a minimum of 8" above finished roof surface. Provide appropriate termination of flashings with metal copings or counterflashings. Provide a compression bar termination of flashings to concrete or block surface if flashings cannot be maintained at 8" minimum height.

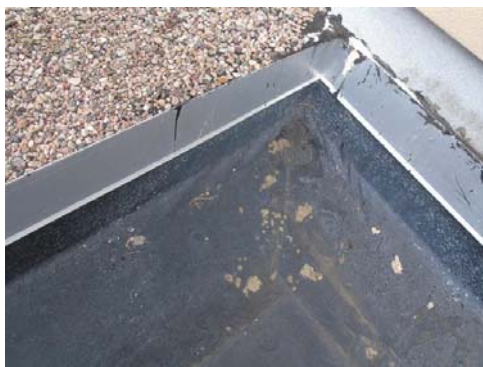
Defect Code:	44	Quantity:	Random	Priority:	Monitor
Description: Bridged flashing					
Cut out all bridged flashings. Clean area thoroughly and apply new flashings. Apply corner flashings and overlay all T-laps, flashings laps, and splice intersections.

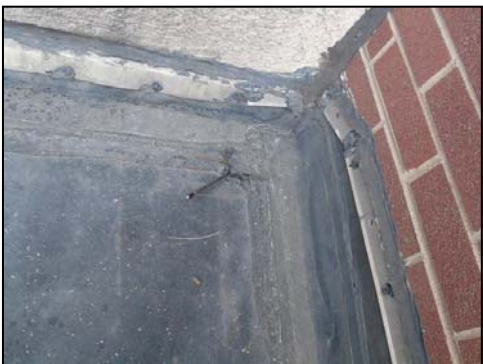
Defect Code:	45	Quantity:	Widespread	Priority:	Monitor
Description: Open flashing lap					
Repair: Open loose lap area and clean thoroughly. Prime and reseam or reweld lap per the manufacturer's requirements. Strip-in defective lap with mimum 6" wide membrane on single ply systems or 6" wide fabric and mastic three-course application on asphalt systems. Regranulate or coat flashing repairs.

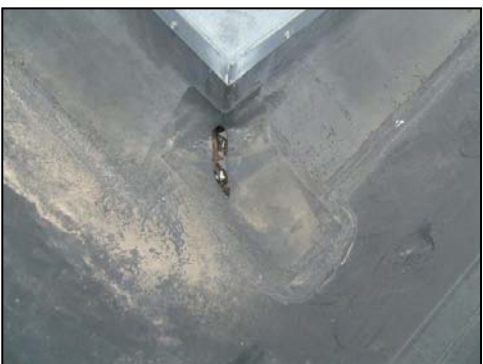
Defect Code:	46	Quantity:	Under 10 LF	Priority:	First Year
Description: Split in flashing					
Repair: Cut away loose flashing and clean and prime repair area. Apply strip in of like material centered over split extending a minimum of 4" in all directions past prepared area.

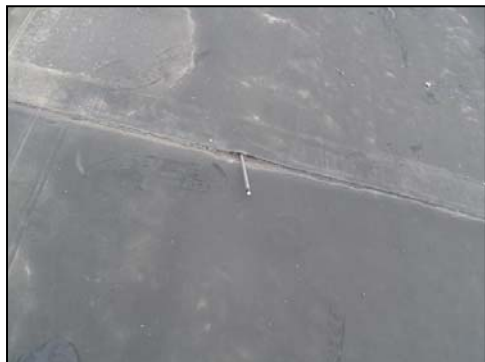
Defect Code:	3	Quantity:	Widespread	Priority:	Monitor
Description: Open lap in field membrane.					
Repair: Clean lap of all dirt and close seam. Overlay edge of affected seam with strip-in of new membrane of like material. Extend a minimum of 4" in all directions past seam edges and repair areas.

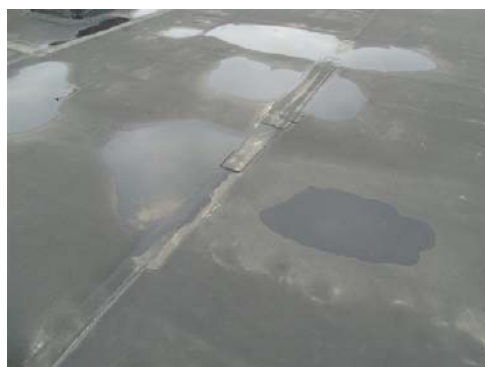
Defect Code:	24	Quantity:	Random	Priority:	Monitor
Description: Evidence of past problem and previous repair.					
Repair: Investigate for chronic leak problems and repair any areas that are suspect.

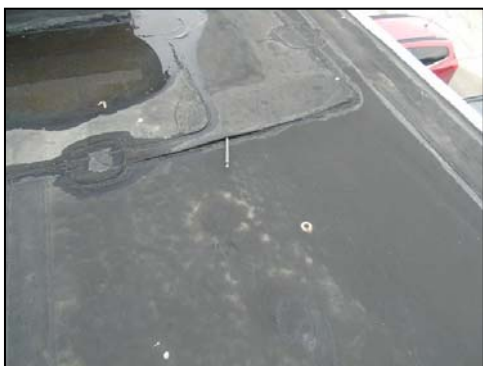
Defect Code:	45	Quantity:	Widespread	Priority:	Monitor
Description: Open flashing lap					
Repair: Open loose lap area and clean thoroughly. Prime and reseam or reweld lap per the manufacturer's requirements. Strip-in defective lap with mimum 6" wide membrane on single ply systems or 6" wide fabric and mastic three-course application on asphalt systems. Regranulate or coat flashing repairs.

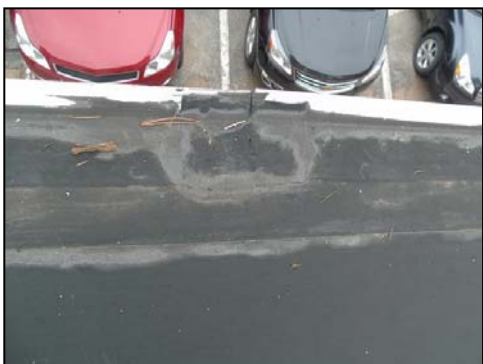
Defect Code:	46	Quantity:	Widespread	Priority:	First Year
Description: Split in flashing					
Repair: Cut away loose flashing and clean and prime repair area. Apply strip in of like material centered over split extending a minimum of 4" in all directions past prepared area.

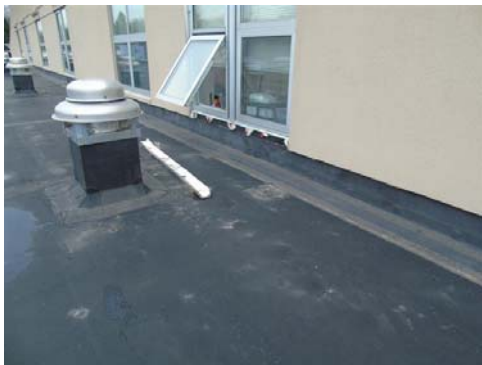
Defect Code:	89	Quantity:	Under 10 LF	Priority:	Monitor
Description: Missing wall covering/cladding.					
Repair: Replace cladding/wall covering with matching materials and methods. Reattach and reseal all joints, seams, laps, etc.

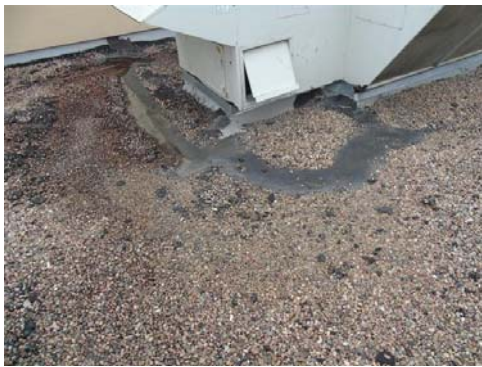
Defect Code:	24	Quantity:	1	Priority:	Monitor
Description: Evidence of past problem and previous repair.					
Repair: Investigate for chronic leak problems and repair any areas that are suspect.

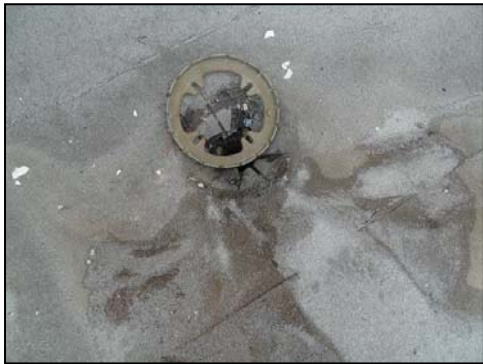
Defect Code:	58	Quantity:	1	Priority:	First Year
Description: Inadequate, incomplete, nonconforming membrane flashings or flashing details.					
Repair: Complete membrane flashing repairs in accordance with NRCA recommendations and good roofing practices. Follow manufacturer requirements on warranted systems.

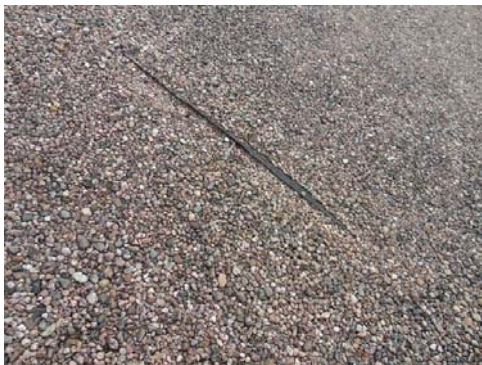
Defect Code:	3	Quantity:	10 LF	Priority:	First Year
Description: Open lap in field membrane.					
Repair: Clean lap of all dirt and close seam. Overlay edge of affected seam with strip-in of new membrane of like material. Extend a minimum of 4" in all directions past seam edges and repair areas.

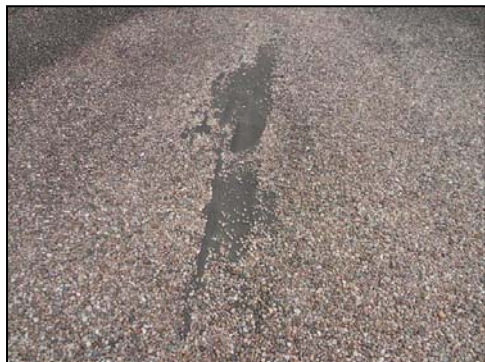
Defect Code:	8	Quantity:	Widespread	Priority:	Monitor
Description: Surface erosion.					
Repair: Prepare membrane surface by thoroughly cleaning and priming. Apply new surfacing of like materials to eroded areas. On gravel surfaced systems apply gravel in hot asphalt or recommended cold adhesive. Apply granulated fiberglass cap sheet or modified bitumen membrane on like systems. Apply coating system on smooth asphalt surfaces. Transition surfacing to provide for a smooth and neat finished appearance to match the existing surfacing.

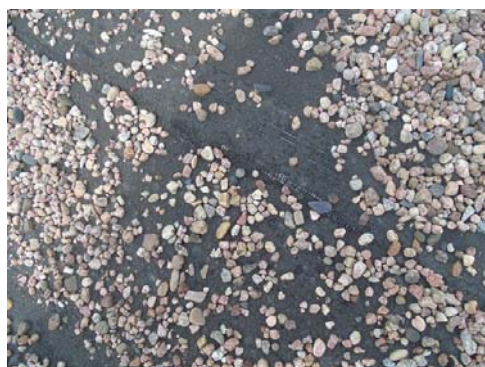
Defect Code:	9	Quantity:	Random	Priority:	First Year
Description: Membrane deterioration.					
Repair: Replace all deteriorated membrane with new membrane of similar type, gauge, and plies.

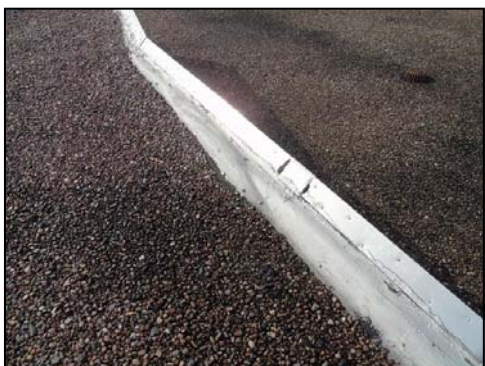
Defect Code:	11	Quantity:	Random	Priority:	Monitor
Description: Blister in field membrane or flashing.					
Repair: Monitor blisters that are not broken. Repair any broken blisters or blisters in traffic areas or those applying stress to seams or flashings. Cut out blistered membrane and remove wet materials. Apply new membrane and extend a minimum of 6" on

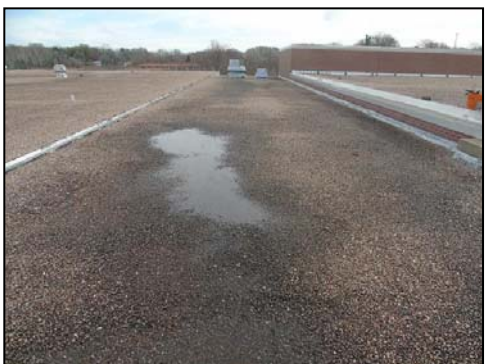
Defect Code:	15	Quantity:	Random	Priority:	Monitor
Description: Ponding of water.					
Repair: Monitor areas for severe or chronic ponding. Provide sacrificial membrane ply in ponded areas where existing membrane is deteriorated. Install additional drain or scupper including collectors and drain piping where ponding conditions are severe and chronic.

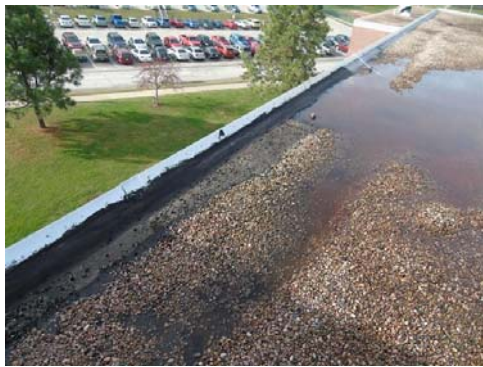
Defect Code:	24	Quantity:	Random	Priority:	Monitor
Description: Evidence of past problem and previous repair.					
Repair: Investigate for chronic leak problems and repair any areas that are suspect.

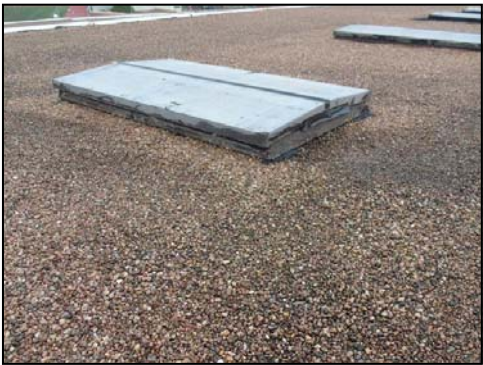
Defect Code:	40	Quantity:	6	Priority:	Monitor
Description: Low flashing height.					
Repair: Raise flashing height to a minimum of 8" above finished roof surface. Provide appropriate termination of flashings with metal copings or counterflashings. Provide a compression bar termination of flashings to concrete or block surface if flashings cannot be maintained at 8" minimum height.

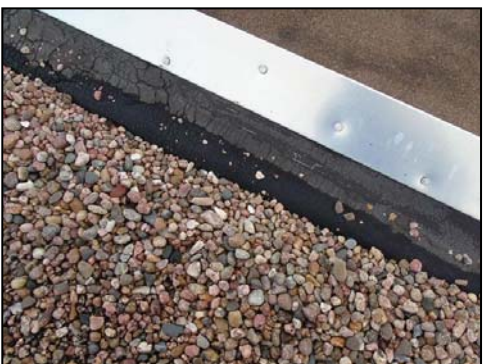
Defect Code:	43	Quantity:	Widespread	Priority:	Monitor
Description: Weathered and deteriorated flashing					
Repair: Clean and prepare surfaces by removing loose granules, dirt, and other debris. Apply two coats of elastomeric coating compatible with the flashing materials.

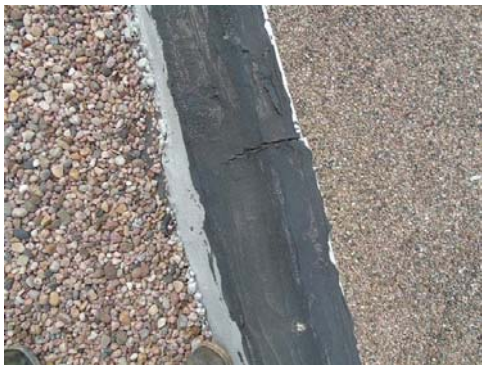
Defect Code:	46	Quantity:	Widespread	Priority:	First Year
Description: Split in flashing					
Repair: Cut away loose flashing and clean and prime repair area. Apply strip in of like material centered over split extending a minimum of 4" in all directions past prepared area.

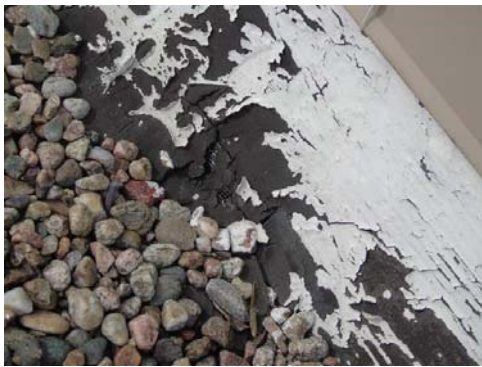
Defect Code:	9	Quantity:	Random	Priority:	Monitor
Description: Membrane deterioration.					
Repair: Replace all deteriorated membrane with new membrane of similar type, gauge, and plies.

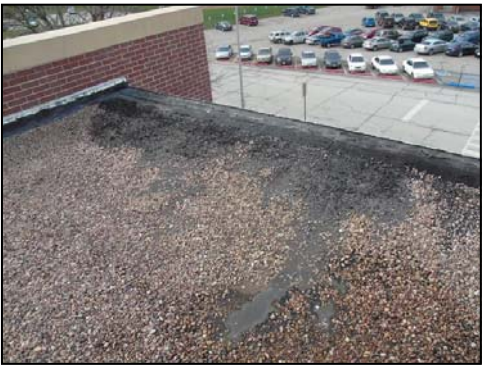
Defect Code:	24	Quantity:	Random	Priority:	Monitor
Description: Evidence of past problem and previous repair.					
Repair: Investigate for chronic leak problems and repair any areas that are suspect.

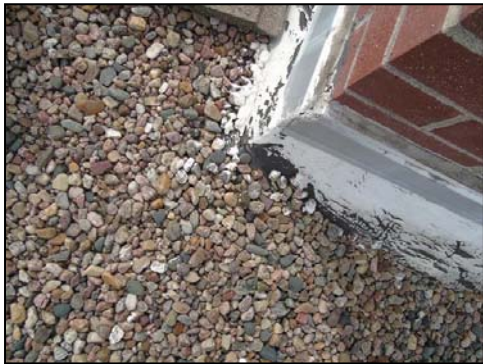
Defect Code:	46	Quantity:	Random	Priority:	Monitor
Description: Split in flashing					
Repair: Cut away loose flashing and clean and prime repair area. Apply strip in of like material centered over split extending a minimum of 4" in all directions past prepared area.

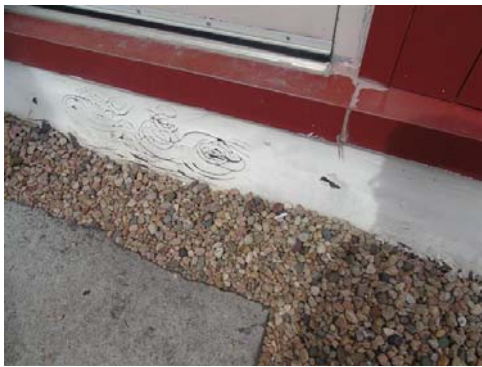
Defect Code:	23	Quantity:	10 SF	Priority:	First Year
Description: Physical damage to membrane including cuts, holes, tears, scrapes, scuffs, or abrasions.					
Repair: Apply repair membrane over damaged area, extending repair material a minimum 6" past damage.

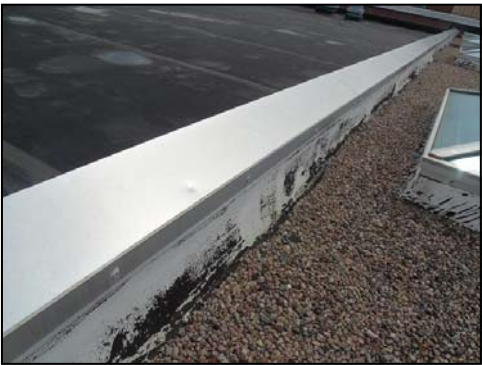
Defect Code:	23	Quantity:	Random	Priority:	Monitor
Description: Physical damage to membrane including cuts, holes, tears, scrapes, scuffs, or abrasions.					
Repair: Apply repair membrane over damaged area, extending repair material a minimum 6" past damage.

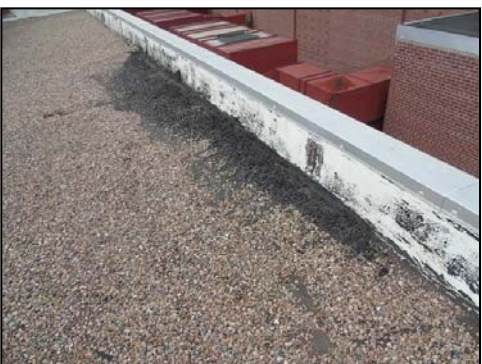
Defect Code:	24	Quantity:	Random	Priority:	Monitor
Description: Evidence of past problem and previous repair.					
Repair: Investigate for chronic leak problems and repair any areas that are suspect.

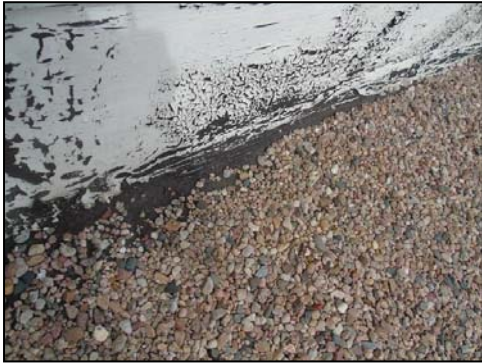
Defect Code:	43	Quantity:	Widespread	Priority:	Monitor
Description: Weathered and deteriorated flashing					
Repair: Clean and prepare surfaces by removing loose granules, dirt, and other debris. Apply two coats of elastomeric coating compatible with the flashing materials.

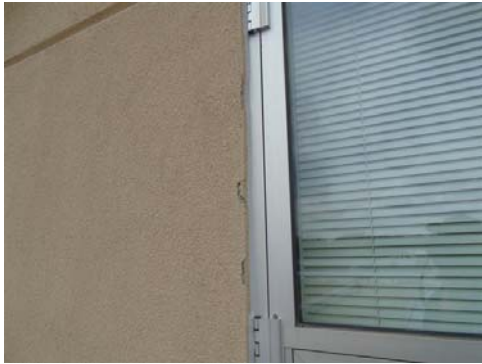
Defect Code:	89	Quantity:	Random	Priority:	Monitor
Description: Missing wall covering/cladding.					
Repair: Replace cladding/wall covering with matching materials and methods. Reattach and reseal all joints, seams, laps, etc.

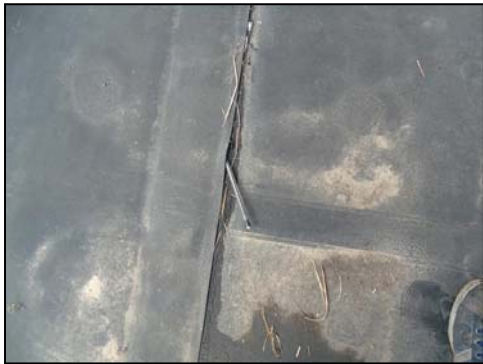
Defect Code:	3	Quantity:	Random	Priority:	Monitor
Description: Open lap in field membrane.					
Repair: Clean lap of all dirt and close seam. Overlay edge of affected seam with strip-in of new membrane of like material. Extend a minimum of 4" in all directions past seam edges and repair areas.

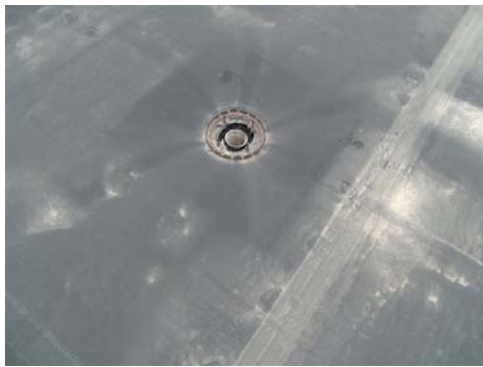
Defect Code:	17	Quantity:	4	Priority:	Monitor
Description: Missing or damaged drain/scupper strainer					
Repair: Replace damaged or missing strainer with a new cast iron strainer sized to fit the drain assembly or scupper opening. Lock in place to prevent loss.

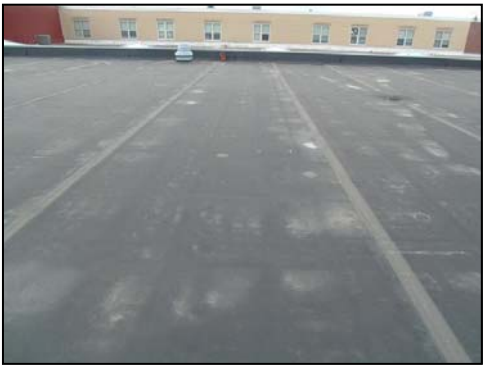
Defect Code:	24	Quantity:	Widespread	Priority:	Monitor
Description: Evidence of past problem and previous repair.					
Repair: Investigate for chronic leak problems and repair any areas that are suspect.

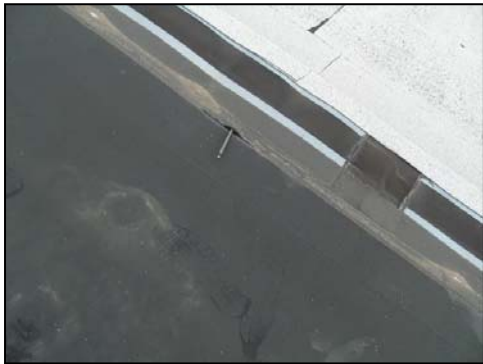
Defect Code:	45	Quantity:	Widespread	Priority:	Monitor
Description: Open flashing lap					
Repair: Open loose lap area and clean thoroughly. Prime and reseam or reweld lap per the manufacturer's requirements. Strip-in defective lap with minimum 6" wide membrane on single ply systems or 6" wide fabric and mastic three-course application on asphalt systems. Regranulate or coat flashing repairs.

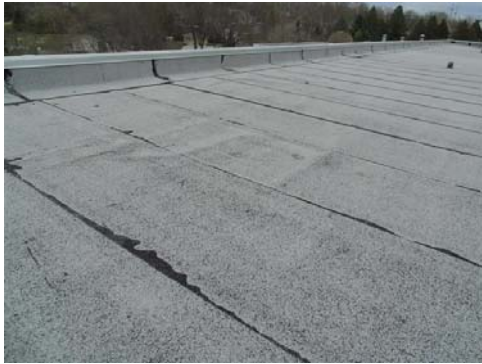
Defect Code:	5	Quantity:	500 SF	Priority:	Monitor
Description: Buckling or ridging of membrane.					
Repair: Cut out deteriorated buckles and ridges and repair membrane with similar membrane material. Extend repair material a minimum of 6" in all directions past repair areas.

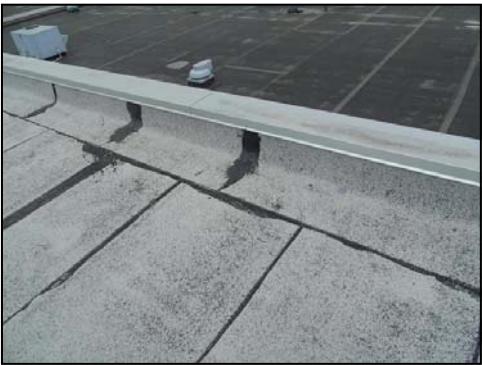
Defect Code:	24	Quantity:	Random	Priority:	Monitor
Description: Evidence of past problem and previous repair.					
Repair: Investigate for chronic leak problems and repair any areas that are suspect.

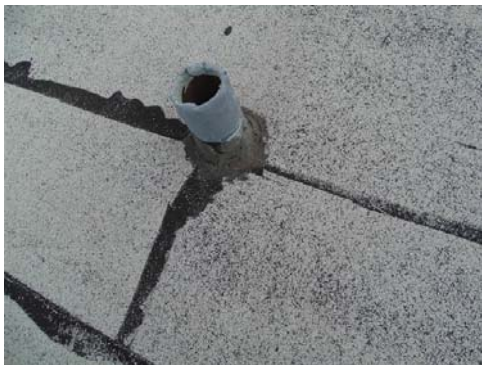
Defect Code:	46	Quantity:	40 LF	Priority:	First Year
Description: Split in flashing					
Repair: Cut away loose flashing and clean and prime repair area. Apply strip in of like material centered over split extending a minimum of 4" in all directions past prepared area.

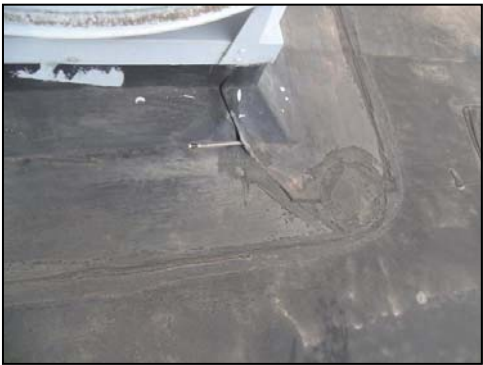
Defect Code:	45	Quantity:	Widespread	Priority:	Monitor
Description: Open flashing lap					
Repair: Open loose lap area and clean thoroughly. Prime and reseam or reweld lap per the manufacturer's requirements. Strip-in defective lap with mimum 6" wide membrane on single ply systems or 6" wide fabric and mastic three-course application on asphalt systems. Regranulate or coat flashing repairs.

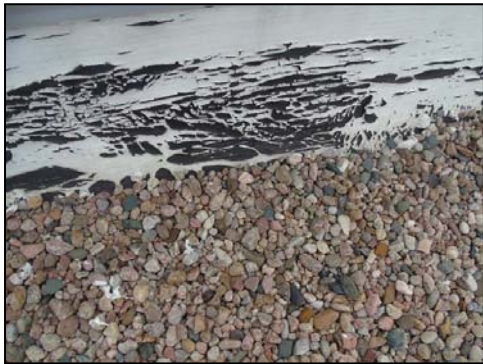
Defect Code:	43	Quantity:	Widespread	Priority:	Monitor
Description: Weathered and deteriorated flashing					
Repair: Clean and prepare surfaces by removing loose granules, dirt, and other debris. Apply two coats of elastomeric coating compatible with the flashing materials.

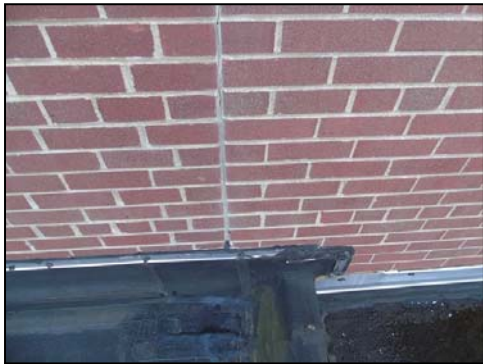
Defect Code:	1	Quantity:	Widespread	Priority:	Monitor
Description: Deteriorated or missing sealant at counterflashing, termination bar, sealant lip, metal flashing, expansion joint, etc.					
Repair: Clean loose sealant and dirt from all surfaces. Apply new polyurethane sealant and tool to shed water.

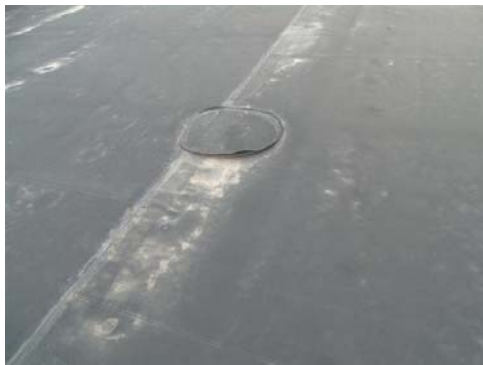
Defect Code:	3	Quantity:	Widespread	Priority:	Monitor
Description: Open lap in field membrane.					
Repair: Clean lap of all dirt and close seam. Overlay edge of affected seam with strip-in of new membrane of like material. Extend a minimum of 4" in all directions past seam edges and repair areas.

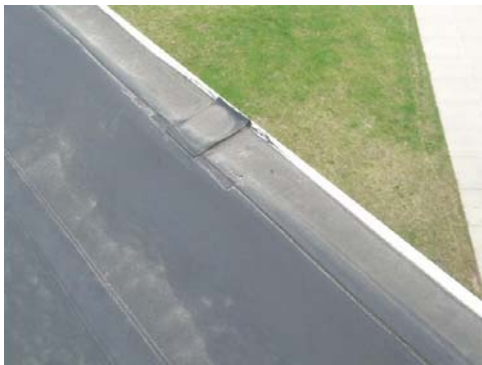
Defect Code:	45	Quantity:	Widespread	Priority:	Monitor
Description: Open flashing lap					
Repair: Open loose lap area and clean thoroughly. Prime and reseam or reweld lap per the manufacturer's requirements. Strip-in defective lap with mimum 6" wide membrane on single ply systems or 6" wide fabric and mastic three-course application on asphalt systems. Regranulate or coat flashing repairs.

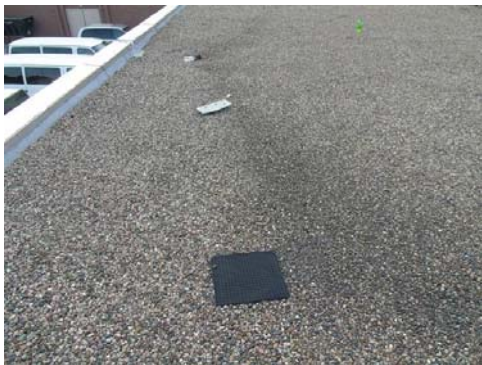
Defect Code:	22	Quantity:	Random	Priority:	First Year
Description: Debris, trash, construction materials, HVAC equipment, filters, motors, etc. on roof surface.					
Repair: Remove all trash and debris from roof. Clean and inspect surfaces and repair any damages to the membrane or flashings.

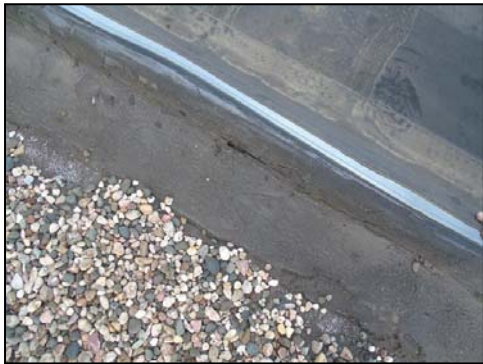
Defect Code:	46	Quantity:	Random	Priority:	First Year
Description: Split in flashing					
Repair: Cut away loose flashing and clean and prime repair area. Apply strip in of like material centered over split extending a minimum of 4" in all directions past prepared area.

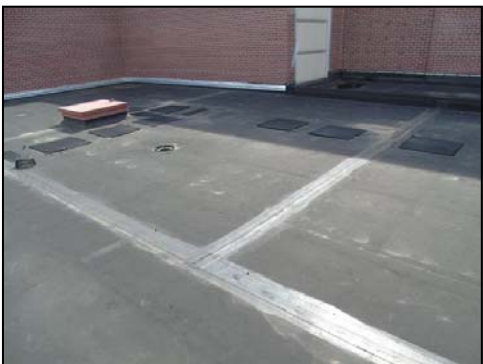
Defect Code:	24	Quantity:	Widespread	Priority:	Monitor
Description: Evidence of past problem and previous repair.					
Repair: Investigate for chronic leak problems and repair any areas that are suspect.
