# Roof Inspection Report

Fort Crook Elementary  
12501 S. 25<sup>th</sup> Street  
Bellevue, NE 68123

Date	Inspection Type	Inspecting Company	Inspector
Mar 09, 2017	Phase 1 Roof Inspection	Roofing Solutions, Inc.	Garry Hendrickson

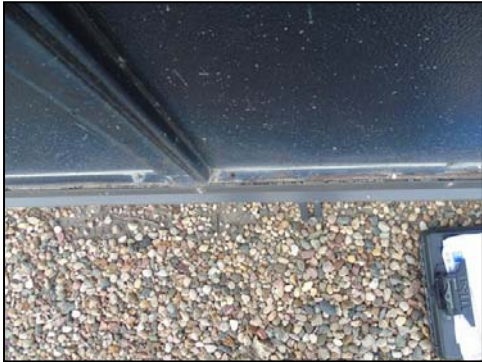
- Deteriorated caulking observed on top of the perimeter wall counter flashing on the B-2 roof area
- Accumulation of debris around the drain strainers
- Minimal flashing height observed on the wall details

<b>Defect Code:</b>	<b>1</b>	<b>Quantity:</b>	<b>10 LF</b>	<b>Priority:</b>	<b>First Year</b>
Description: Deteriorated or missing sealant at counterflashing, termination bar, sealant lip, metal flashing, expansion joint, etc.					
Repair: Clean loose sealant and dirt from all surfaces. Apply new polyurethane sealant and tool to shed water.

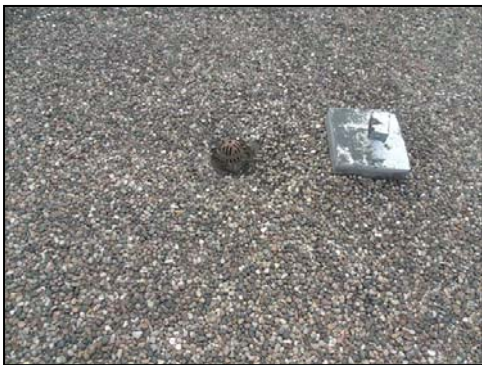
<b>Defect Code:</b>	<b>22</b>	<b>Quantity:</b>	<b>Random</b>	<b>Priority:</b>	<b>First Year</b>
Description: Debris, trash, construction materials, HVAC equipment, filters, motors, etc. on roof surface.					
Repair: Remove all trash and debris from roof. Clean and inspect surfaces and repair any damages to the membrane or flashings.

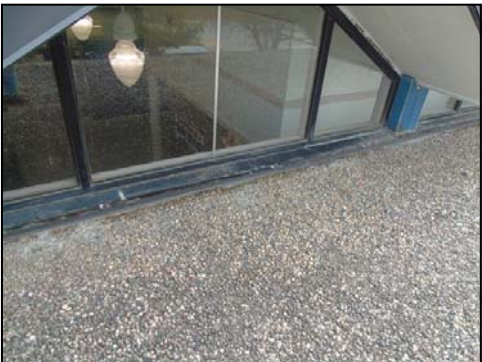
<b>Defect Code:</b>	<b>40</b>	<b>Quantity:</b>	<b>Widespread</b>	<b>Priority:</b>	<b>Monitor</b>
Description: Low flashing height.					
Repair: Raise flashing height to a minimum of 8" above finished roof surface. Provide appropriate termination of flashings with metal copings or counterflashings. Provide a compression bar termination of flashings to concrete or block surface if flashings cannot be maintained at 8" minimum height.

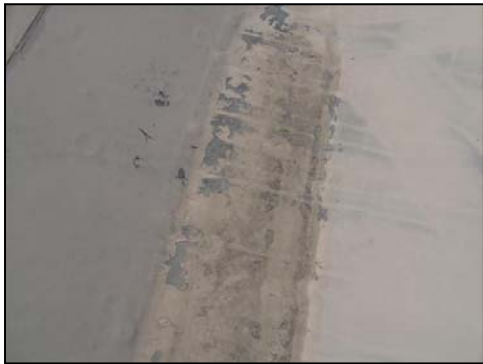
<b>Defect Code:</b>	<b>8</b>	<b>Quantity:</b>	<b>Widespread</b>	<b>Priority:</b>	<b>Monitor</b>
Description: Surface erosion.					
Repair: Prepare membrane surface by thoroughly cleaning and priming. Apply new surfacing of like materials to eroded areas. On gravel surfaced systems apply gravel in hot asphalt or recommended cold adhesive. Apply granulated fiberglass cap sheet or modified bitumen membrane on like systems. Apply coating system on smooth asphalt surfaces. Transition surfacing to provide for a smooth and neat finished appearance to match the existing surfacing.

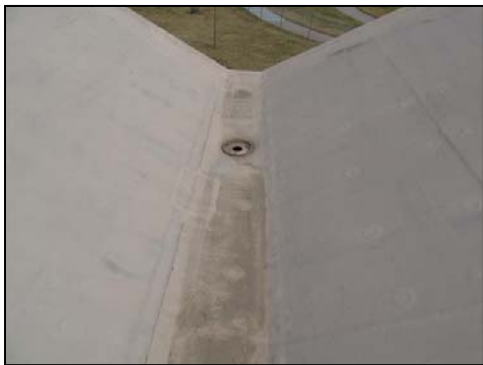
<b>Defect Code:</b>	<b>17</b>	<b>Quantity:</b>	<b>1</b>	<b>Priority:</b>	<b>First Year</b>
Description: Missing or damaged drain/scupper strainer					
Repair: Replace damaged or missing strainer with a new cast iron strainer sized to fit the drain assembly or scupper opening. Lock in place to prevent loss.

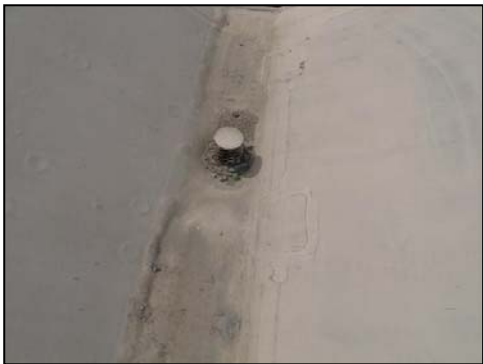
<b>Defect Code:</b>	<b>22</b>	<b>Quantity:</b>	<b>Random</b>	<b>Priority:</b>	<b>First Year</b>
Description: Debris, trash, construction materials, HVAC equipment, filters, motors, etc. on roof surface.					
Repair: Remove all trash and debris from roof. Clean and inspect surfaces and repair any damages to the membrane or flashings.

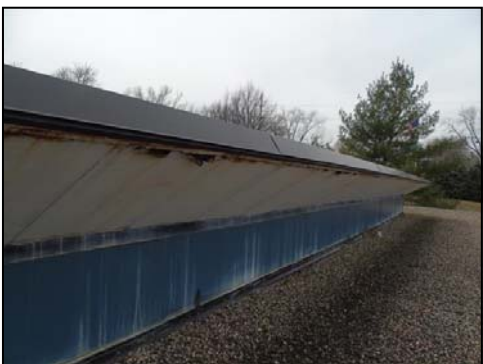
<b>Defect Code:</b>	<b>86</b>	<b>Quantity:</b>	<b>300 SF</b>	<b>Priority:</b>	<b>First Year</b>
Description: Corrosion or rust					
Repair: Remove rusted components and replace with similar metal fabricated and installed per SMACNA requirements.

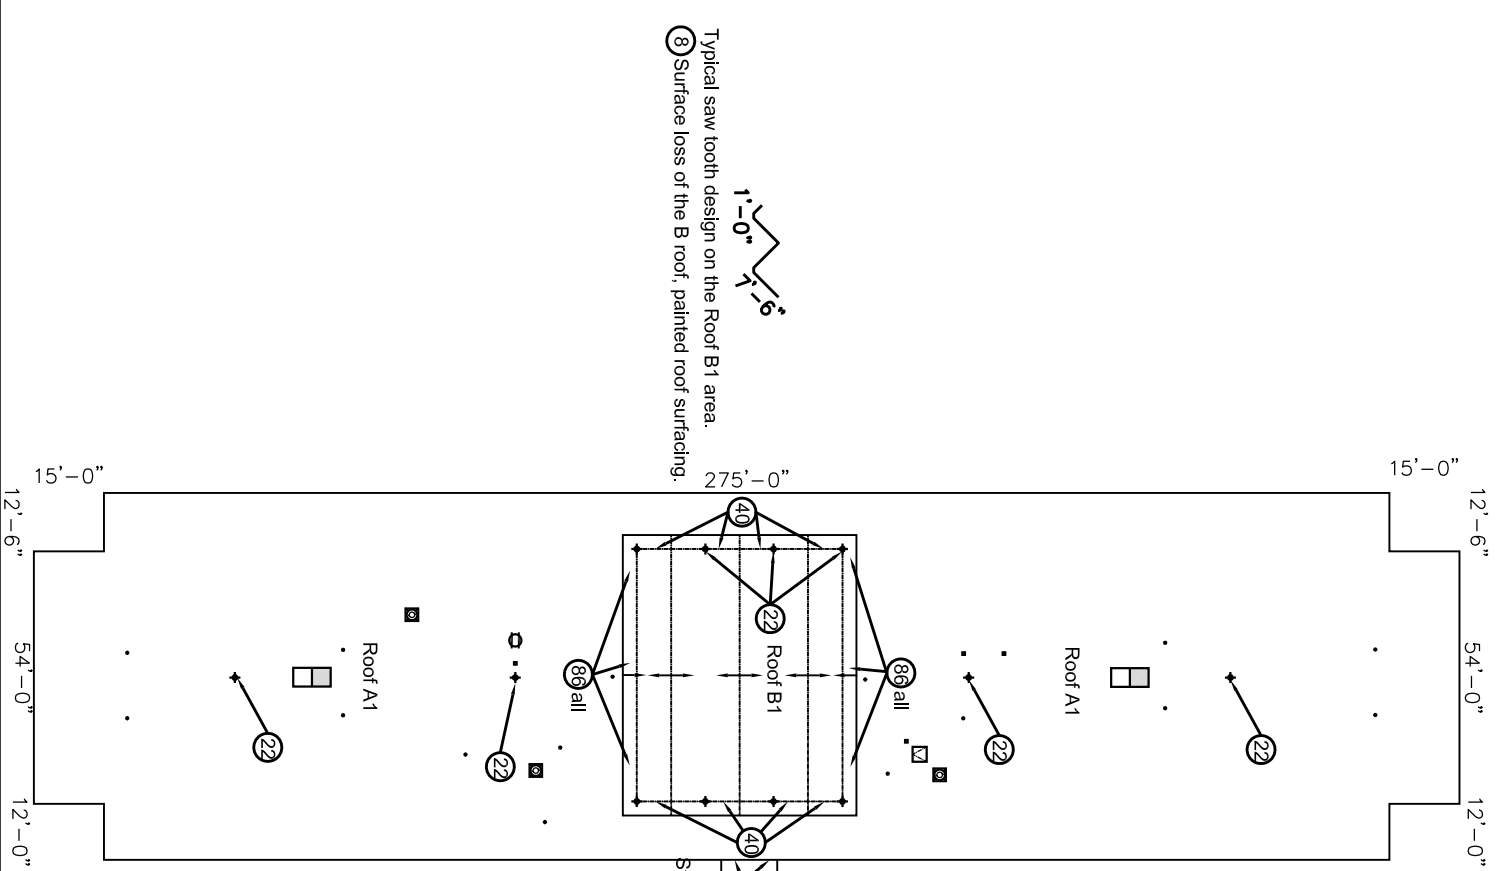
Typical saw tooth design on the Roof B1 area.  
 (8) Surface loss of the B roof, painted roof surfacing.

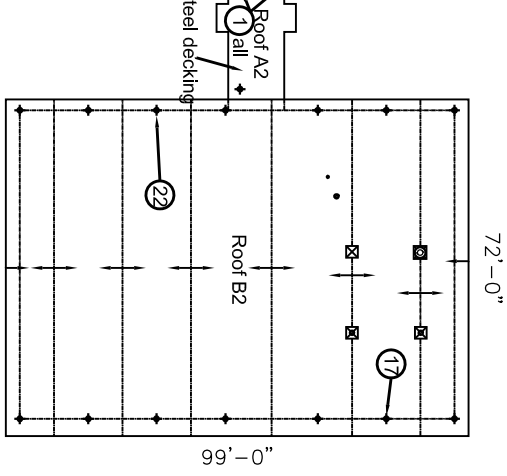
Typical saw tooth design on the Roof B2 area.  
 (8) Surface loss of the B roof, painted roof surfacing.
