Roof Inspection Report

Logan Fontenelle Middle School
701 Kayleen Drive
Bellevue, NE 68005

Date of Last Inspection: Mar 21, 2017

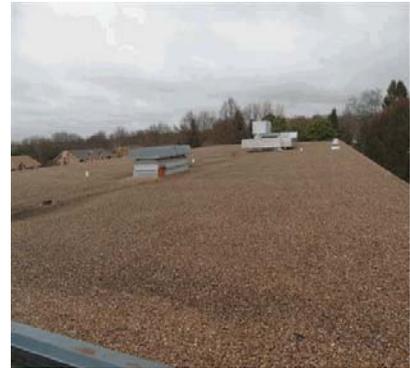
- Surface loss of the gravel roof surfacing
- The raised edge flashing is weathered and splitting
- Open laps observed in the edge metal stripping laps
- Splits observed in the raised edge flashing, ends of the control joint & around pipe penetration flashings
- The edge metal laps are beginning to open
- The large vent curb has an additional curb set on top of the original curb

Overall, the roof system is in poor condition due to its age and the deteriorated nature of the roof system. With leaks performed only as needed, in addition to routine maintenance and regular inspection, the roof system should remain effective for the duration of its assessed service life, approximately one (1) year. There was no warranty information available for this roof section at the time of inspection.

Budget Year	Activity Type	Action Item ?	Allocation	Urgency	Quotation \$
2017	Repair	Yes	Expense	Moderate	\$1,500
RSI recommends leak repairs be completed only as needed until the roofs recommended replacement in 2018.					
2018	Replacement	Yes	Capital	High	\$145,162
RSI recommends a complete tear-off of existing roof system and the installation of a new twenty (20) year design life roof system. We further recommend the replacement of all perimeter coping cap and projection details per SMACNA Architectural Sheet Metal Manual.					
					\$146,662

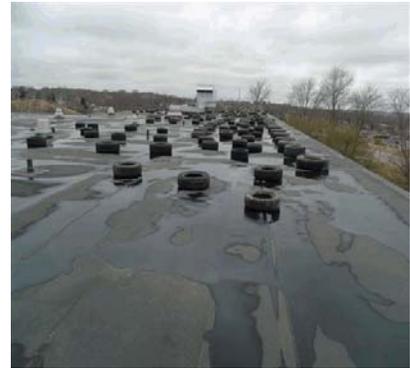
- Numerous open EPDM laps observed
- Most of the EPDM membrane is no longer adhered with emergency ballast in place
- The flexible walkway pads are deteriorated and loose
- Past EPDM stripping repairs observed
- The EPDM membrane is pulling at the pipe penetrations and edges of the roof area
- The EPDM flashings are bridged
- Open EPDM flashing laps observed
- Abandoned equipment stand post supports observed

Overall, the roof system is in urgent condition due to the loose roof membrane along with its age, leak history and the deteriorated nature of the roof system. Given the observed conditions, it is our opinion comprehensive repairs in an effort to extend the life of the system would be neither feasible nor cost effective. We recommend the roof be replaced. There was no warranty information available for this roof section at the time of inspection.

RSI recommends a complete tear-off of existing roof system and the installation of a new twenty (20) year design life roof system. We further recommend the replacement of all perimeter coping cap and projection details per SMACNA Architectural Sheet Metal Manual.

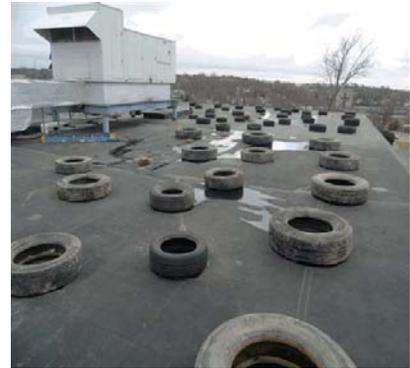
- Open EPDM field laps observed
- Random areas with high roof system attachment anchors observed
- Some of the insulation appears to be displaced and bowing up
- The EPDM curb covering is loose
- The EPDM flashings are bridged
- Open EPDM flashing laps observed
- One (1) abandoned roof curb has a plywood top and loose EPDM membrane covering

Overall, the roof system is in urgent condition due to the loose roof membrane, along with its age, leak history and the deteriorated nature of the roof system. Given the observed conditions, it is our opinion comprehensive repairs in an effort to extend the life of the system would be neither feasible nor cost effective. We recommend the roof be replaced. There was no warranty information available for this roof section at the time of inspection.

Budget Year	Activity Type	Action Item ?	Allocation	Urgency	Quotation \$
2017	Replacement	Yes	Capital	Urgent	\$91,260
<p>RSI recommends a complete tear-off of existing roof system and the installation of a new twenty (20) year design life roof system. We further recommend the replacement of all perimeter coping cap and projection details per SMACNA Architectural Sheet Metal Manual.</p>					\$91,260

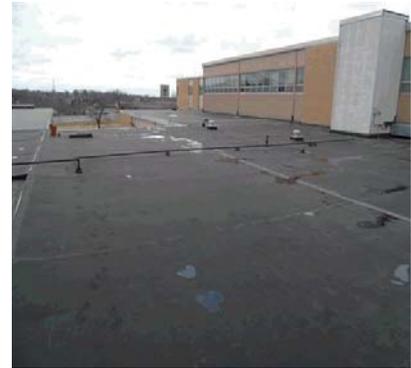
- Split caulking observed in the brick wall expansion joints above the roof system
- Numerous open EPDM laps observed
- High roof system attachment anchors observed
- Loose and unadhered EPDM membrane observed
- Accumulation of debris observed around a drain strainer and along the side of the roof areas
- Cuts or damage observed to the EPDM membrane
- Past EPDM stripping repairs observed
- The EPDM flashings are bridged
- Open EPDM flashing laps observed
- Abandoned roof curbs with EPDM covering
- Rusted flue stacks and vent covers observed
- One (1) damaged skylight lens observed

Overall, the roof system is in poor condition due to its age and the deteriorated nature of the roof system. Given the observed conditions, it is our opinion comprehensive repairs in an effort to extend the life of the system would be neither feasible nor cost effective. We recommend the roof be replaced. There was no warranty information available for this roof section at the time of inspection.

RSI recommends a complete tear-off of existing roof system and the installation of a new twenty (20) year design life roof system. We further recommend the replacement of all perimeter coping cap and projection details per SMACNA Architectural Sheet Metal Manual.

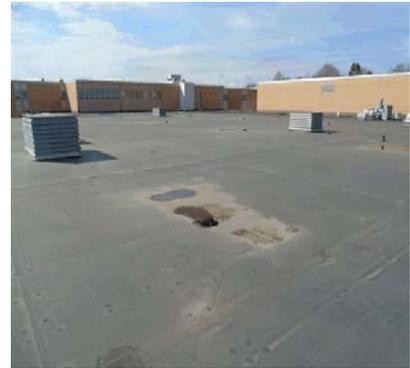
- High roof system attachment anchors observed in the SW corner of the roof area
- Caulking repair attempts observed to the cracks in the stone wall cap
- Numerous cracks observed in the stone wall cap

Overall, the roof system is in good working condition. With the aforementioned defects addressed, in addition to routine maintenance and regular inspection, the roof system should remain effective for the duration of its assessed service life. There was no warranty information available for this roof section at the time of inspection.

Please Note: The high roof system attachment anchors may be covered under a roofing manufacturer's warranty if one is found to be active. Possible further investigations may need to be performed to determine if there is bad gypsum decking under this roof section, which could be the cause of the loose anchors.

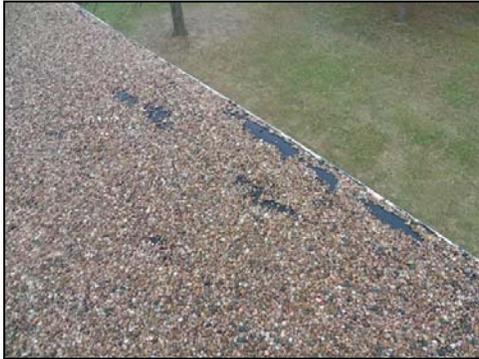
Defect Code:	8	Quantity:	Random	Priority:	Monitor
Description: Surface erosion.					
Repair: Prepare membrane surface by thoroughly cleaning and priming. Apply new surfacing of like materials to eroded areas. On gravel surfaced systems apply gravel in hot asphalt or recommended cold adhesive. Apply granulated fiberglass cap sheet or modified bitumen membrane on like systems. Apply coating system on smooth asphalt surfaces. Transition surfacing to provide for a smooth and neat finished appearance to match the existing surfacing.

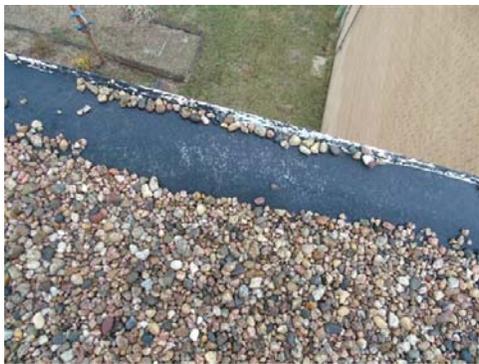
Defect Code:	43	Quantity:	Widespread	Priority:	First Year
Description: Weathered and deteriorated flashing					
Repair: Clean and prepare surfaces by removing loose granules, dirt, and other debris. Apply two coats of elastomeric coating compatible with the flashing materials.

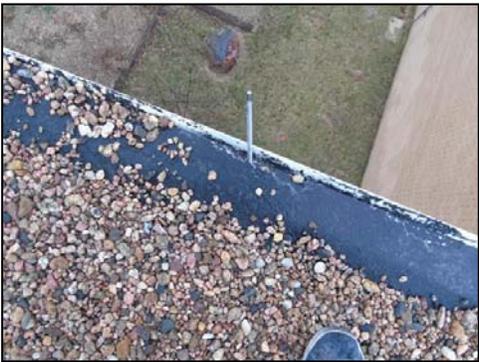
Defect Code:	45	Quantity:	Widespread	Priority:	First Year
Description: Open flashing lap					
Repair: Open loose lap area and clean thoroughly. Prime and reseat or reweld lap per the manufacturer's requirements. Strip-in defective lap with minimum 6" wide membrane on single ply systems or 6" wide fabric and mastic three-course application on asphalt systems. Regranulate or coat flashing repairs.

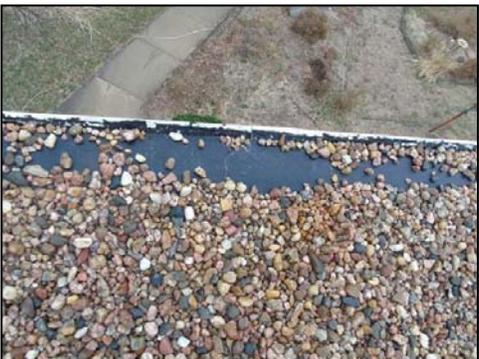
Defect Code:	46	Quantity:	Widespread	Priority:	First Year
Description: Split in flashing					
Repair: Cut away loose flashing and clean and prime repair area. Apply strip in of like material centered over split extending a minimum of 4" in all directions past prepared area.

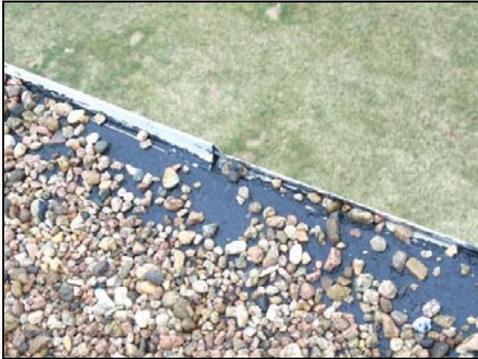
Defect Code:	70	Quantity:	Random	Priority:	First Year
Description: Open joint in metal flashing.					
Repair: Remove metal and old sealants from joint. Reinstall metal with new polyurethane sealants at joints per SMACNA requirements.

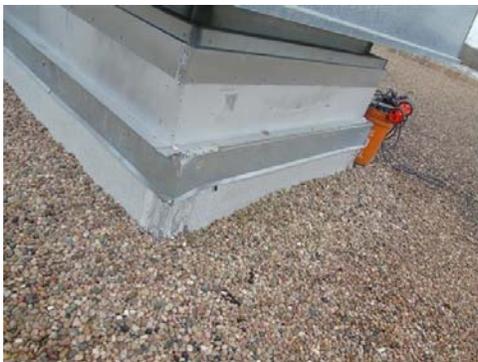
Defect Code:	73	Quantity:	1	Priority:	Monitor
Description: Improper sheet metal detail.					
Repair: Remove sheet metal and fabricate new metal per SMACNA requirements. Solder all joints in drainage systems, scuppers, etc., and seal all other sheet metal joints with polyurethane sealant.

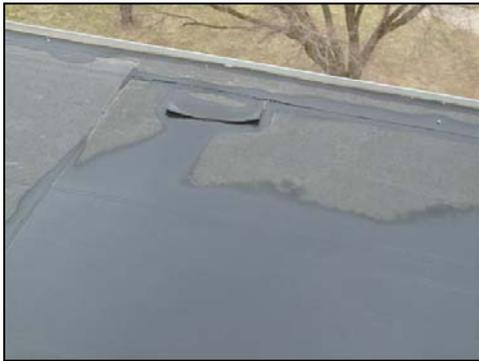
Defect Code:	3	Quantity:	Widespread	Priority:	Monitor
Description: Open lap in field membrane.					
Repair: Clean lap of all dirt and close seam. Overlay edge of affected seam with strip-in of new membrane of like material. Extend a minimum of 4" in all directions past seam edges and repair areas.

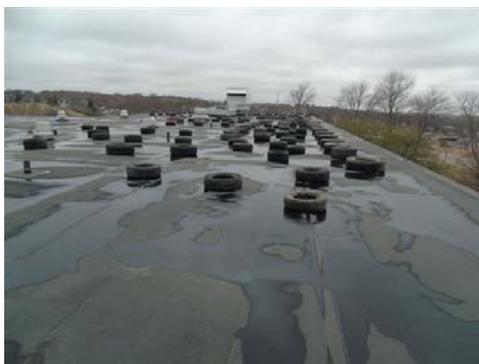
Defect Code:	18	Quantity:	Widespread	Priority:	Urgent
Description: Unadhered membrane or inadequate membrane attachment.					
Repair: At unadhered areas, cut open membrane and readhere to substrate with manufacturer's approved adhesive. At areas with missing securement, provide securement in the form of screws and plates installed a maximum of 12" O.C. Overlay repaired areas with new membrane of similar gauge, type, and plies and extend repairs a minimum of 4" past cut areas or edges of plates.

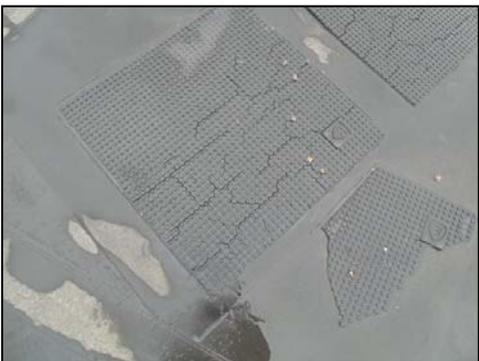
Defect Code:	21	Quantity:	Widespread	Priority:	Monitor
Description: Loose walkway pad or deteriorated paver.					
Repair: Readhere or reweld walkway pads. Provide new pads to replace damaged or missing pads. Replace deteriorated concrete pavers with pavers of like kind and weight to ensure a flush walking surface.

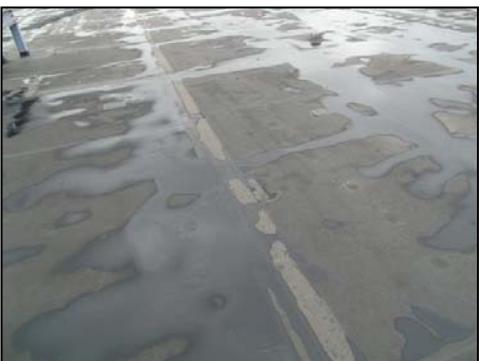
Defect Code:	24	Quantity:	Widespread	Priority:	Monitor
Description: Evidence of past problem and previous repair.					
Repair: Investigate for chronic leak problems and repair any areas that are suspect.

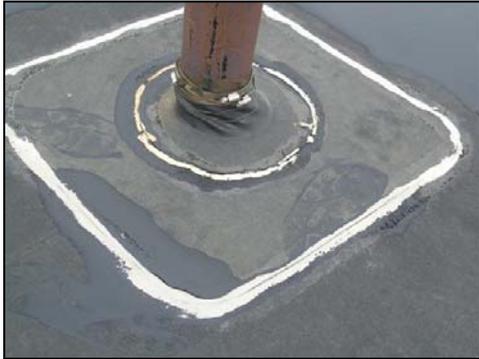
Defect Code:	26	Quantity:	Widespread	Priority:	Monitor
Description: Membrane shrinkage					
Repair: Investigate and repair cause of shrinkage. Cut away affected areas and prepare to receive new membrane. Install new membrane and secure at base flashings. Adhere to walls and substrates and reinstall metal copings, counterflashings, and termination bars to complete the repair. On ballasted systems redistribute ballast evenly.

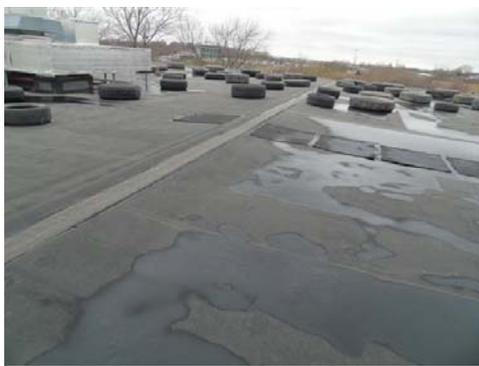
Defect Code:	44	Quantity:	Widespread	Priority:	Monitor
Description: Bridged flashing					
Repair: Cut out all bridged flashings. Clean area thoroughly and apply new flashings. Apply corner flashings and overlay all T-laps, flashings laps, and splice intersections.

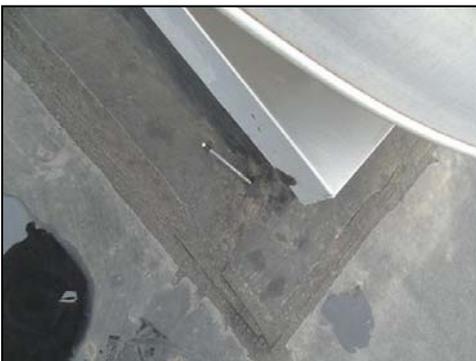
Defect Code:	45	Quantity:	Widespread	Priority:	Monitor
Description: Open flashing lap					
Repair: Open loose lap area and clean thoroughly. Prime and reseam or reweld lap per the manufacturer's requirements. Strip-in defective lap with minimum 6" wide membrane on single ply systems or 6" wide fabric and mastic three-course application on asphalt systems. Regranulate or coat flashing repairs.

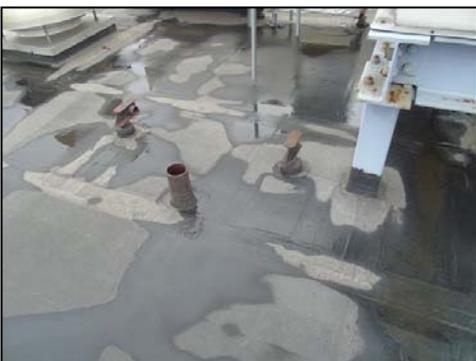
Defect Code:	56	Quantity:	2	Priority:	Monitor
Description: Abandoned and obsolete equipment.					
Repair: Monitor for leaks. Check systems are abandoned and disconnected and will not be used in the future. Remove abandoned equipment and repair deck at scheduled roof replacement.

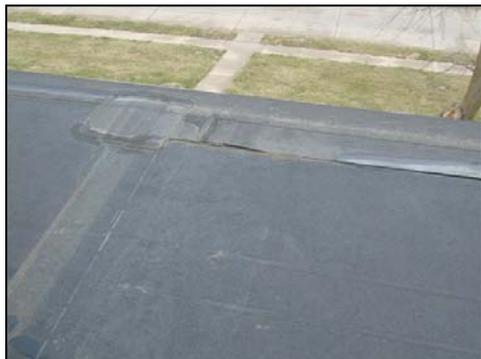
Defect Code:	3	Quantity:	Random	Priority:	Monitor
Description: Open lap in field membrane.					
Repair: Clean lap of all dirt and close seam. Overlay edge of affected seam with strip-in of new membrane of like material. Extend a minimum of 4" in all directions past seam edges and repair areas.

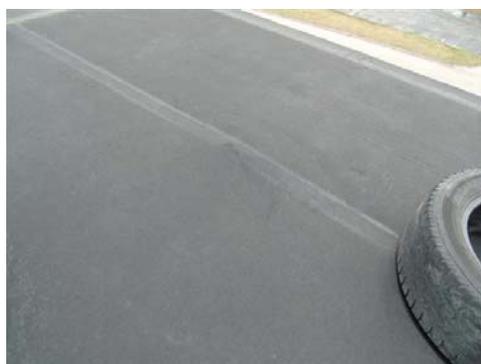
Defect Code:	10	Quantity:	Random	Priority:	Monitor
Description: Tented membrane at fastener.					
Repair: Remove fasteners that are loose or not flush with the substrate. Remove underlying substrate materials including insulation and coverboard and replace with matching materials of similar thicknesses to provide for a smooth flush surface.. Install new fasteners and plates per manufacturer's recommendations for system type and apply new membrane repair materials of similar type, gauge, and plies as existing roof system.

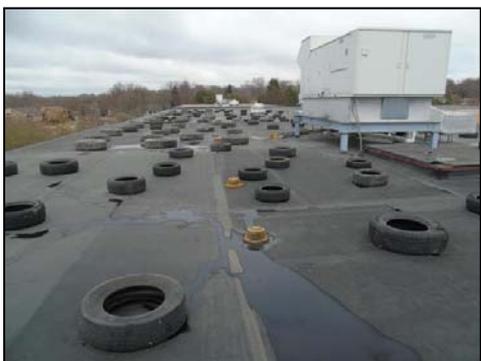
Defect Code:	18	Quantity:	Widespread	Priority:	Monitor
Description: Unadhered membrane or inadequate membrane attachment.					
Repair: At unadhered areas, cut open membrane and readhere to substrate with manufacturer's approved adhesive. At areas with missing securement, provide securement in the form of screws and plates installed a maximum of 12" O.C. Overlay repaired areas with new membrane of similar gauge, type, and plies and extend repairs a minimum of 4" past cut areas or edges of plates.

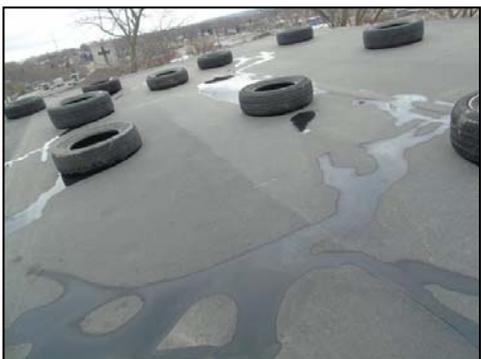
Defect Code:	19	Quantity:	Random	Priority:	Monitor
Description: Unadhered insulation or inadequate insulation attachment.					
Repair: On systems with adhered insulation, open system and readhere all loose insulation to substrate using manufacturer's approved adhesive. On systems with mechanically attached insulation, open system and attach insulation with screws and plates at a minimum rate of one fastener and plate per every 2 square feet. Install new membrane over all repaired areas and seam per the manufacturer's requirements.

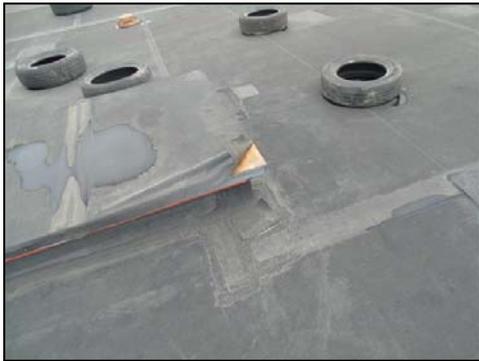
Defect Code:	42	Quantity:	Random	Priority:	Monitor
Description: Loose or unadhered flashings.					
Repair: Cut away loose and unadhered flashing materials. Apply new flashings of like material and fully adhere to substrate with manufacturer's recommended adhesive. Mechanically attach top of flashings 6" O.C. and reinstall all metal terminations.

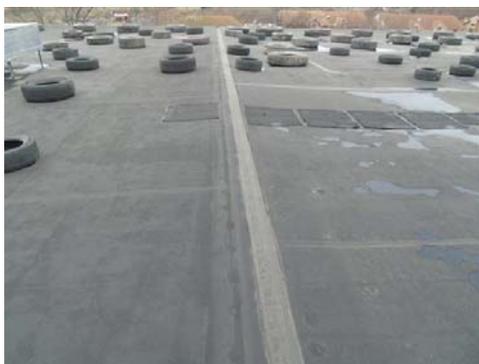
Defect Code:	44	Quantity:	Widespread	Priority:	Monitor
Description: Bridged flashing					
Repair: Cut out all bridged flashings. Clean area thoroughly and apply new flashings. Apply corner flashings and overlay all T-laps, flashings laps, and splice intersections.

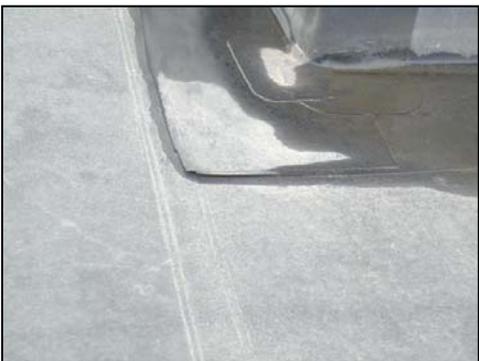
Defect Code:	45	Quantity:	Widespread	Priority:	Monitor
Description: Open flashing lap					
Repair: Open loose lap area and clean thoroughly. Prime and reseam or reweld lap per the manufacturer's requirements. Strip-in defective lap with minimum 6" wide membrane on single ply systems or 6" wide fabric and mastic three-course application on asphalt systems. Regranulate or coat flashing repairs.

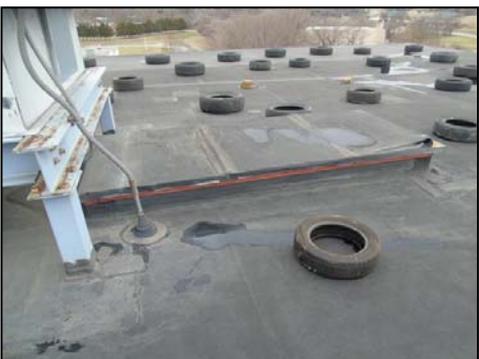
Defect Code:	56	Quantity:	1	Priority:	Monitor
Description: Abandoned and obsolete equipment.					
Repair: Monitor for leaks. Check systems are abandoned and disconnected and will not be used in the future. Remove abandoned equipment and repair deck at scheduled roof replacement.

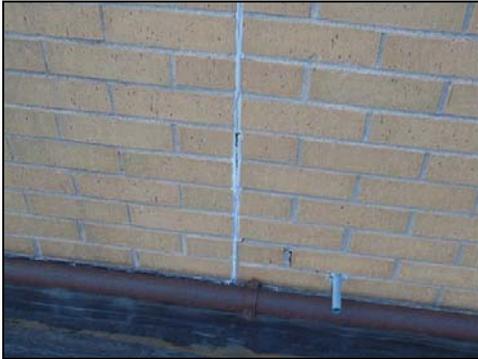
Defect Code:	1	Quantity:	Widespread	Priority:	First Year
Description: Deteriorated or missing sealant at counterflashing, termination bar, sealant lip, metal flashing, expansion joint, etc.					
Repair: Clean loose sealant and dirt from all surfaces. Apply new polyurethane sealant and tool to shed water.

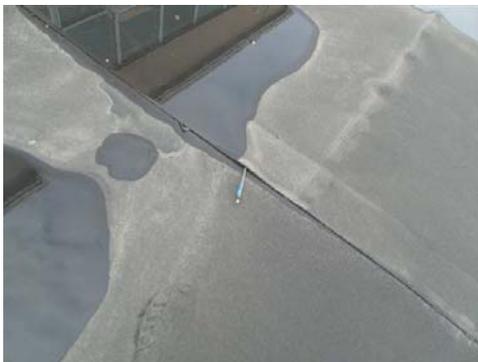
Defect Code:	3	Quantity:	Widespread	Priority:	First Year
Description: Open lap in field membrane.					
Repair: Clean lap of all dirt and close seam. Overlay edge of affected seam with strip-in of new membrane of like material. Extend a minimum of 4" in all directions past seam edges and repair areas.

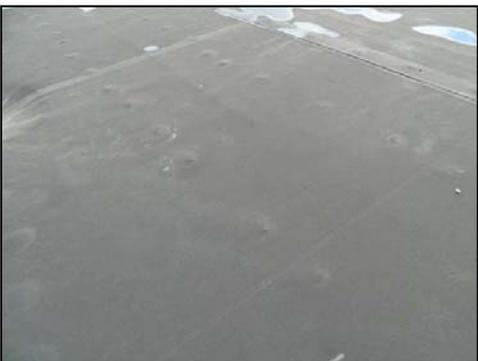
Defect Code:	10	Quantity:	Random	Priority:	Monitor
Description: Tented membrane at fastener.					
Repair: Remove fasteners that are loose or not flush with the substrate. Remove underlying substrate materials including insulation and coverboard and replace with matching materials of similar thicknesses to provide for a smooth flush surface.. Install new fasteners and plates per manufacturer's recommendations for system type and apply new membrane repair materials of similar type, gauge, and plies as existing roof system.

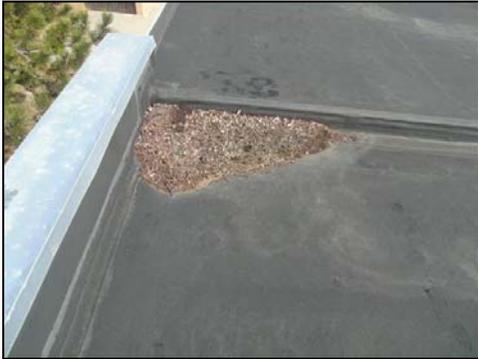
Defect Code:	22	Quantity:	Random	Priority:	First Year
Description: Debris, trash, construction materials, HVAC equipment, filters, motors, etc. on roof surface.					
Repair: Remove all trash and debris from roof. Clean and inspect surfaces and repair any damages to the membrane or flashings.

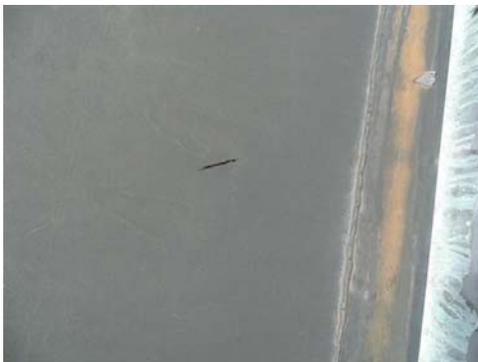
Defect Code:	23	Quantity:	Under 10 LF	Priority:	First Year
Description: Physical damage to membrane including cuts, holes, tears, scrapes, scuffs, or abrasions.					
Repair: Apply repair membrane over damaged area, extending repair material a minimum 6" past damage.

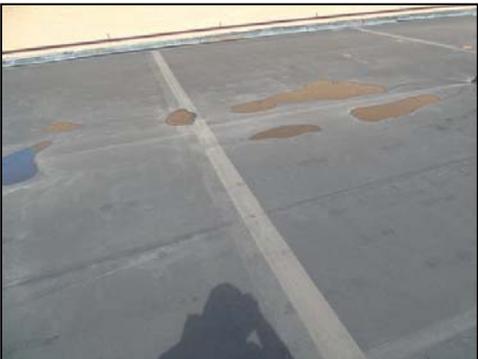
Defect Code:	24	Quantity:	Widespread	Priority:	Monitor
Description: Evidence of past problem and previous repair.					
Repair: Investigate for chronic leak problems and repair any areas that are suspect.

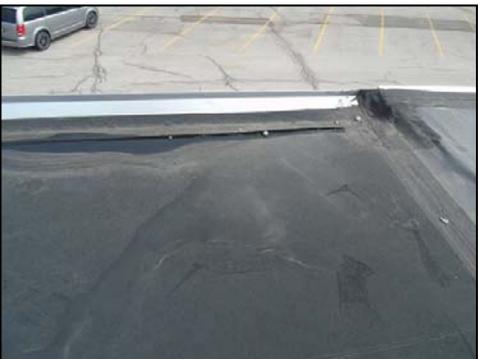
Defect Code:	44	Quantity:	Widespread	Priority:	Monitor
Description: Bridged flashing					
Cut out all bridged flashings. Clean area thoroughly and apply new flashings. Apply corner flashings and overlay all T-laps, flashings laps, and splice intersections.

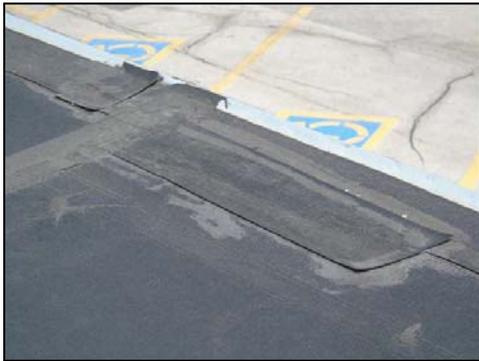
Defect Code:	45	Quantity:	Widespread	Priority:	First Year
Description: Open flashing lap					
Repair: Open loose lap area and clean thoroughly. Prime and reseam or reweld lap per the manufacturer's requirements. Strip-in defective lap with minimum 6" wide membrane on single ply systems or 6" wide fabric and mastic three-course application on asphalt systems. Regranulate or coat flashing repairs.

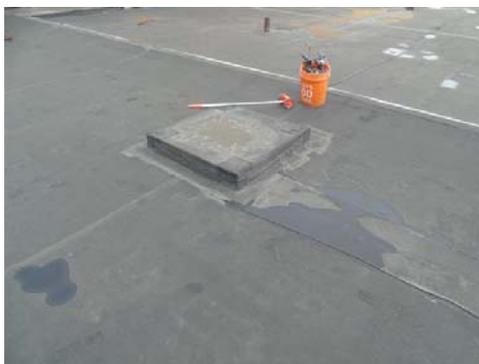
Defect Code:	56	Quantity:	2	Priority:	Monitor
Description: Abandoned and obsolete equipment.					
Repair: Monitor for leaks. Check systems are abandoned and disconnected and will not be used in the future. Remove abandoned equipment and repair deck at scheduled roof replacement.

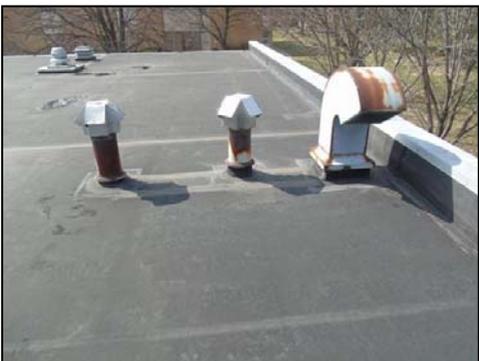
Defect Code:	86	Quantity:	Random	Priority:	Monitor
Description: Corrosion or rust					
Repair: Remove rusted components and replace with similar metal fabricated and installed per SMACNA requirements.

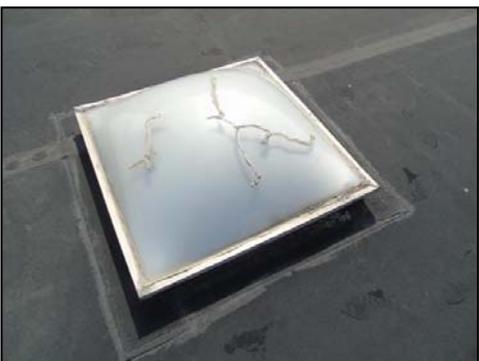
Defect Code:	88	Quantity:	1	Priority:	First Year
Description: Skylight defect/cracked/deteriorated					
Repair: Remove and replace affected components.

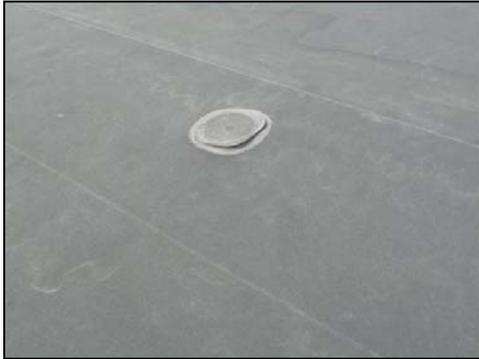
Defect Code:	3	Quantity:	Random	Priority:	First Year
Description: Open lap in field membrane.					
Repair: Clean lap of all dirt and close seam. Overlay edge of affected seam with strip-in of new membrane of like material. Extend a minimum of 4" in all directions past seam edges and repair areas.

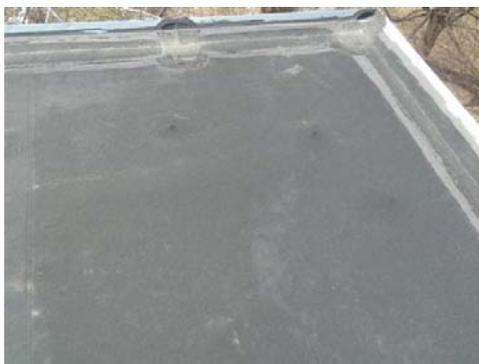
Defect Code:	10	Quantity:	Random	Priority:	Monitor
Description: Tented membrane at fastener.					
Repair: Remove fasteners that are loose or not flush with the substrate. Remove underlying substrate materials including insulation and coverboard and replace with matching materials of similar thicknesses to provide for a smooth flush surface.. Install new fasteners and plates per manufacturer's recommendations for system type and apply new membrane repair materials of similar type, gauge, and plies as existing roof system.

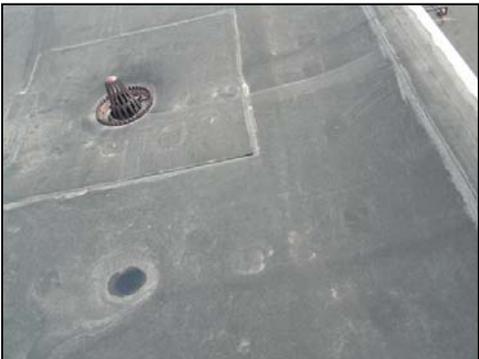
Defect Code:	45	Quantity:	Random	Priority:	Monitor
Description: Open flashing lap					
Repair: Open loose lap area and clean thoroughly. Prime and reseam or reweld lap per the manufacturer's requirements. Strip-in defective lap with mimum 6" wide membrane on single ply systems or 6" wide fabric and mastic three-course application on asphalt systems. Regranulate or coat flashing repairs.

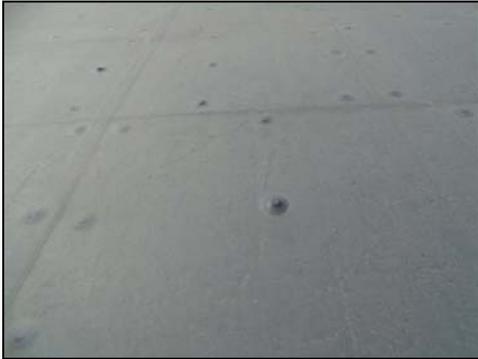
Defect Code:	10	Quantity:	1000+ SF	Priority:	First Year
Description: Tented membrane at fastener.					
Repair: Remove fasteners that are loose or not flush with the substrate. Remove underlying substrate materials including insulation and coverboard and replace with matching materials of similar thicknesses to provide for a smooth flush surface.. Install new fasteners and plates per manufacturer's recommendations for system type and apply new membrane repair materials of similar type, gauge, and plies as existing roof system.

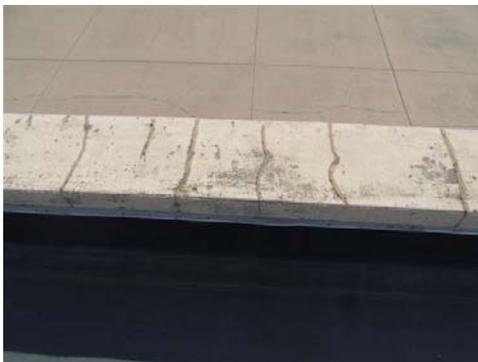
Defect Code:	24	Quantity:	Widespread	Priority:	Monitor
Description: Evidence of past problem and previous repair.					
Repair: Investigate for chronic leak problems and repair any areas that are suspect.

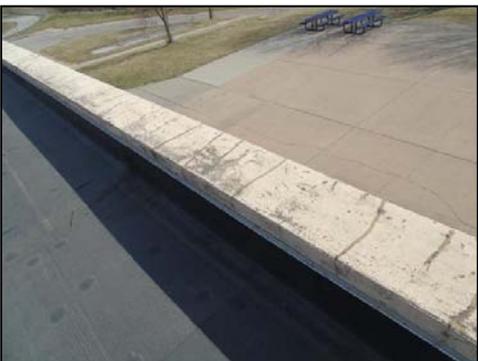
Defect Code:	79	Quantity:	Widespread	Priority:	Monitor
Description: Cracks in walls.					
Repair: Investigate and repair cracks in walls. Apply elastomeric coating or membrane waterproofing to seal wall surface.

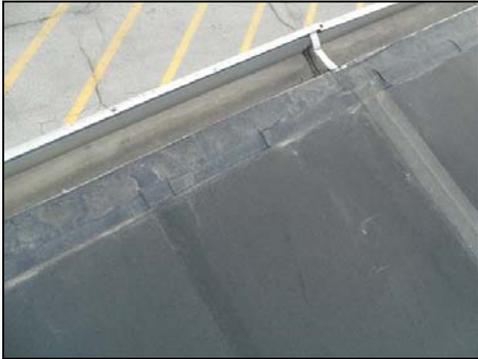
Defect Code:	9	Quantity:	150 LF	Priority:	First Year
Description: Membrane deterioration.					
Repair: Replace all deteriorated membrane with new membrane of similar type, gauge, and plies.

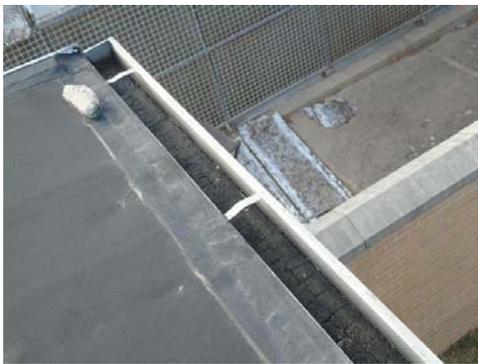
Defect Code:	22	Quantity:	Random	Priority:	First Year
Description: Debris, trash, construction materials, HVAC equipment, filters, motors, etc. on roof surface.					
Repair: Remove all trash and debris from roof. Clean and inspect surfaces and repair any damages to the membrane or flashings.

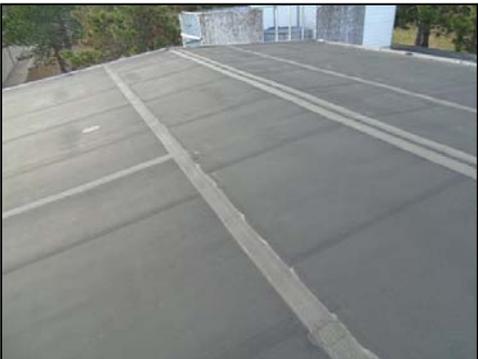
Defect Code:	24	Quantity:	Widespread	Priority:	Monitor
Description: Evidence of past problem and previous repair.					
Repair: Investigate for chronic leak problems and repair any areas that are suspect.

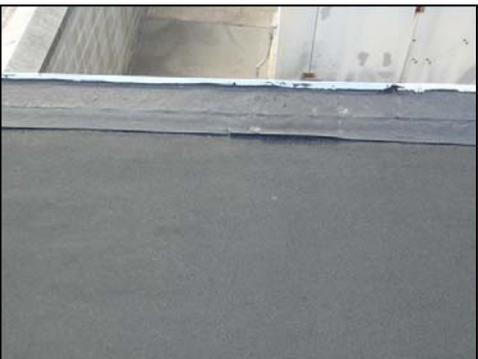
Defect Code:	45	Quantity:	150 LF	Priority:	First Year
Description: Open flashing lap					
Repair: Open loose lap area and clean thoroughly. Prime and reseam or reweld lap per the manufacturer's requirements. Strip-in defective lap with mimum 6" wide membrane on single ply systems or 6" wide fabric and mastic three-course application on asphalt systems. Regranulate or coat flashing repairs.

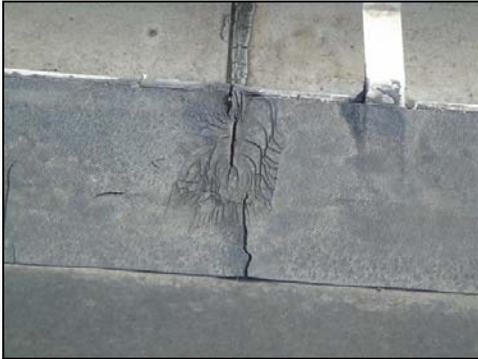
Defect Code:	46	Quantity:	Widespread	Priority:	First Year
Description: Split in flashing					
Repair: Cut away loose flashing and clean and prime repair area. Apply strip in of like material centered over split extending a minimum of 4" in all directions past prepared area.
