Roof Inspection Report

Mr. Greg Boettger
Bellevue Schools
&
Mr. Ralph Gladbach
GP Architecture, LLC.

Roofing Solutions, Inc.
6728 W. 153rd Street
Overland Park, KS 66223

Belleaire Elementary
1200 W. Mission Avenue
Bellevue, NE 68005

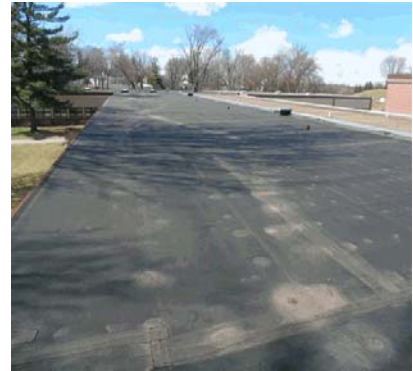
Drainage and Leak Details: The A-1 roof area slopes from a central ridge line towards the north and south. The A-2 roof area slopes from north to south. The A-3 roof area slopes from a central ridge line towards the east and west. All three (3) roof areas drain to primary drains located along the edges of the roof areas.

Facility personnel reported active leak issues on the A-3 roof area.

- Open and loose EPDM lap edges observed
- One (1) area with standing water observed on the A-3 area
- One (1) blocked and sunken overflow drain on the A-3 area
- One (1) missing drain strainer
- Loose areas of EPDM membrane observed along the edges of the roof areas
- Accumulation of debris around the drain strainers and along the sides of the roof areas
- EPDM stripping repair attempts observed to the roof system laps
- Evidence of roof membrane shrinkage with pulled roof edging and pipe boots pulled
- The EPDM flashings are bridged
- Numerous open EPDM flashing laps observed
- Abandoned roof curbs with metal covers
- There are cracked, leaking or condensation forming on the skylight lenses

Overall, the roof system is in poor condition due to its age and extremely deteriorated nature of the roof system, including membrane shrinkage. Given the observed conditions, it is our opinion comprehensive repairs in an effort to extend the life of the system would be neither feasible nor cost effective. We recommend the roof be replaced. There was no warranty information available for this roof section at the time of inspection.

Please Note: The loose EPDM roof membrane and pulled-away roof edging pose a potential for roof areas to blow off and should be addressed as soon as possible.

RSI recommends a complete tear-off of existing roof system and the installation of a new twenty (20) year design life roof system. We further recommend the replacement of all perimeter coping cap and projection details per SMACNA Architectural Sheet Metal Manual.

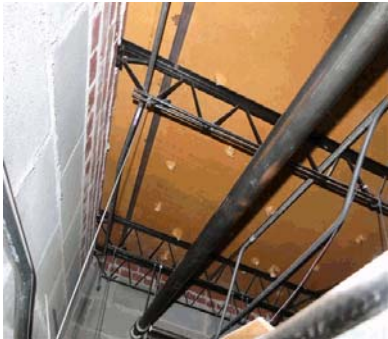
Mar 07, 2017	Deck Underside

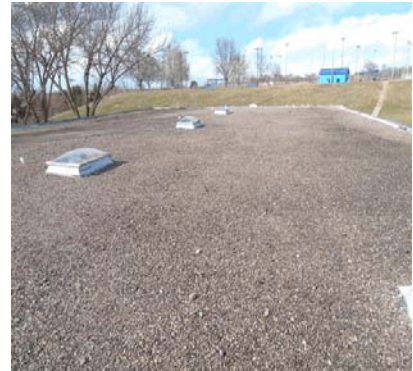
Drainage and Leak Details: The B-1 roof area slopes from a central ridge line towards the east and west and the B-2 roof area slopes from south to north. Both roof areas drain to primary roof drains located along the edges of the roof areas.

No recent leaks were reported on these roof areas at the time of inspection.

- Accumulation of debris around the drain strainers
- The BUR flashings are weathered with numerous areas of deterioration observed
- Random areas with split BUR flashings
- Abandoned roof curbs have metal covers
- Rusted flue stacks and rusted vent covers observed
- Small cracks, leaking or condensation observed on the skylight lenses

Overall, the roof system is in poor condition due to its age and deteriorated nature of the roof system. Given the observed conditions, it is our opinion comprehensive repairs in an effort to extend the life of the system would be neither feasible nor cost effective. We recommend the roof be replaced. There was no warranty information available for this roof section at the time of inspection.

RSI recommends a complete tear-off of existing roof system and the installation of a new twenty (20) year design life roof system. We further recommend the replacement of all perimeter coping cap and projection details per SMACNA Architectural Sheet Metal Manual.

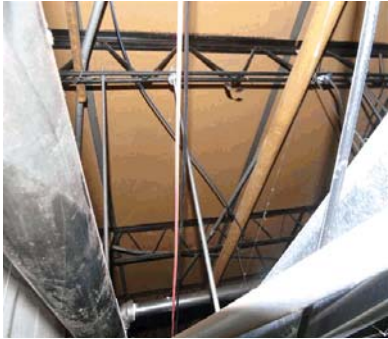
Mar 07, 2017	Deck Underside

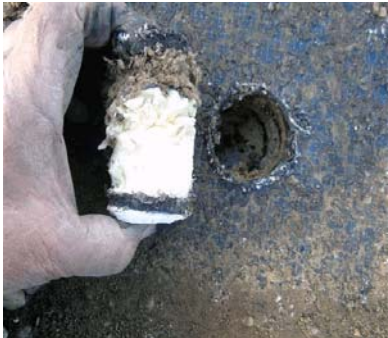
Mar 07, 2017	Roof System Core

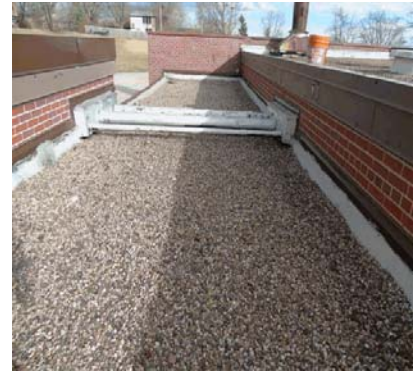
Roof Name: C**Roof Size:** 714 sq. ft.**Est. replacement Cost:** \$ 10,710.00**Existing System Type:** Built-Up Asphalt Roofing**Year Installed:** 1999**Assessed Service Life Remaining (Years) :** 2**Height:** 16 Ft.**Slope:****Interior Sensitivity:****Drainage:** Adequate**Currently Leaking?** No**History of Leaking?** Yes**Drainage and Leak Details:** Roof Section C slopes from a central ridge line towards the east and west with an external gutter at the west end and a roof drain at the east end.

No recent leaks were reported on this roof section at the time of inspection.

- Deteriorated and missing caulking observed on top of the perimeter wall counter flashing
- Accumulation of debris observed in the guttering and along the perimeter of the roof area
- Service pipes that penetrate through the side walls are close to the top of the roof elevation
- One (1) loose roof edging cover plate observed

Overall, the roof system is in poor condition due to its age. With the aforementioned defects addressed, in addition to routine maintenance and regular inspection, the roof system should remain effective for the duration of its assessed service life, approximately two (2) years. There was no warranty information available for this roof section at the time of inspection.

Budget Year	Activity Type	Action Item ?	Allocation	Urgency	Quotation \$
2017	Repair	Yes	Expense	High	\$1,000
RSI recommends repairs be completed in accordance with the attached deficiency list.					
2019	Retrofit	Yes	Capital	High	\$10,710
RSI recommends the installation of a new twenty (20) year design life roof system. We further recommend installation of new perimeter metal and projection details per the SMACNA Architectural Sheet Metal Manual.					
					\$11,710

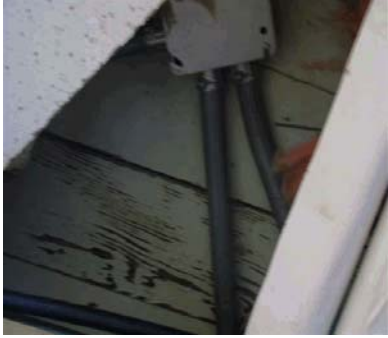
Mar 07, 2017	Deck Underside

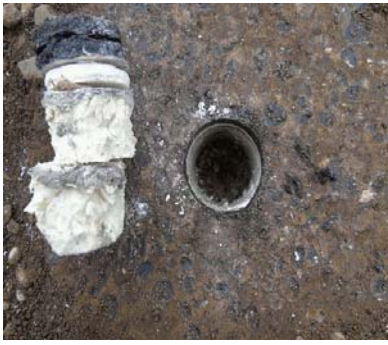
Mar 07, 2017	Roof System Core

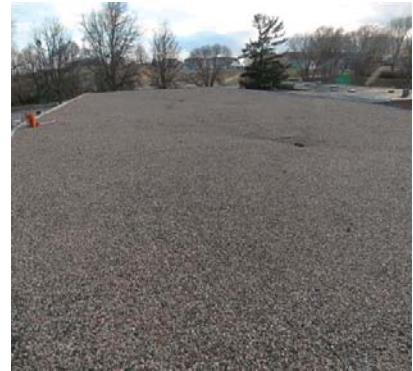
Roof Name: D**Roof Size:** 5,959 sq. ft.**Est. replacement Cost:** \$ 89,385.00**Existing System Type:** Built-Up Asphalt Roofing**Year Installed:** 1999**Assessed Service Life Remaining (Years) :** 2**Height:** 22 Ft.**Slope:****Interior Sensitivity:****Drainage:** Adequate**Currently Leaking?** Yes**History of Leaking?** Yes**Drainage and Leak Details:** The D roof areas slope to the interior and drain to primary roof drains.

Facility personnel reported one (1) recent leak on the D-2 roof area.

- Deteriorated/missing caulking on top of perimeter wall counter flashing and in brick expansion joints
- One (1) split BUR flashing corner observed near the reported leak area

Overall, the roof system is in poor condition due to its age. With the aforementioned defects addressed, in addition to routine maintenance and regular inspection, the roof system should remain effective for the duration of its assessed service life, approximately two (2) years. There was no warranty information available for this roof section at the time of inspection.

Budget Year	Activity Type	Action Item ?	Allocation	Urgency	Quotation \$
2017	Repair	Yes	Expense	High	\$1,500
RSI recommends repairs be completed in accordance with the attached deficiency list.					
2019	Replacement	Yes	Capital	High	\$89,385
RSI recommends a complete tear-off of existing roof system and the installation of a new twenty (20) year design life roof system. We further recommend the replacement of all perimeter coping cap and projection details per SMACNA Architectural Sheet Metal Manual.					
					\$90,885

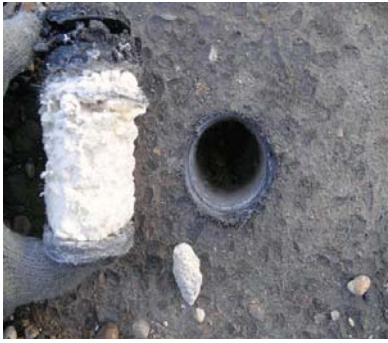
Mar 07, 2017	Core cut #1
 	Mar 07, 2017	Core cut #2

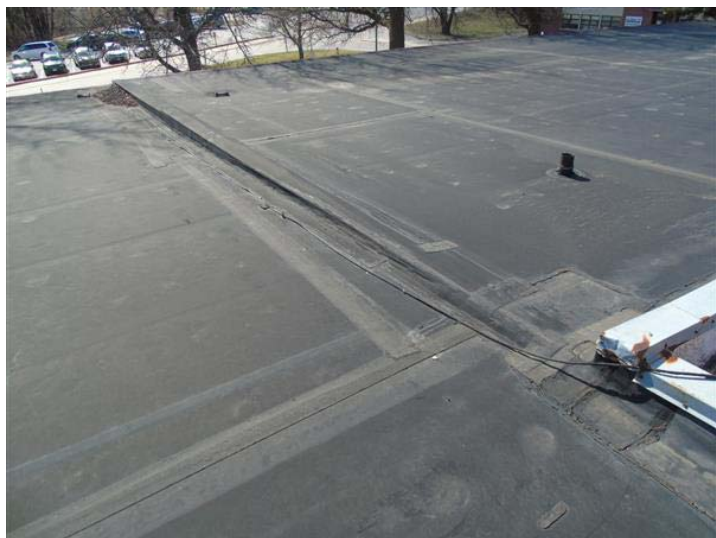
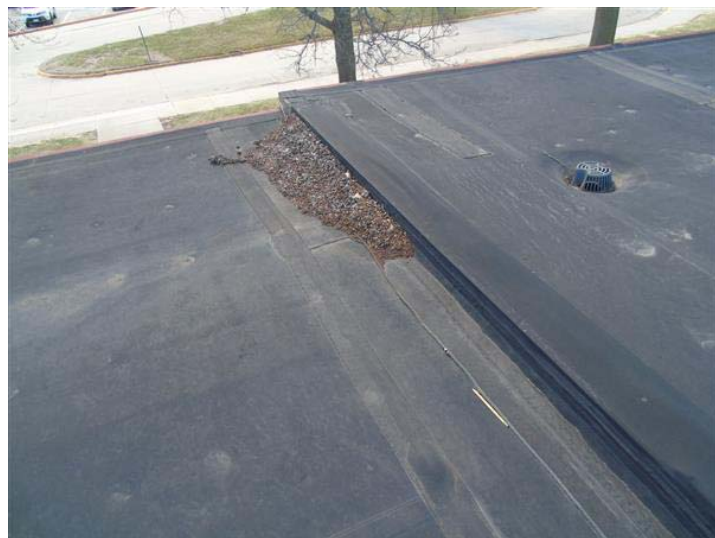
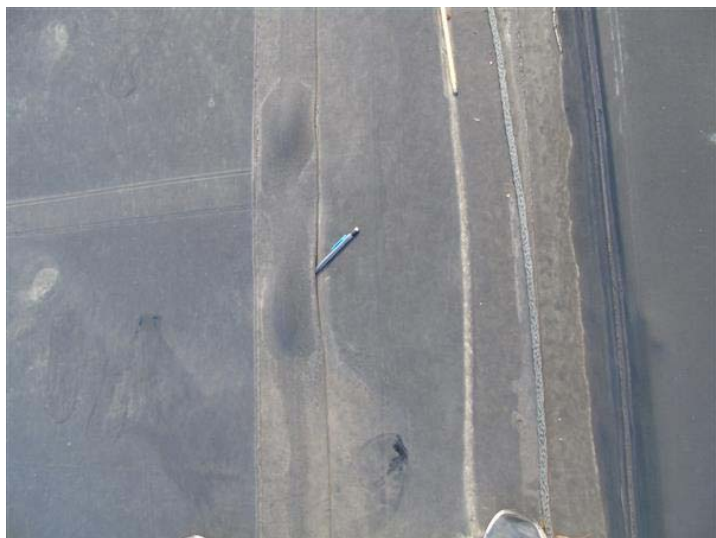
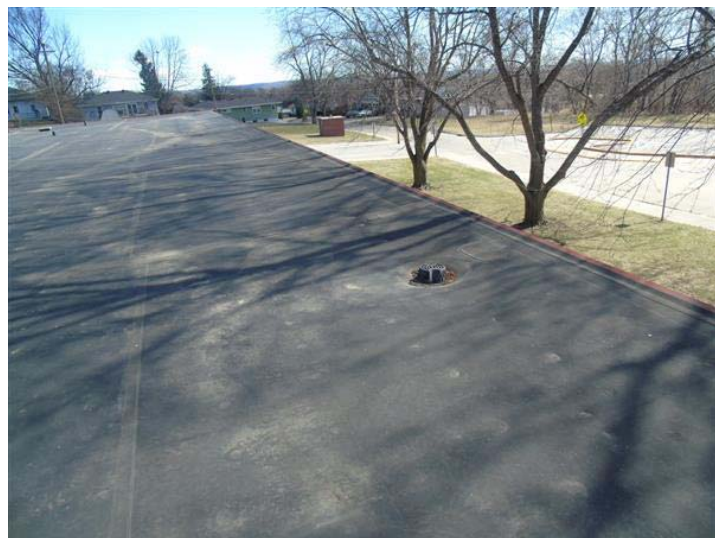
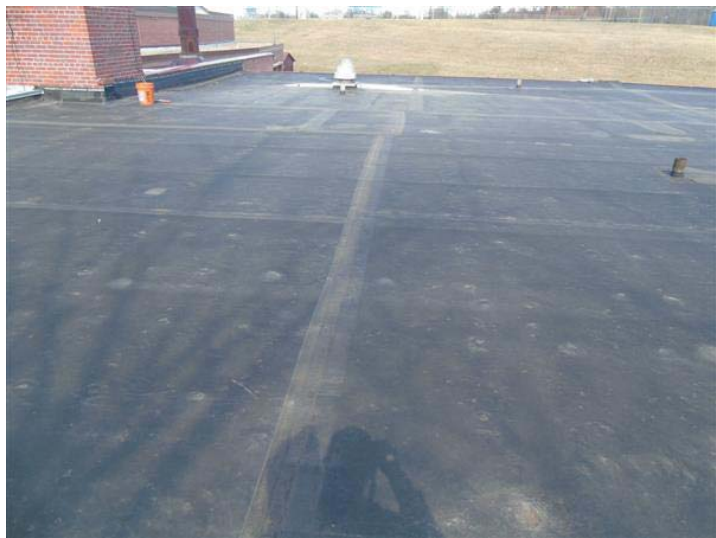
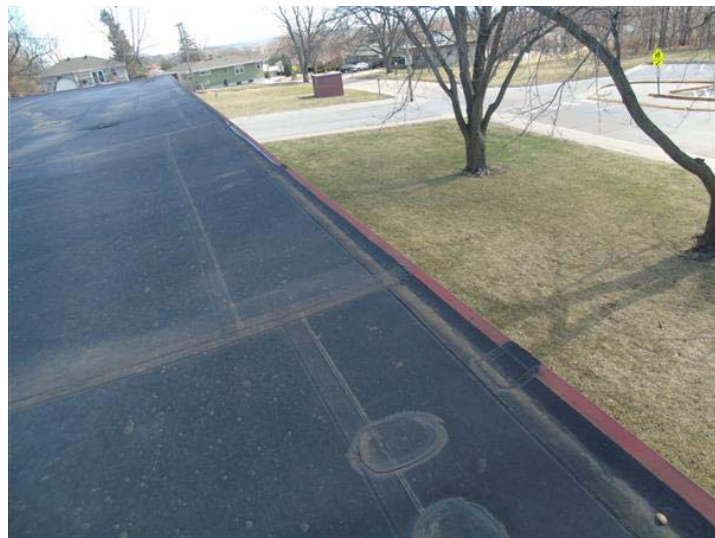
Belleaire Elementary_Bellevue, NE
Ph 1 Roof Inspection_Roof A-1_2017-03-07

- Typical defects for the A roof areas:
- (3) Numerous open or loose EPDM laps.
 - (19) Loose EPDM membrane along the edges of the roof areas.
 - (29) EPDM stripping repair attempts to the roof system laps.
 - (28) The EPDM membrane has pulled on the perimeter edges of the roof system.
 - (44) The EPDM flashing's are bridged and loose.
 - (45) Numerous open EPDM flashing laps.

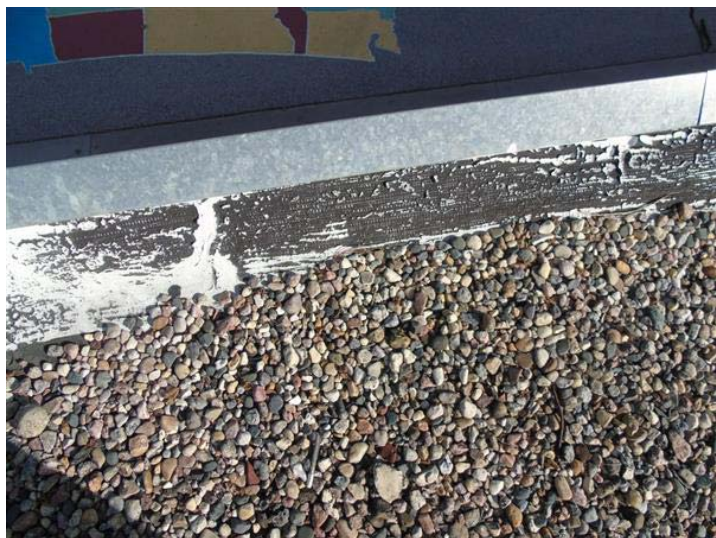
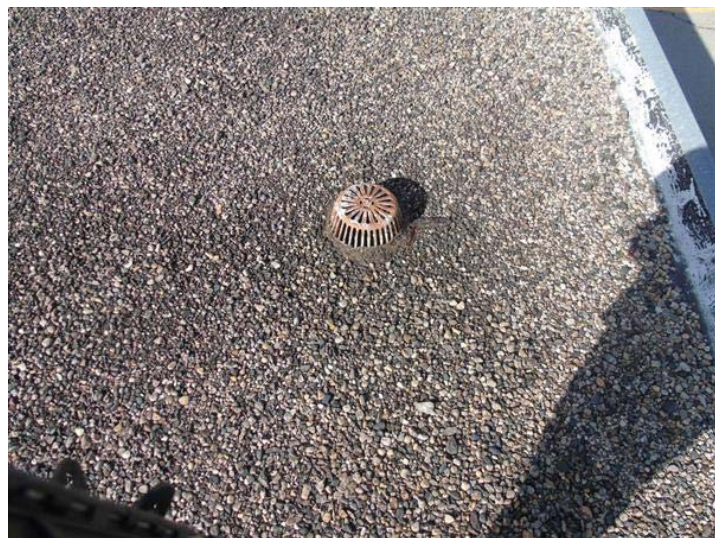
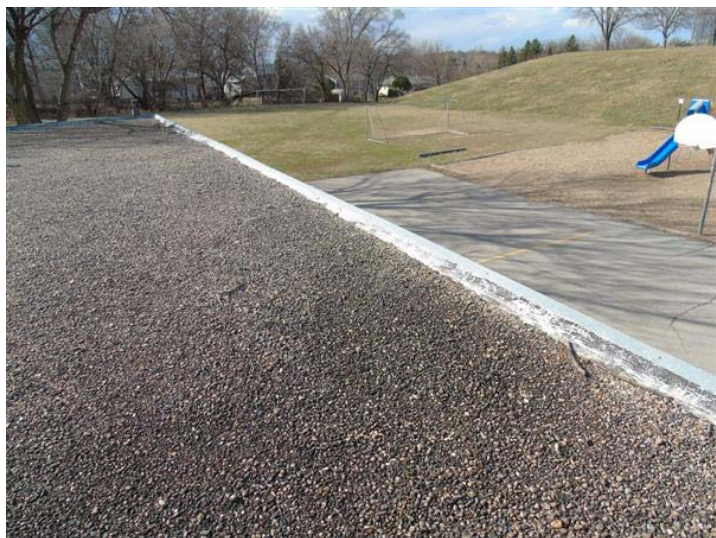
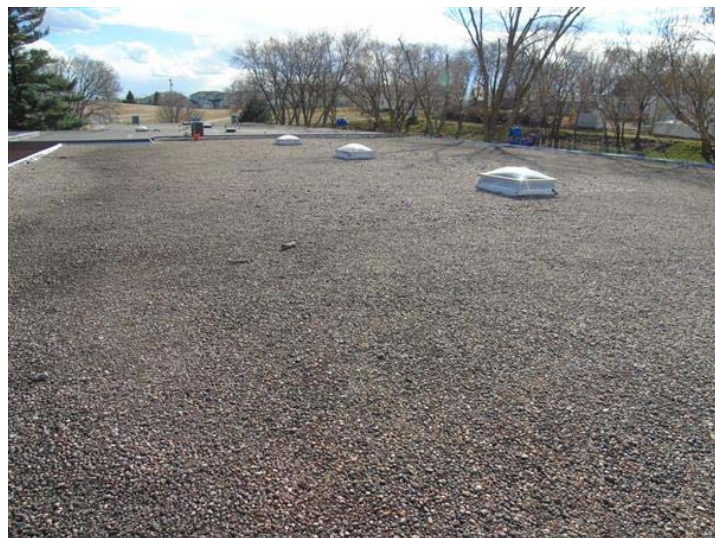
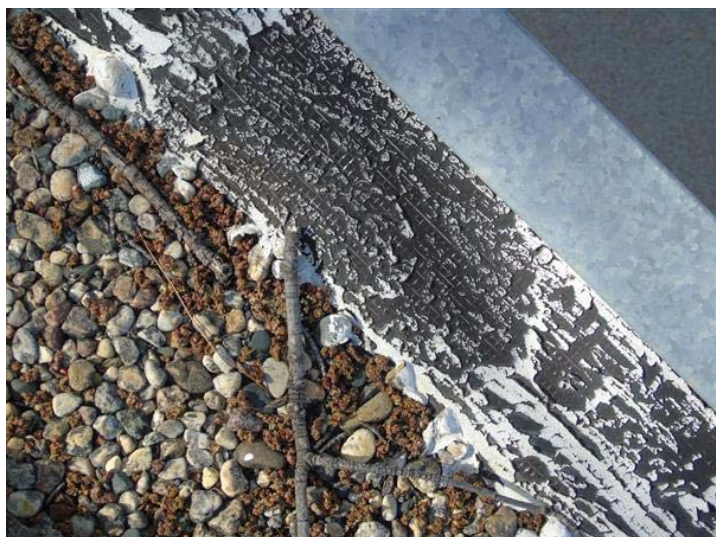
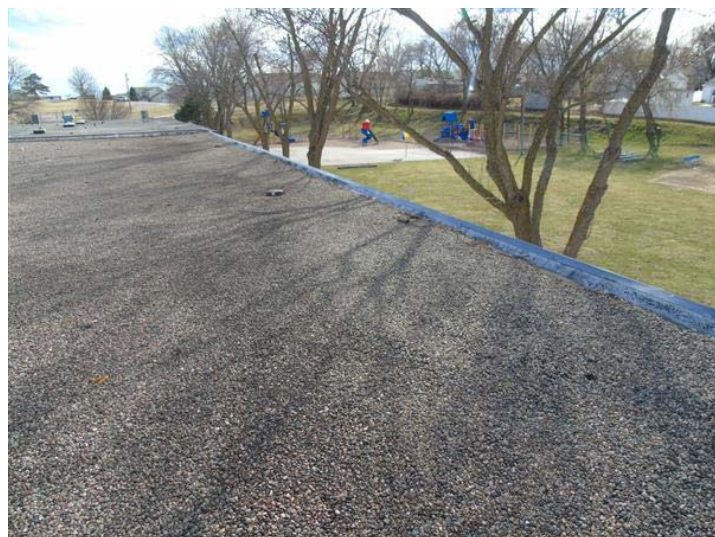
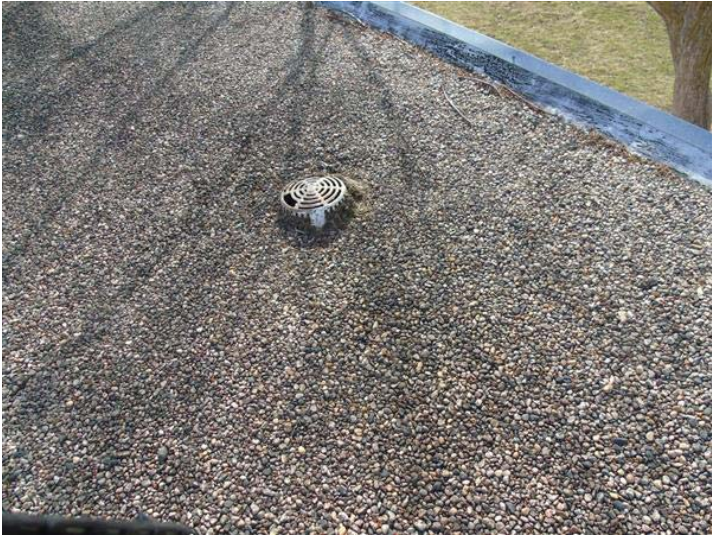
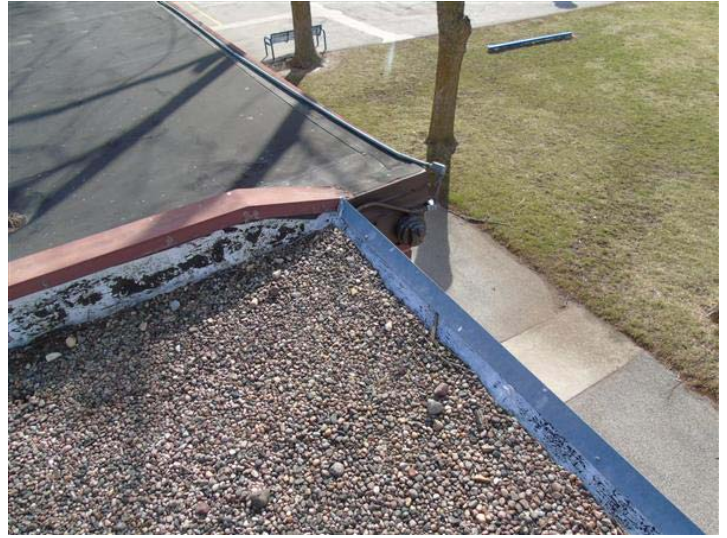
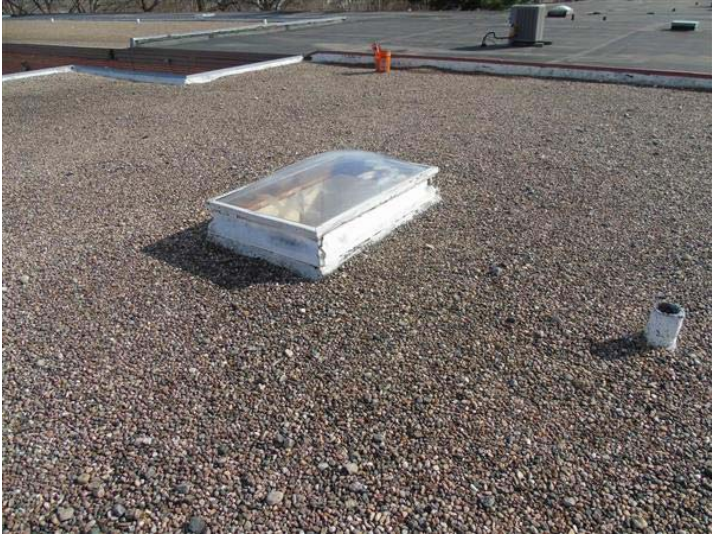
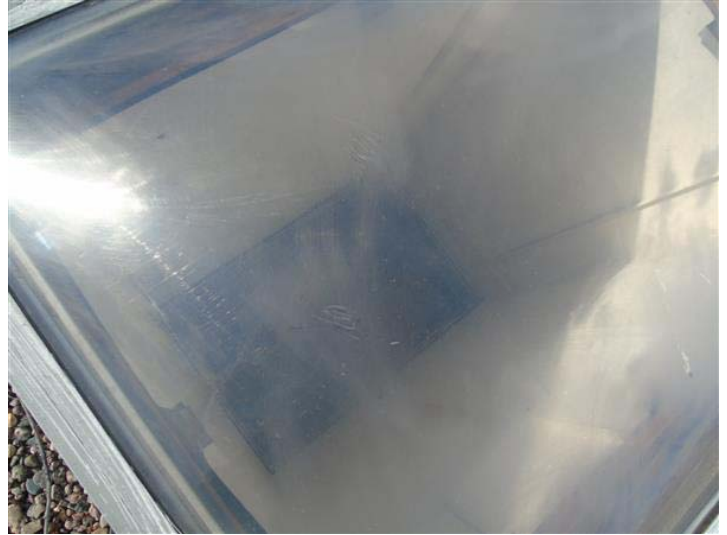
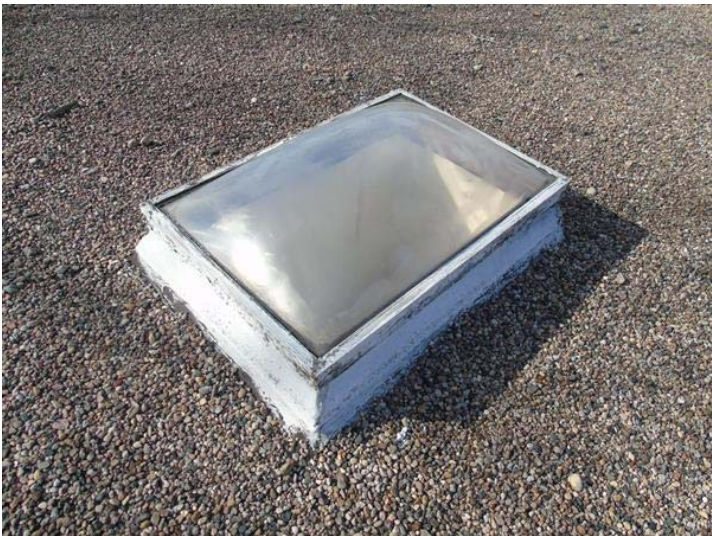
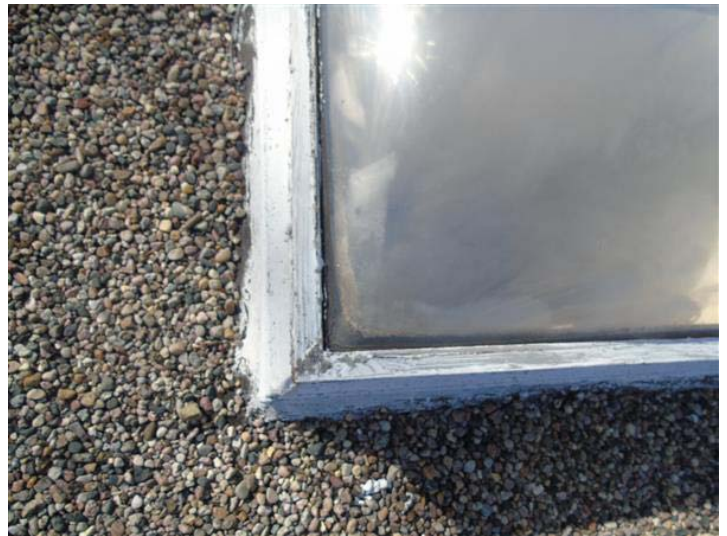
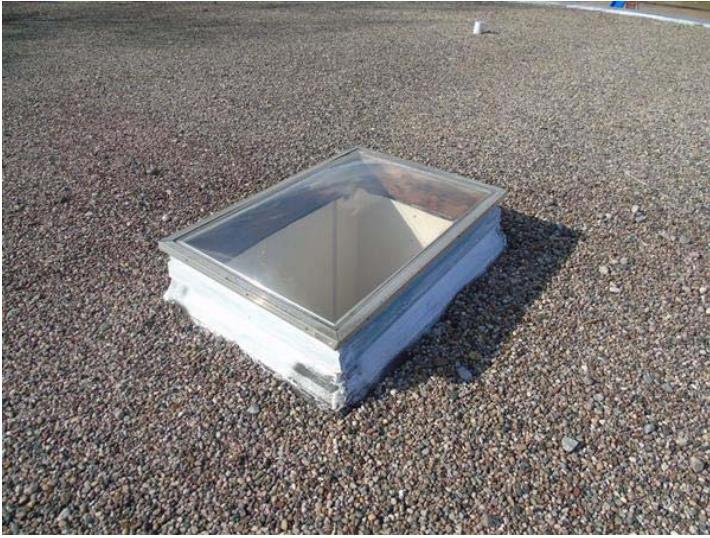
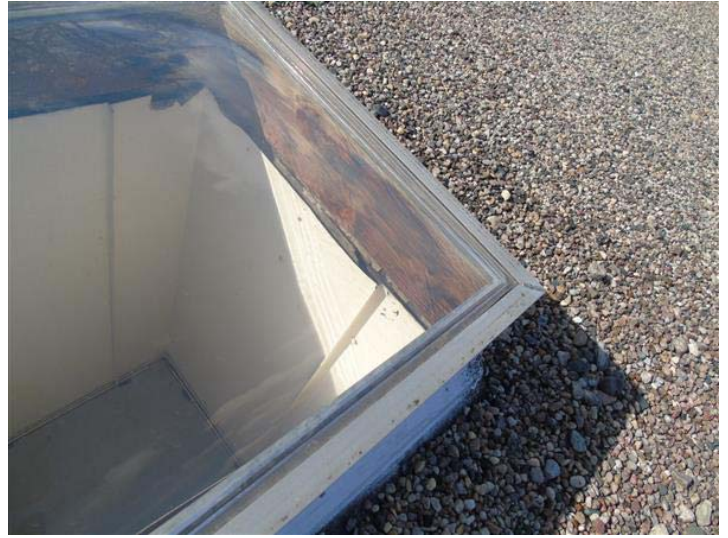
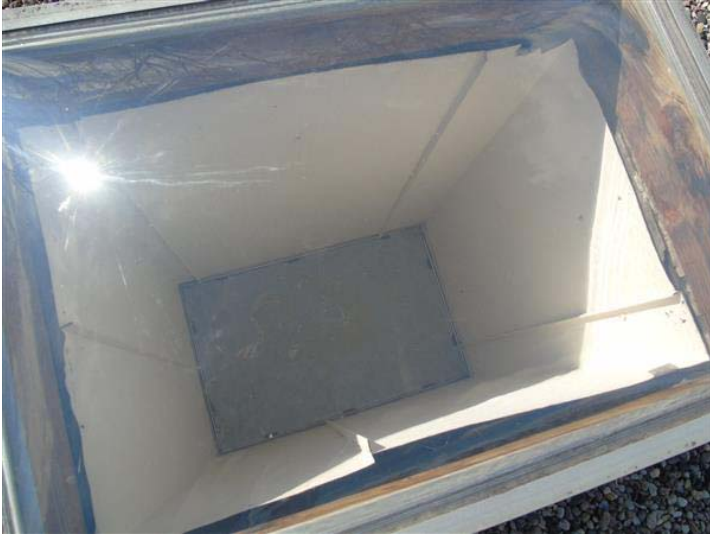
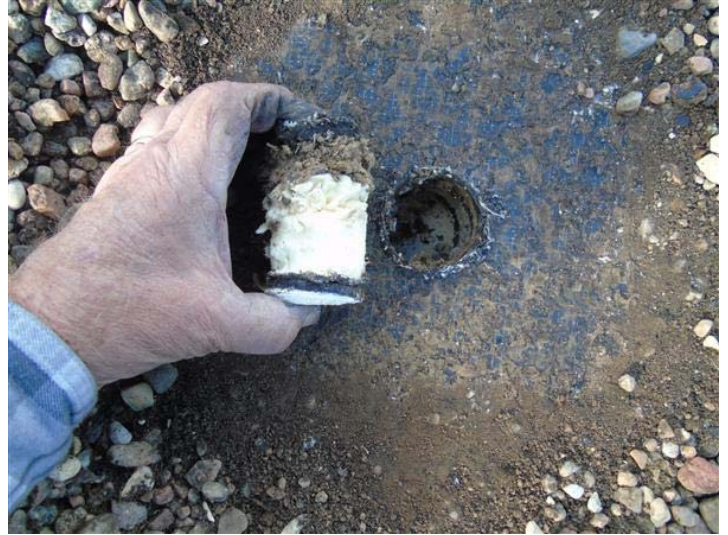
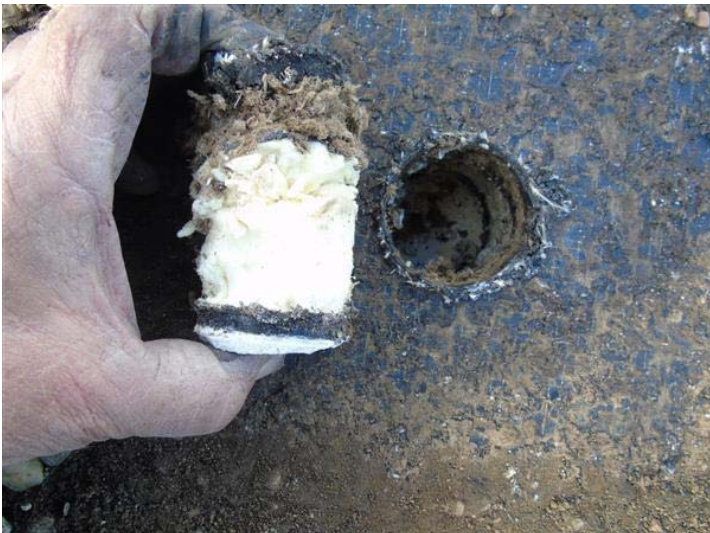
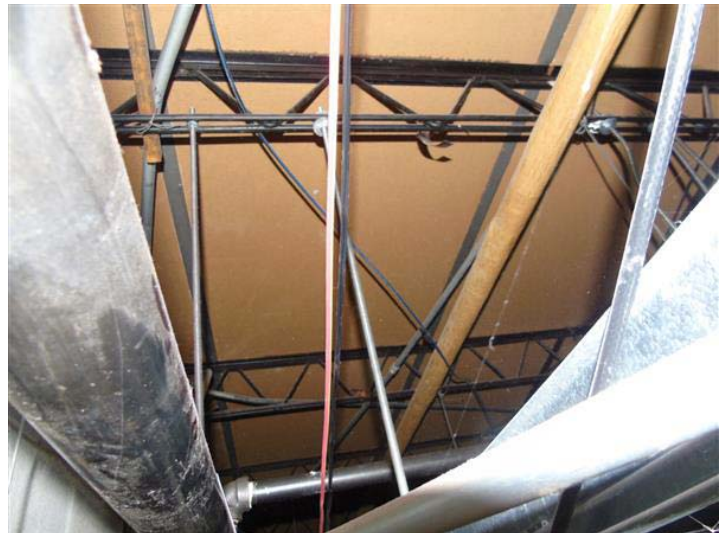
Belleaire Elementary_Bellevue, NE
Ph 1 Roof Inspection_Roof B-1_2017-03-07

Typical defects for the B roof areas:
 (43) The BUR flashing's are weathered with areas of deterioration.

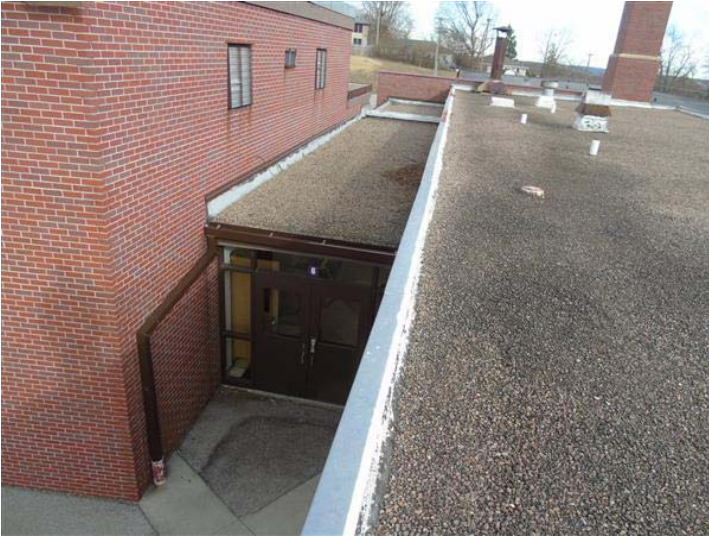
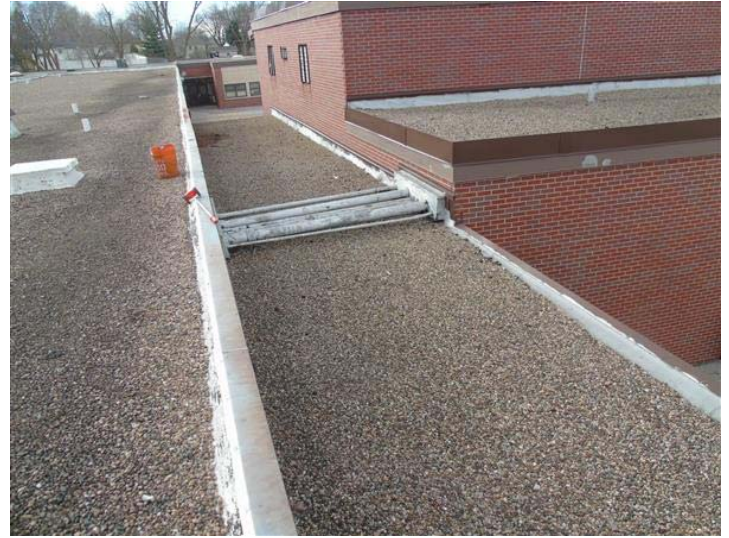
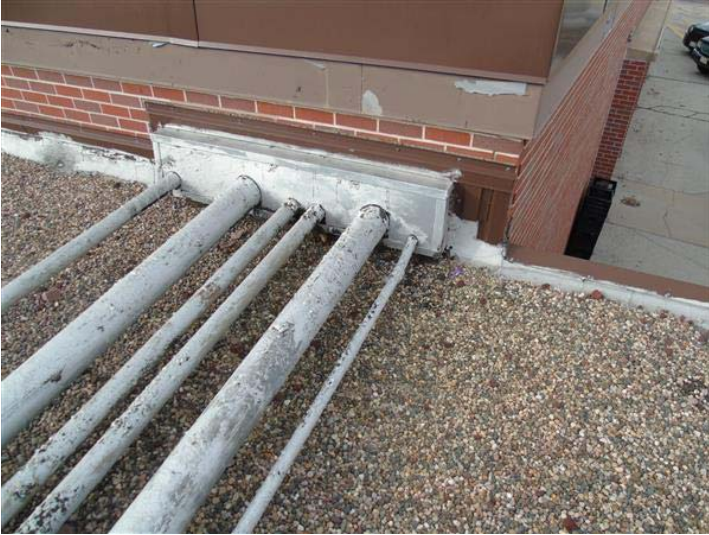
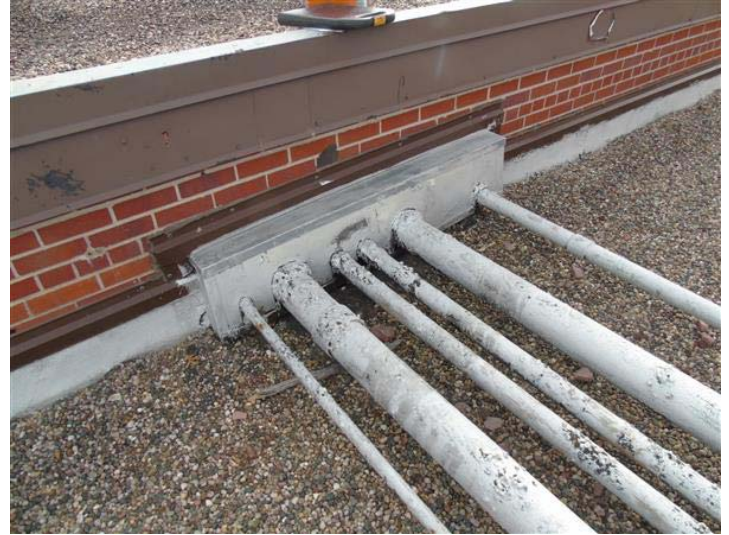
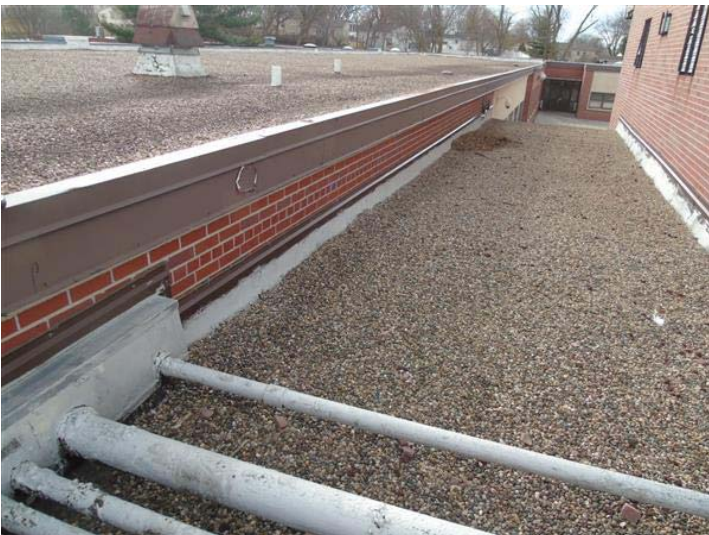
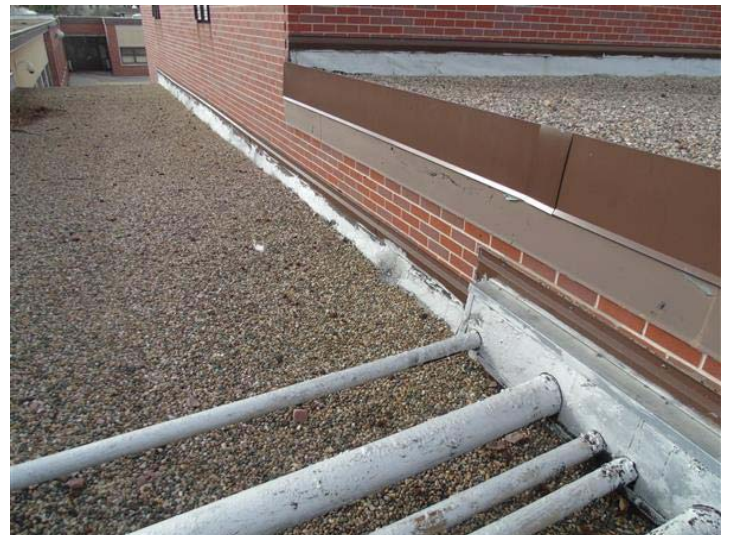
Belleaire Elementary_Bellevue, NE
Ph 1 Roof Inspection_Roof C_2017-03-07

Typical defects for the C roof area:
 (1) Missing/deteriorated caulking on the top of the perimeter wall counter flashings.
