# Roof Inspection Report

Betz Elementary  
605 W. 27<sup>th</sup> Avenue  
Bellevue, NE 68005

**Date of Last Inspection:** Mar 08, 2017

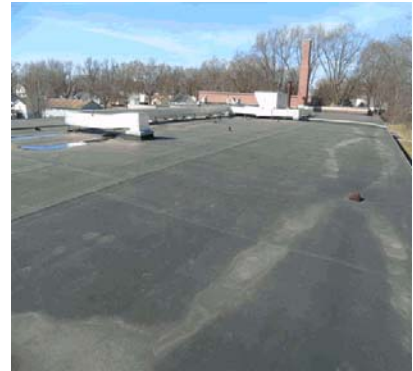
**Drainage and Leak Details:** The A roof areas mainly slope to the interior and drain to primary roof drains, however, some of the drains are located along the perimeter edges of the roof areas.

Facility personnel reported scattered leak issues on the A-2 roof area at the time of inspection.

- Open and loose EPDM lap edges observed
- Areas with standing water observed on the A-2 roof area
- Loose areas of EPDM membrane along the edges of the roof areas
- Accumulation of debris observed around the drain strainers and along the sides of the A-3 roof area
- Areas with EPDM stripping repair attempts to the A-1 roof membrane laps
- Open EPDM flashing laps observed
- Abandoned roof curbs with metal covers observed

Overall, the roof system is in poor condition due to its age and the deteriorated nature of the roof system. Given the observed conditions, it is our opinion comprehensive repairs in an effort to extend the life of the system would be neither feasible nor cost effective. We recommend the roof be replaced. There was no warranty information available for this roof section at the time of inspection.

RSI recommends a complete tear-off of existing roof system and the installation of a new twenty (20) year design life roof system. We further recommend the replacement of all perimeter coping cap and projection details per SMACNA Architectural Sheet Metal Manual.

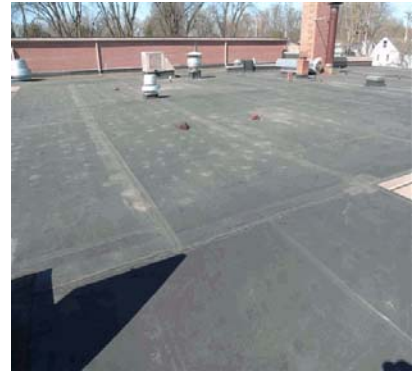
Recent leaks were reported on the main roof area and there was evidence of a leak under the smaller, lower elevated, B-1 roof area.

- Open and loose EPDM lap edges observed
- EPDM stripping repair attempts to the roof membrane laps
- Open EPDM flashing laps observed

Overall, the roof system is in poor condition due to its age and the deteriorated nature of the roof system. Given the observed conditions, it is our opinion comprehensive repairs in an effort to extend the life of the system would be neither feasible nor cost effective. We recommend the roof be replaced. There was no warranty information available for this roof section at the time of inspection.

RSI recommends a partial tear-off of the existing roof system, leaving the existing insulation in place, and installation of a new twenty (20) year design life roof system. We further recommend installation of new perimeter metal and projection details per SMACNA Architectural Sheet Metal Manual.

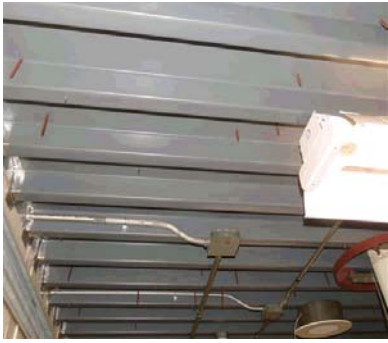
Mar 08, 2017	Deck Underside

One (1) core sample was taken on the main B roof area which revealed a factory primed steel decking. There is one (1) layer of 3" polyisocyanurate insulation, one (1) layer of air-expanded polystyrene, which is a tapered insulation system, and a .5" layer of wood fiber cover board. The membrane is a fully-adhered, .060 mil Firestone EPDM. The wood fiber cover board was found to be deteriorated at the core cut location. Under views of both B roof areas revealed the same type of factory primed steel decking.

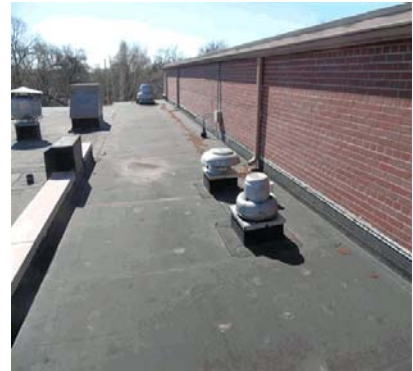
Facility personnel reported a recent leak at the north end of the roof area, by the large chimney.

- Open and loose EPDM lap edges observed
- Accumulation of debris observed in the guttering
- Open EPDM flashing laps observed

Overall, the roof system is in poor condition due to its age and above referenced defects. Given the observed conditions, it is our opinion comprehensive repairs in an effort to extend the life of the system would be neither feasible nor cost effective. We recommend the roof be replaced. There was no warranty information available for this roof section at the time of inspection.

Budget Year	Activity Type	Action Item ?	Allocation	Urgency	Quotation \$
2017	Partial Tear-Off	Yes	Capital	High	\$9,980
<p>RSI recommends a partial tear-off of the existing roof system, leaving the existing insulation in place, and installation of a new twenty (20) year design life roof system. We further recommend installation of new perimeter metal and projection details per SMACNA Architectural Sheet Metal Manual.</p>					<b>\$9,980</b>

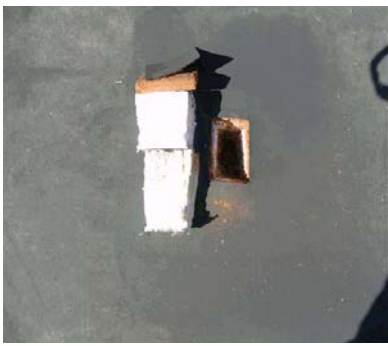
Mar 08, 2017	Roof System Core

One (1) core cut revealed a wood decking. There is one (1) layer of 3" polyisocyanurate board, one (1) layer of air-expanded polystyrene, which is a tapered system, a .5" layer of wood fiber cover board and a fully-adhered, .060 mil Firestone EPDM. The wood fiber cover board was deteriorated at the core cut location.

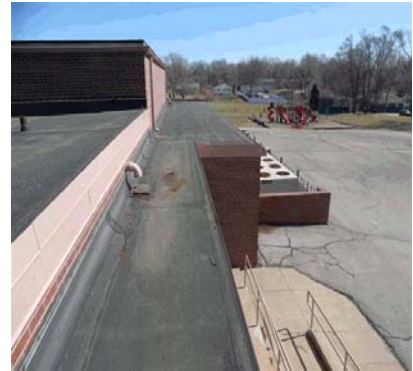
- Blocked outlets or downspouts observed in the guttering
- Loose EPDM membrane observed at the west end of the roof area
- Accumulation of debris observed in the guttering
- Open EPDM flashing laps observed

Overall, the roof system is in poor condition due to its age and the deteriorated nature of the roof system. Given the observed conditions, it is our opinion comprehensive repairs in an effort to extend the life of the system would be neither feasible nor cost effective. We recommend the roof be replaced. There was no warranty information available for this roof section at the time of inspection.

Budget Year	Activity Type	Action Item ?	Allocation	Urgency	Quotation \$
2017	Replacement	Yes	Capital	High	\$14,518
<p>RSI recommends a complete tear-off of existing roof system and the installation of a new twenty (20) year design life roof system. We further recommend the replacement of all perimeter coping cap and projection details per SMACNA Architectural Sheet Metal Manual.</p>					
					<b>\$14,518</b>

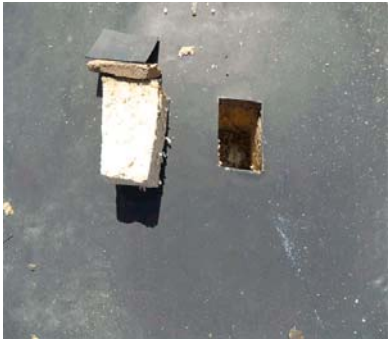
Mar 08, 2017	Roof System Core

One (1) core cut revealed a poured in place gypsum deck. There is one (1) layer of 4" polyisocyanurate board, a .5" layer wood fiber cover board and a fully-adhered, .060 mil Firestone EPDM. The wood fiber cover board was deteriorated at the core cut location.

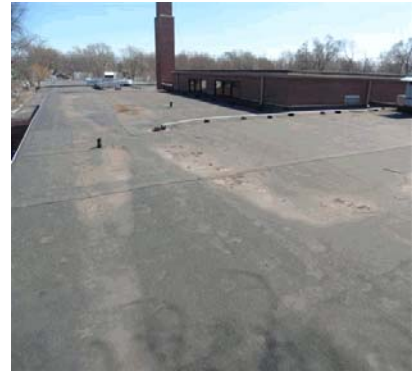
- Open and loose EPDM lap edges observed
- Accumulation of debris around the drain strainers and along the sides of the roof
- EPDM flashings are bridged
- Open EPDM flashing laps observed
- One (1) split edge metal EPDM end lap cover patch observed

Overall, the roof system is in poor condition due to its age and the deteriorated nature of the roof system. Given the observed conditions, it is our opinion comprehensive repairs in an effort to extend the life of the system would be neither feasible nor cost effective. We recommend the roof be replaced. There was no warranty information available for this roof section at the time of inspection.

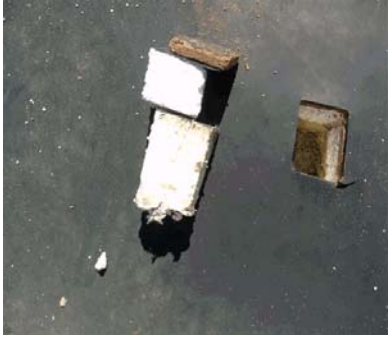
Mar 08, 2017	Roof System Core

One (1) core cut revealed a poured in place gypsum deck. There is one (1) layer of 3" polyisocyanurate board, one (1) layer of air-expanded polystyrene, which is a tapered system, one (1) .5" layer of wood fiber cover board and a fully-adhered, .060 mil Firestone EPDM. The wood fiber cover board was deteriorated at the core cut location.

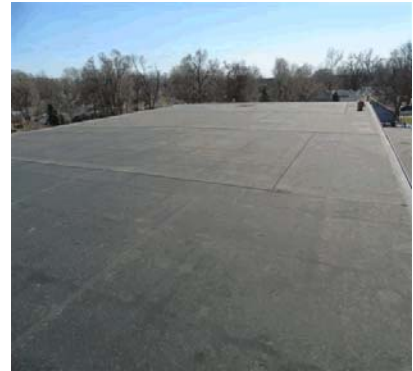
**Drainage and Leak Details:** Roof Section F has a slight slope to the exterior sides of the roof and drains to an external guttering. The roof area also has a single roof drain at the south end and a small scupper at the north end.

Facility personnel reported past leak issues at the NE and SW corners of the roof area. EPDM stripping repairs have been performed in these areas and may have resolved the leak issues.

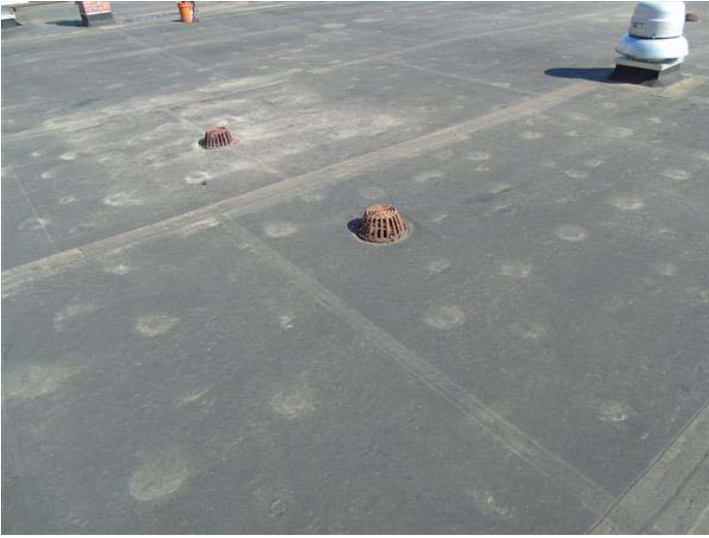
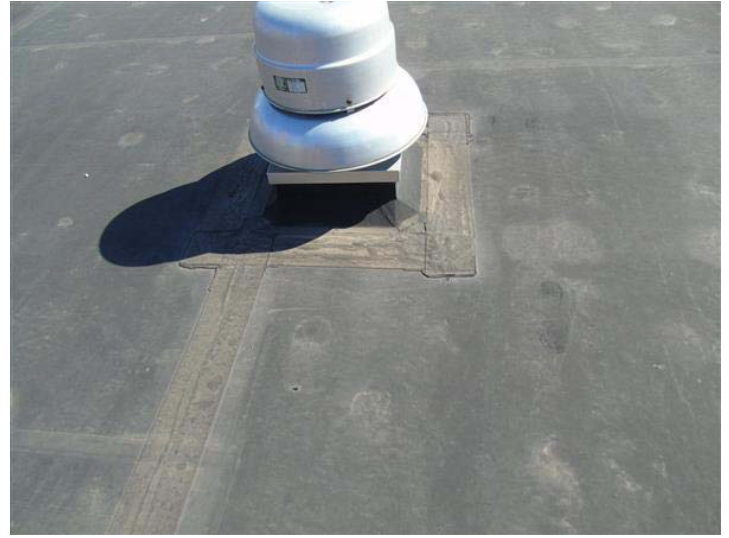
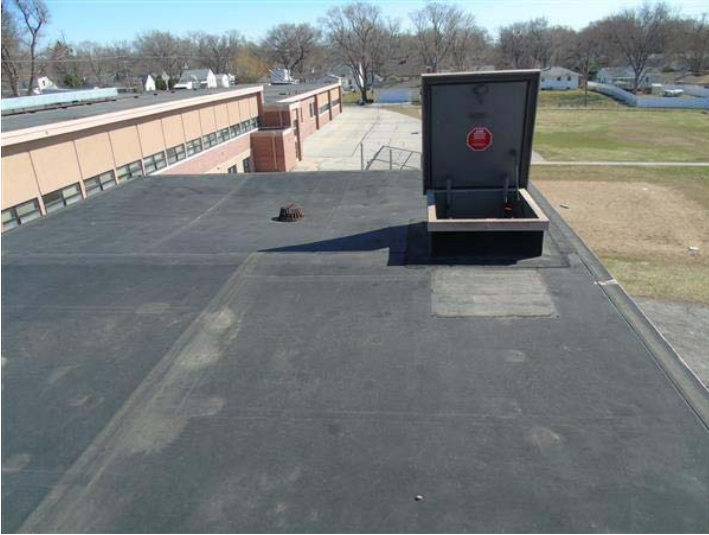
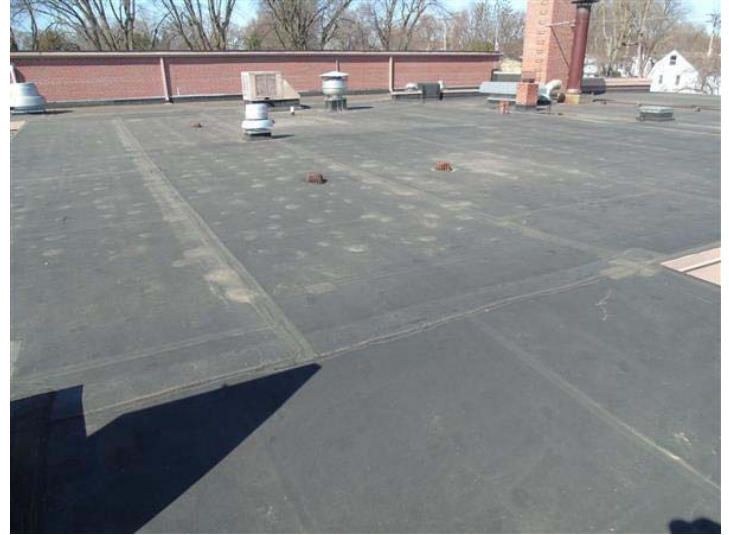
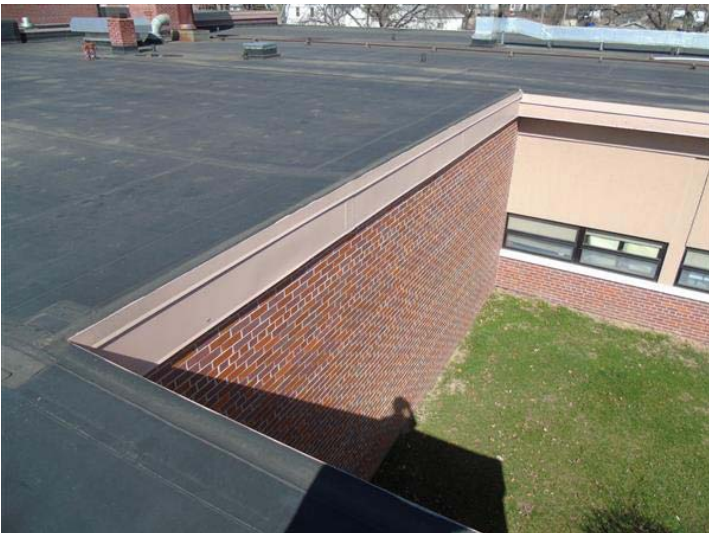
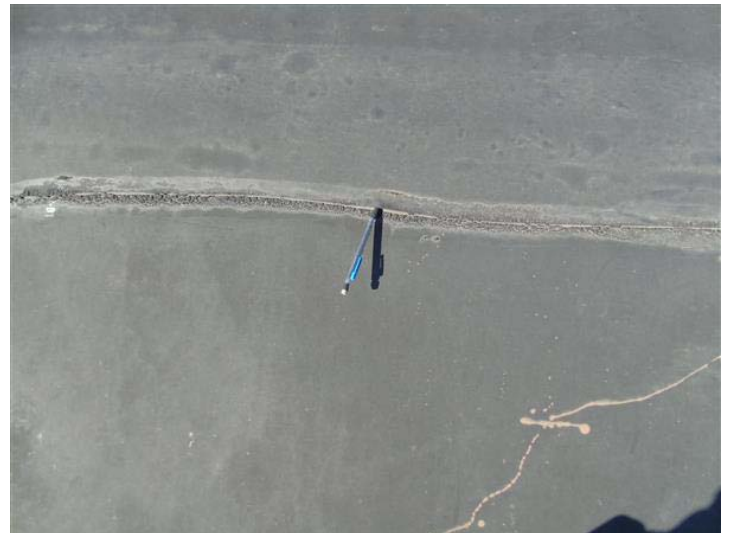
Betz Elementary\_Bellevue, NE  
Ph 1 Roof Inspection\_Roof B\_2017-03-08

Typical defects for the B&C roof areas:  
 3 Loose EPDM lap edges on the B roof membrane laps.  
 24 EPDM stripping repairs to the B roof membrane laps.  
 3 Loose EPDM lap edges on the C roof area.

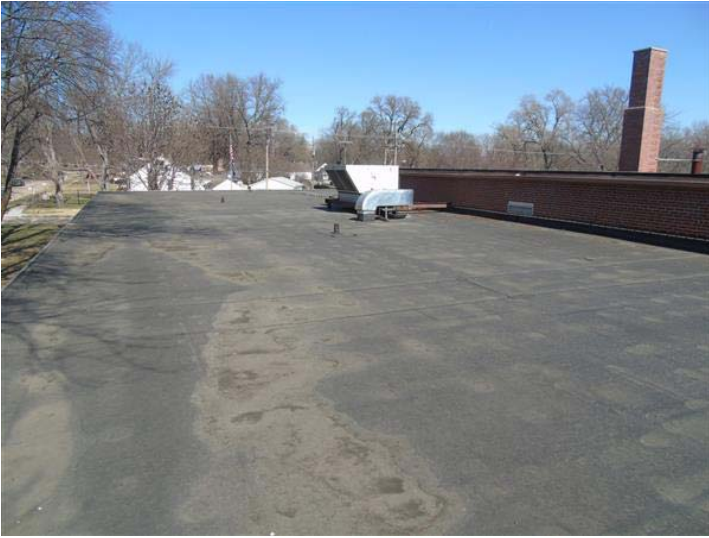
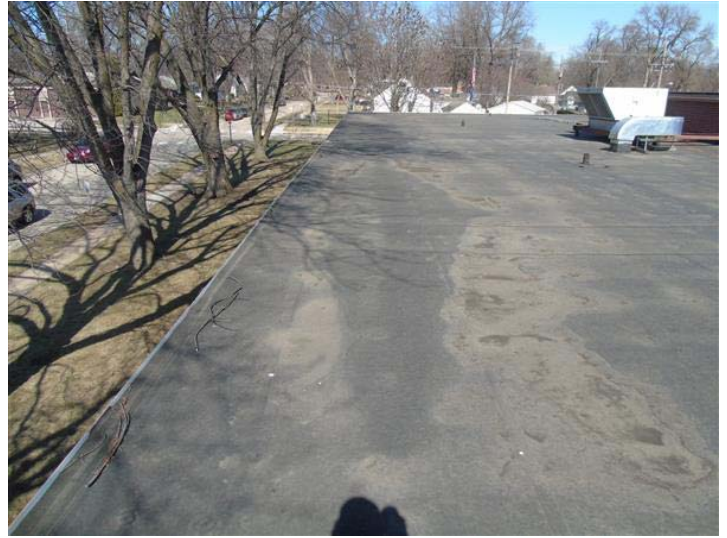
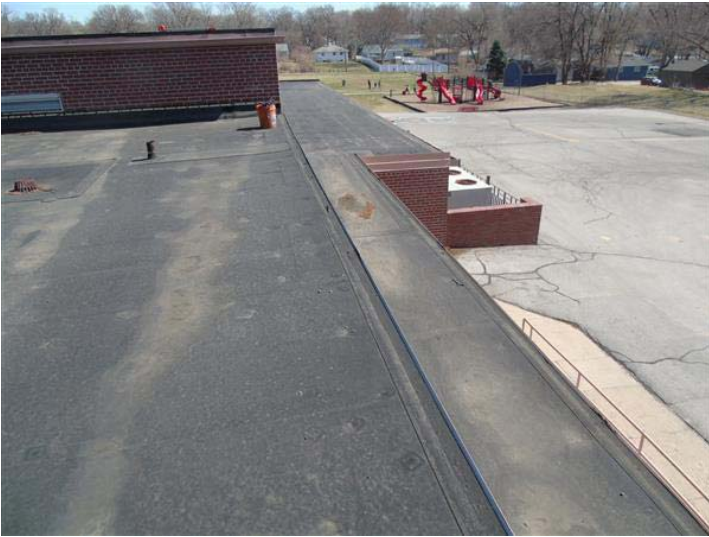
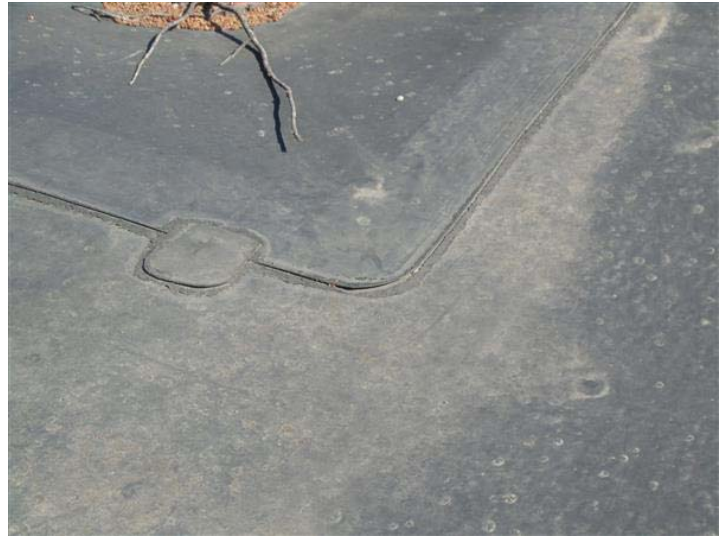
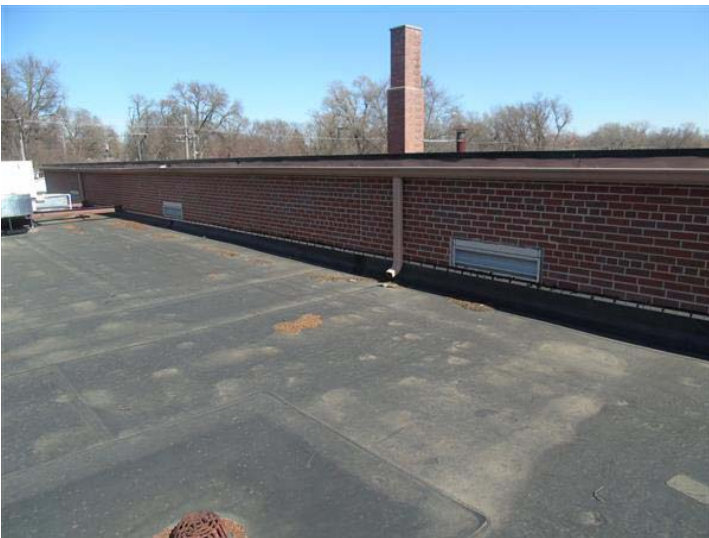
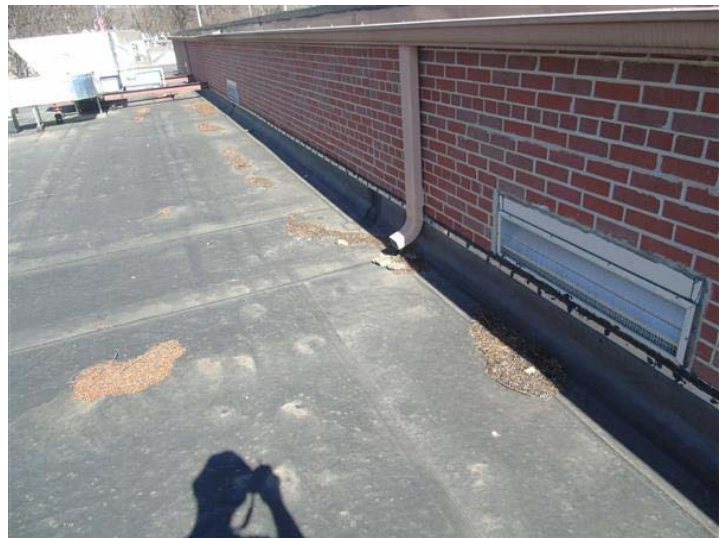
Betz Elementary\_Bellevue, NE  
Ph 1 Roof Inspection\_Roof E\_2017-03-08

Typical defects for the E roof area:  
 3 Loose EPDM lap edges.  
 49 Open and loose EPDM flashing laps.
