Roof Inspection Report

Chap Elementary
1201 Gregg Road
Bellevue, NE 68005

Date	Inspection Type	Inspecting Company	Inspector
Mar 23, 2017	Phase 1 Roof Inspection	Roofing Solutions, Inc.	Garry Hendrickson

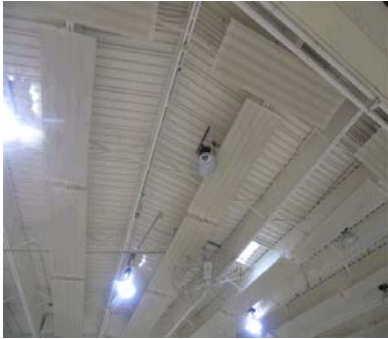
Mar 23, 2017	Deck Underside

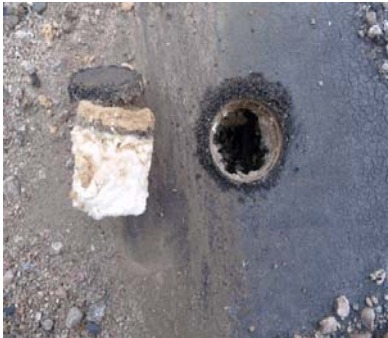
One (1) core sample was taken on the A-1 roof area. The deck is a steel decking. The insulation consists of one (1) layer of 2" polyisocyanurate insulation board and one (1) layer of 1/2" wood fiber cover board. The membrane is a multiply BUR with a gravel surface. An under view of the A-2 roof area revealed a steel decking and the roof system appears to be the same type and age of the A-1 roof area.

Mar 23, 2017	Roof System Core
