Roof Inspection Report

East High School
1401 High School Drive
Bellevue, NE 68005

Date of Last Inspection: Apr 03, 2017

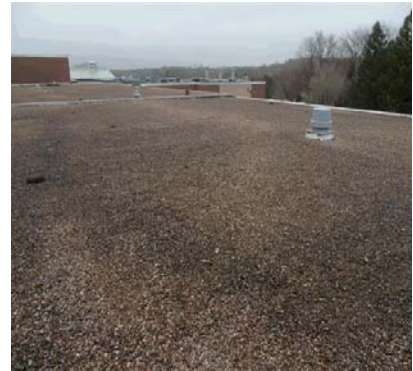
Facility personnel reported leaks over the band room.

- One (1) split in the BUR membrane
- Random areas with blistered roof membrane and flashing plies
- Roof mastic repair attempts observed to the BUR system
- The expansion joint BUR flashing is weathered
- Loose attachment anchors observed in the expansion joint cap

Overall, the roof system is in poor condition due to the above referenced defects and deteriorated nature of the roof system. With leak repairs performed only as needed, the roof system should remain effective for the duration of its assessed service life, approximately two (2) years. There was no warranty information available for this roof section at the time of inspection.

Budget Year	Activity Type	Action Item ?	Allocation	Urgency	Quotation \$
2017	Repair	Yes	Expense	High	\$1,500
RSI recommends leak repairs be performed only as needed until the roofs recommended replacement in 2019.					
2019	Infrared Scan	Yes	Expense	High	\$1,000
RSI recommends an infrared scan be performed to locate any wet insulation present in the current roof system.					
2019	Retrofit	Yes	Capital	High	\$39,760
RSI recommends the installation of a new twenty (20) year design life roof system. We further recommend installation of new perimeter metal and projection details per the SMACNA Architectural Sheet Metal Manual.					
					\$42,260

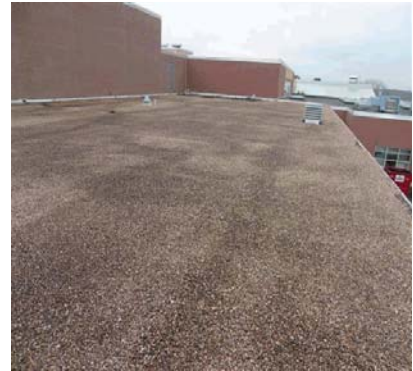
Roof Section B refers to the low slope roof system over the A-21 and A-23 roof areas at the Bellevue East High School facility. The roof is an approximately sixteen (16) year old BUR with a gravel surface. Facility personnel indicated that the roofing was installed in 2001, but the conditions indicate that the roof system is older. The exterior perimeter side of the roof area is a raised roof edge detail where the roof system terminates with a metal roof edging. The internal walls and the expansion joint curbs are flashed with a BUR type of membrane flashing which has been coated with an aluminum paint. The wall flashings terminate with a caulk strip detail and the expansion joint curbs are topped with a metal cap.

- Deteriorated caulking observed in the brick wall expansion joints located above the roof system
- Ridged or buckling roof membrane plies observed near the roof drains
- Surface loss of the gravel roof surfacing
- Cold process and roof mastic repair attempts observed to the BUR system
- Open laps observed in the edge metal stripping laps
- One (1) detached tectum sound panel observed on the underside of the decking

Overall, the roof system is in poor condition due to the above listed defects and the deteriorated nature of the roof system. With the aforementioned defects addressed, in addition to routine maintenance and regular inspection, the roof system should remain effective for the duration of its assessed service life, approximately two (2) years. There was no warranty information available for this roof section at the time of inspection.

RSI recommends repairs be completed in accordance with the attached deficiency list.

Please Note: RSI further recommends that the detached tectum panel be repaired or replaced as soon as possible as it poses a safety issue.

RSI recommends a complete tear-off of existing roof system and the installation of a new twenty (20) year design life roof system. We further recommend the replacement of all perimeter coping cap and projection details per SMACNA Architectural Sheet Metal Manual.

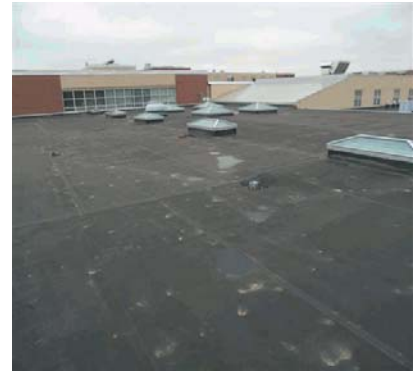
Facility personnel reported ongoing leak issues over the cafeteria and adjoining rooms, along with reported leaks over the pool lobby area.

- Split or deteriorated caulking observed in the wall joints
- Open or loose EPDM lap edges observed
- Standing water observed around the skylight curbs
- Areas of loose EPDM field membrane at the SE corner of the C-2 roof area
- Accumulation of debris in the corner of the C-3 roof area
- One (1) puncture in the EPDM membrane was temporarily sealed with caulking at the time of inspection
- Past EPDM patch repair attempts observed to the roof system laps
- One (1) set of deteriorated wood equipment supports
- Low flashing height observed on the common wall with the raised K-2 roof area
- The EPDM flashings are bridged
- There are open or loose EPDM lap edges
- Split EPDM corner and curbed unit flashings

Overall, the roof system is in poor condition due to its age and the deteriorated nature of the roof system. Given the observed conditions, it is our opinion comprehensive repairs in an effort to extend the life of the system would be neither feasible nor cost effective. We recommend the roof be replaced. There was no warranty information available for this roof section at the time of inspection.

Budget Year	Activity Type	Action Item ?	Allocation	Urgency	Quotation \$
2017	Replacement	Yes	Capital	High	\$320,520
<p>RSI recommends a complete tear-off of existing roof system and the installation of a new twenty (20) year design life roof system. We further recommend the replacement of all perimeter coping cap and projection details per SMACNA Architectural Sheet Metal Manual.</p>					
					\$320,520

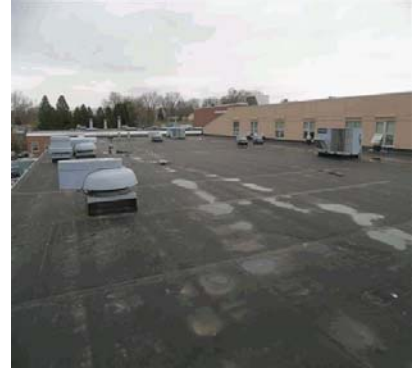
Facility personnel reported recent leaks over the H-01 room.

- Open or loose EPDM lap edges observed
- Past EPDM patch repair attempts to the roof system laps
- Split EPDM cover patches on the edge metal lap joints
- One (1) section of loose metal roof edging observed at the north end of the E-2 roof area
- One (1) detached piece of EIFS trim observed below a window

Overall, the roof system is in poor condition due to its age and the deteriorated nature of the roof system. Given the observed conditions, it is our opinion comprehensive repairs in an effort to extend the life of the system would be neither feasible nor cost effective. We recommend the roof be replaced. There was no warranty information available for this roof section at the time of inspection.

RSI recommends a complete tear-off of existing roof system and the installation of a new twenty (20) year design life roof system. We further recommend the replacement of all perimeter coping cap and projection details per SMACNA Architectural Sheet Metal Manual.

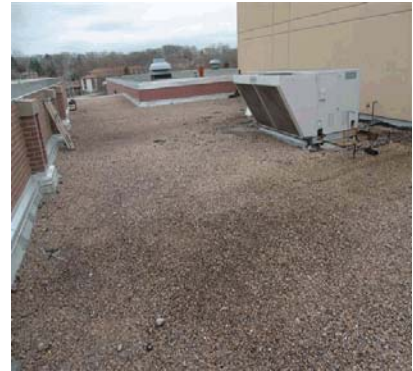
Facility personnel reported ongoing leak issues over the Pool Lobby area.

- Deteriorated caulking observed on the top of the northern pool wall counter flashing
- Roof mastic repair attempts observed near the HVAC unit at the reported leak area
- One (1) abandoned roof curb has a metal cover

Overall, the roof system is in poor condition due to its age and reported leak history. Given the observed conditions, it is our opinion comprehensive repairs in an effort to extend the life of the system would be neither feasible nor cost effective. We recommend the roof be replaced. There was no warranty information available for this roof section at the time of inspection.

Budget Year	Activity Type	Action Item ?	Allocation	Urgency	Quotation \$
2017	Replacement	Yes	Capital	High	\$43,000
<p>RSI recommends a complete tear-off of existing roof system and the installation of a new twenty (20) year design life roof system. We further recommend the replacement of all perimeter coping cap and projection details per SMACNA Architectural Sheet Metal Manual.</p>					
					\$43,000

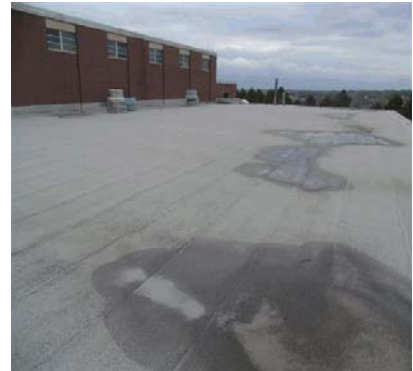
- Fishmouths observed in the modified bitumen laps
- There are fan hoods and metal filter frames which have been left on the roof area
- Random areas with open modified bitumen edge metal stripping laps at the edge metal end laps
- Split pipe penetration flashing seals and split sealant observed on the edge metal end laps
- One (1) roof drain has a detached retaining ring and missing drain strainer

Overall, the roof system is in fair working condition due to its age and above referenced defects. With the aforementioned defects addressed, in addition to routine maintenance and regular inspection, the roof system should remain effective for the duration of its assessed service life, approximately three (3) years. There was no warranty information available for this roof section at the time of inspection.

Budget Year	Activity Type	Action Item ?	Allocation	Urgency	Quotation \$
2017	Repair	Yes	Expense	High	\$2,500
RSI recommends repairs be completed in accordance with the attached deficiency list.					
2020	Infrared Scan	Yes	Expense	High	\$1,000
RSI recommends an infrared scan be performed to locate any wet insulation present in the current roof system.					
2020	Retrofit	Yes	Capital	High	\$96,460
RSI recommends the installation of a new twenty (20) year design life roof system. We further recommend installation of new perimeter metal and projection details per the SMACNA Architectural Sheet Metal Manual.					
					\$99,960

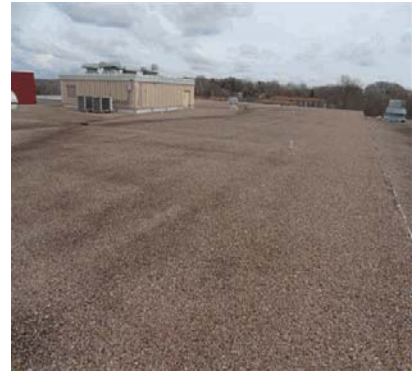
Facility personnel reported active leaks over the stage area.

- Deteriorated caulking observed in the brick wall expansion joints located above the roof system
- Loose BUR ply edges observed
- Ridged or buckling roof membrane plies

- One (1) split area in BUR field membrane
- Surface loss of the gravel roof surfacing
- Deteriorated BUR flashings and field membrane observed
- Blistered BUR flashings observed

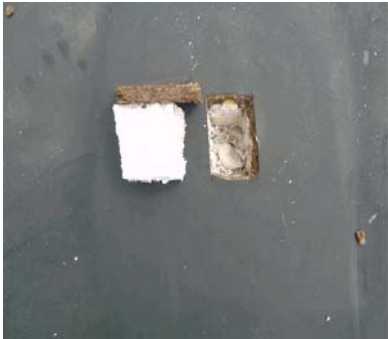
A photograph showing two small, rectangular core samples. The sample on the left is white and appears to be a foam or insulation material. The sample on the right is brown and appears to be a wood or fiber-based material. They are placed on a dark, flat surface.	Apr 03, 2017	Core cut #1

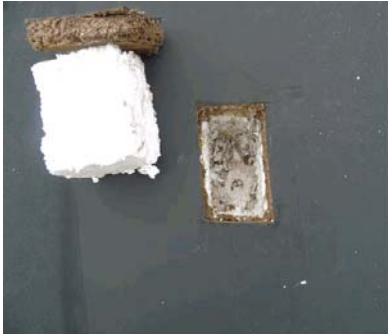
A photograph showing two small, rectangular core samples. The sample on the left is white and appears to be a foam or insulation material. The sample on the right is brown and appears to be a wood or fiber-based material. They are placed on a dark, flat surface.	Apr 03, 2017	Core cut #2

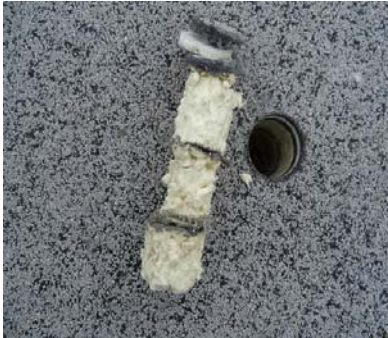
Apr 03, 2017	Roof System Core

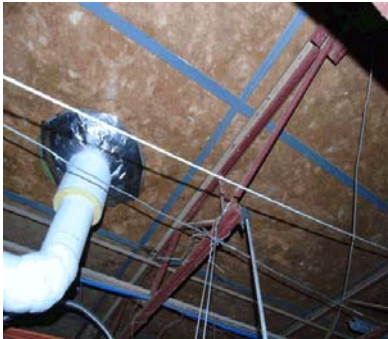
Apr 03, 2017	Deck Underside

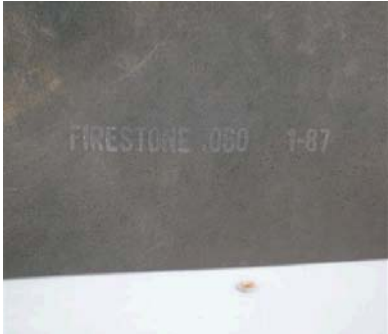
Apr 03, 2017	Membrane stamp

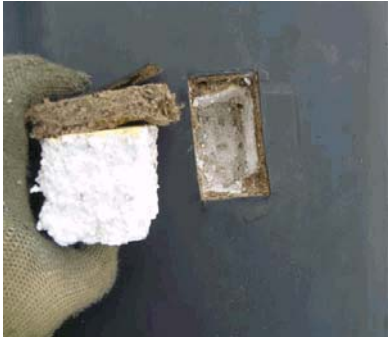
Apr 03, 2017	Roof System Core

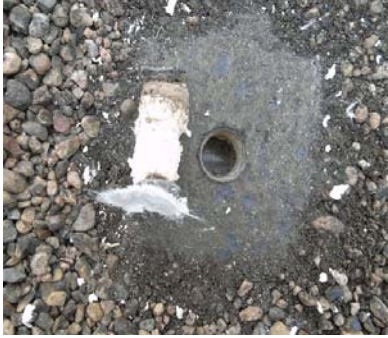
Apr 03, 2017	Roof System Core

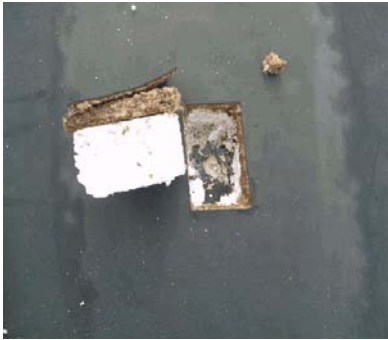
Apr 03, 2017	Core cut #1

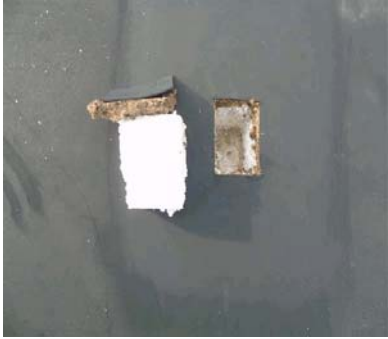
Apr 03, 2017	Core cut #2

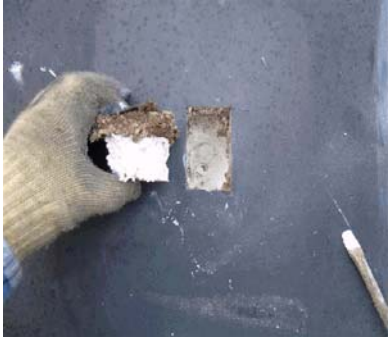
Apr 03, 2017	Core cut #3

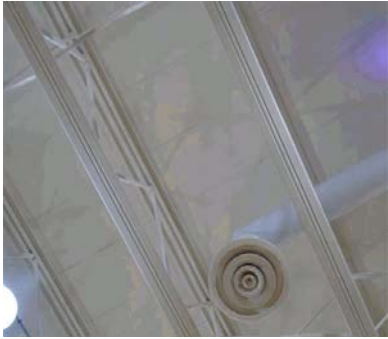
Apr 03, 2017	Deck Underside

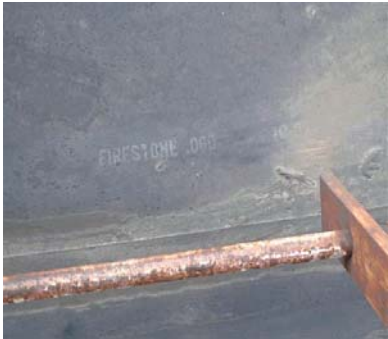
Apr 03, 2017	Membrane stamp

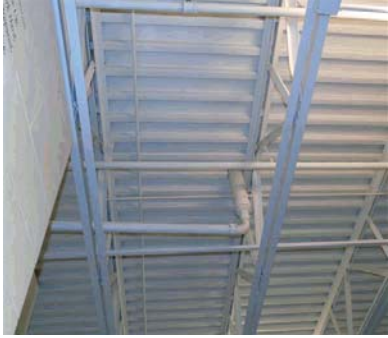
Apr 03, 2017	Deck Underside

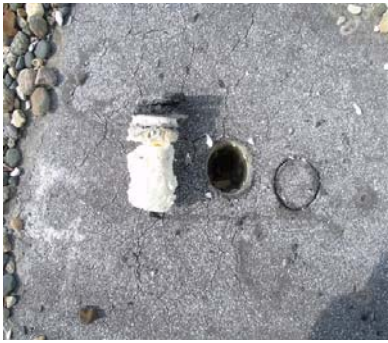
Apr 03, 2017	Roof System Core

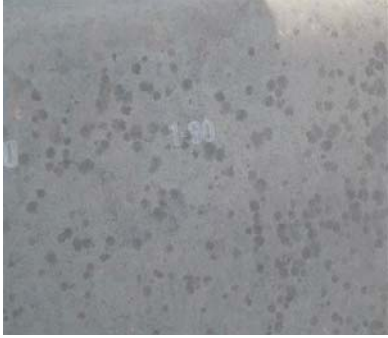
Apr 03, 2017	Membrane stamp

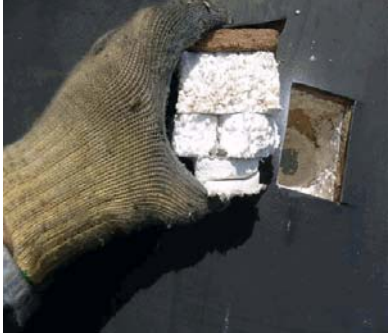
Apr 03, 2017	Roof System Core

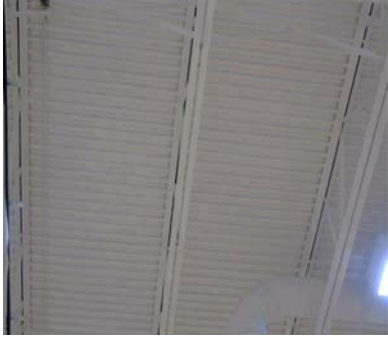
Apr 03, 2017	Deck Underside

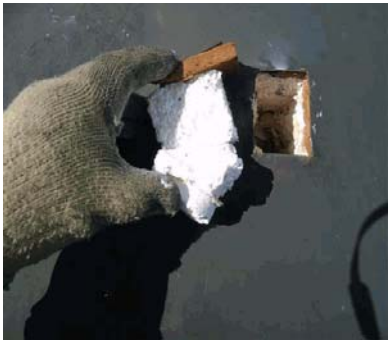
Apr 03, 2017	Roof System Core

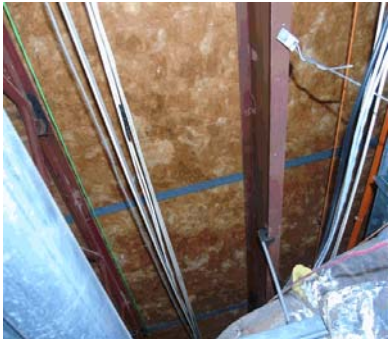
Apr 03, 2017	Deck Underside

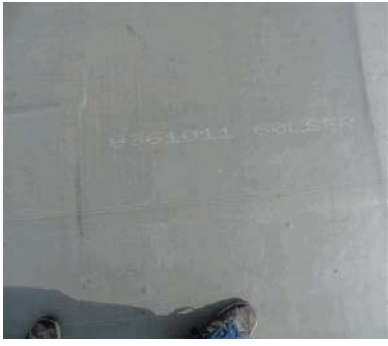
Apr 03, 2017	Membrane stamp

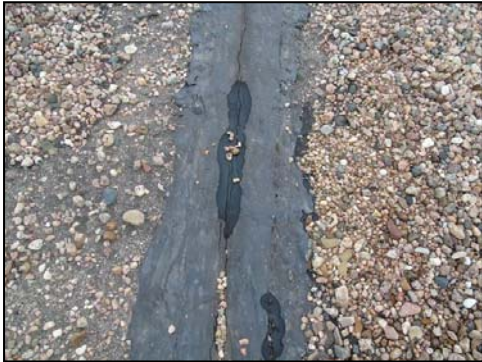
Defect Code:	6	Quantity:	10 LF	Priority:	First Year
Description: Split in membrane.					
Repair: Cut out splits and repair membrane with similar membrane material. Extend repair material a minimum of 6" in all directions past repair areas.

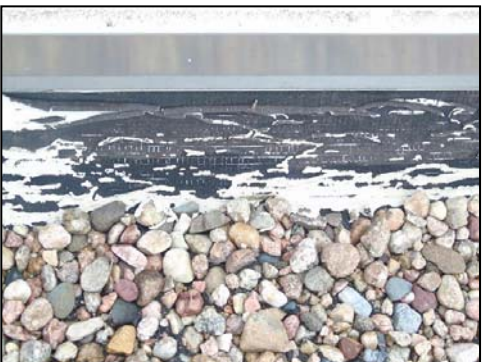
Defect Code:	43	Quantity:	Widespread	Priority:	Monitor
Description: Weathered and deteriorated flashing					
Repair: Clean and prepare surfaces by removing loose granules, dirt, and other debris. Apply two coats of elastomeric coating compatible with the flashing materials.

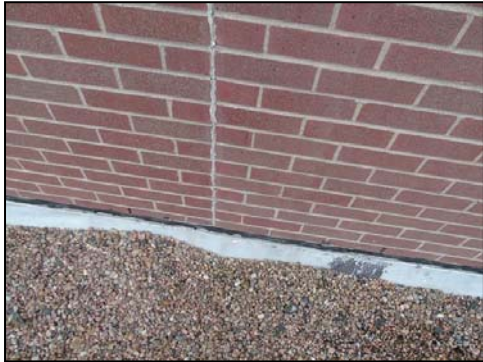
Defect Code:	1	Quantity:	Widespread	Priority:	First Year
Description: Deteriorated or missing sealant at counterflashing, termination bar, sealant lip, metal flashing, expansion joint, etc.					
Repair: Clean loose sealant and dirt from all surfaces. Apply new polyurethane sealant and tool to shed water.

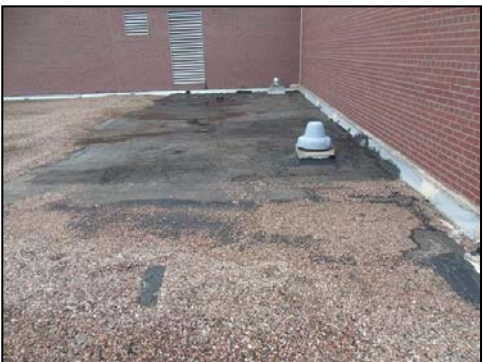
Defect Code:	24	Quantity:	Widespread	Priority:	Monitor
Description: Evidence of past problem and previous repair.					
Repair: Investigate for chronic leak problems and repair any areas that are suspect.

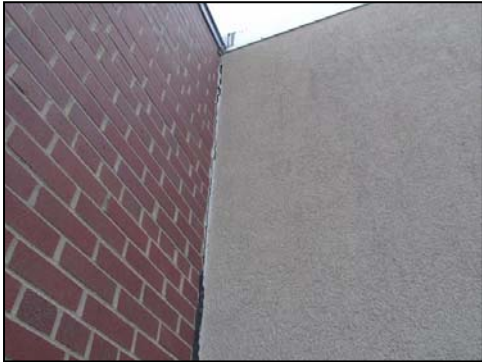
Defect Code:	1	Quantity:	Widespread	Priority:	First Year
Description: Deteriorated or missing sealant at counterflashing, termination bar, sealant lip, metal flashing, expansion joint, etc.					
Repair: Clean loose sealant and dirt from all surfaces. Apply new polyurethane sealant and tool to shed water.

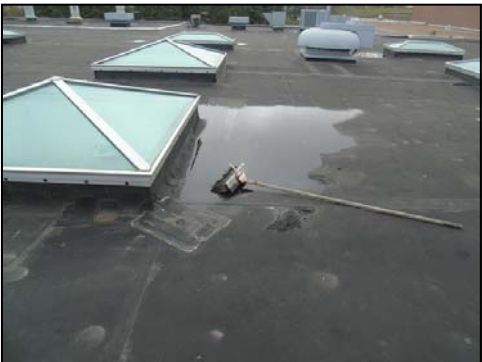
Defect Code:	15	Quantity:	Random	Priority:	Monitor
Description: Ponding of water.					
Repair: Monitor areas for severe or chronic ponding. Provide sacrificial membrane ply in ponded areas where existing membrane is deteriorated. Install additional drain or scupper including collectors and drain piping where ponding conditions are severe and chronic.

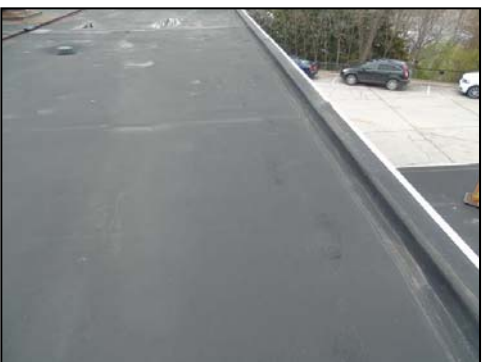
Defect Code:	18	Quantity:	Random	Priority:	Monitor
Description: Unadhered membrane or inadequate membrane attachment.					
Repair: At unadhered areas, cut open membrane and readhere to substrate with manufacturer's approved adhesive. At areas with missing securement, provide securement in the form of screws and plates installed a maximum of 12" O.C. Overlay repaired areas with new membrane of similar gauge, type, and plies and extend repairs a minimum of 4" past cut areas or edges of plates.

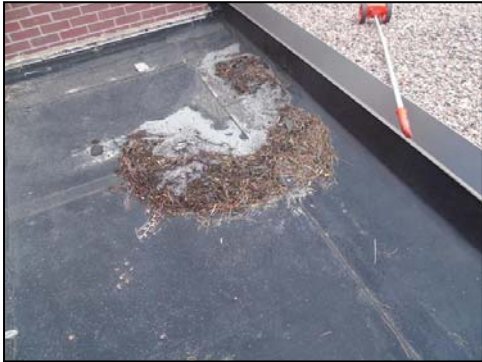
Defect Code:	22	Quantity:	Random	Priority:	Monitor
Description: Debris, trash, construction materials, HVAC equipment, filters, motors, etc. on roof surface.					
Repair: Remove all trash and debris from roof. Clean and inspect surfaces and repair any damages to the membrane or flashings.

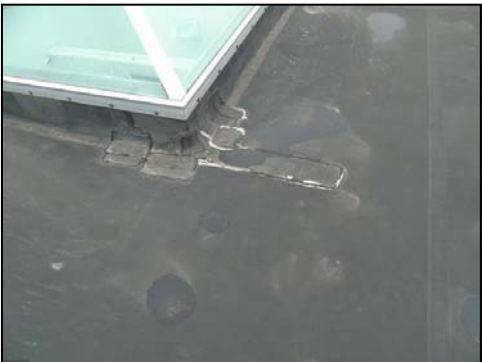
Defect Code:	24	Quantity:	Random	Priority:	Monitor
Description: Evidence of past problem and previous repair.					
Repair: Investigate for chronic leak problems and repair any areas that are suspect.

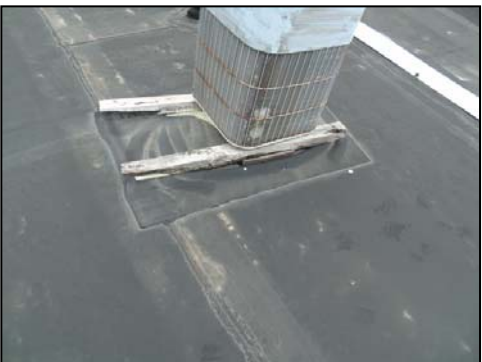
Defect Code:	27	Quantity:	Under 10 LF	Priority:	Monitor
Description: Missing or damaged membrane protection layer at sleeper, antenna, satellite sled, blocking, pipe stand, paver, etc.					
Repair: Install protective membrane layer and extend a minimum of 4" in all directions past sleeper, blocking, etc. Adhere or weld to synthetic membranes and set in cold adhesive for asphalt systems.

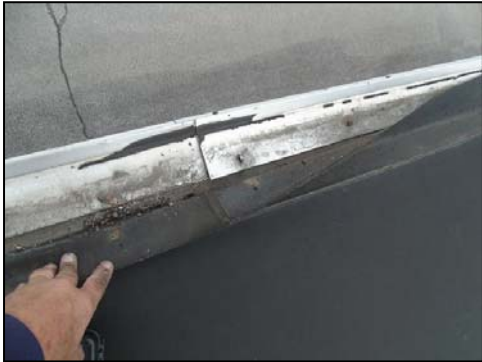
Defect Code:	75	Quantity:	40 LF	Priority:	First Year
Description: Inadequate attachment of metal flashings.					
Repair: Reattach metal flashings a maximum of two EPDM washered fasteners per side of curb or attach a maximum of 12" O.C for flashings more than 24 " in length.

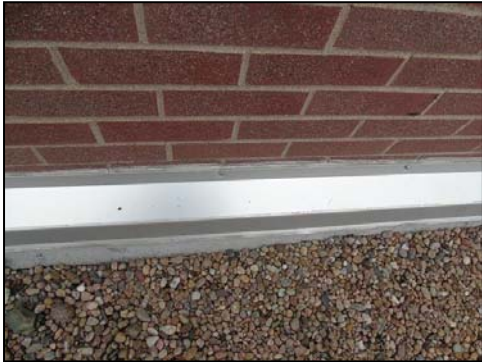
Defect Code:	1	Quantity:	50 LF	Priority:	First Year
Description: Deteriorated or missing sealant at counterflashing, termination bar, sealant lip, metal flashing, expansion joint, etc.					
Repair: Clean loose sealant and dirt from all surfaces. Apply new polyurethane sealant and tool to shed water.

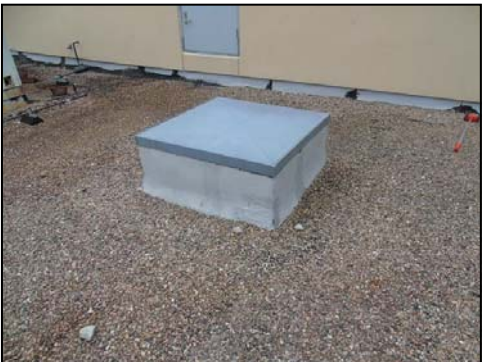
Defect Code:	56	Quantity:	1	Priority:	Monitor
Description: Abandoned and obsolete equipment.					
Repair: Monitor for leaks. Check systems are abandoned and disconnected and will not be used in the future. Remove abandoned equipment and repair deck at scheduled roof replacement.

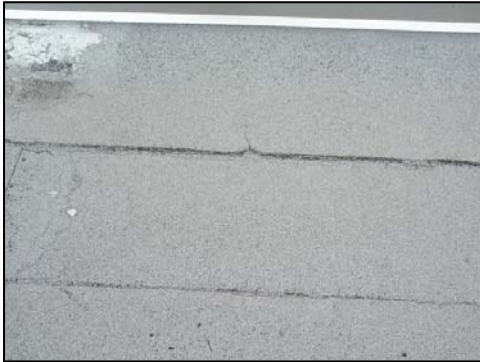
Defect Code:	2	Quantity:	Under 10 LF	Priority:	First Year
Description: Fishmouth in field or flashing seam.					
Repair: Cut away fishmouth and lay material flat. Apply repair of like material and extend onto existing roof surface a minimum of 4". Complete laps per manufacturer's requirements. On asphalt systems, apply three-course of mastic and fabric over lap. Resurface membrane with ballast, gravel, or granules.

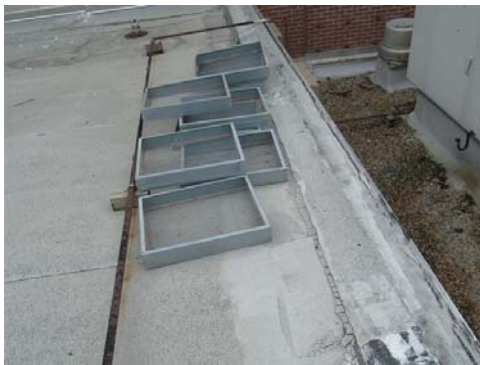
Defect Code:	22	Quantity:	Random	Priority:	First Year
Description: Debris, trash, construction materials, HVAC equipment, filters, motors, etc. on roof surface.					
Repair: Remove all trash and debris from roof. Clean and inspect surfaces and repair any damages to the membrane or flashings.

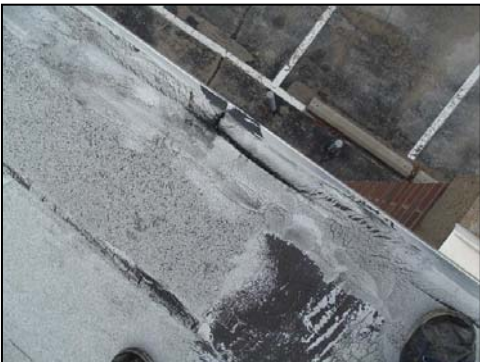
Defect Code:	45	Quantity:	Random	Priority:	First Year
Description: Open flashing lap					
Repair: Open loose lap area and clean thoroughly. Prime and reseam or reweld lap per the manufacturer's requirements. Strip-in defective lap with mimum 6" wide membrane on single ply systems or 6" wide fabric and mastic three-course application on asphalt systems. Regranulate or coat flashing repairs.

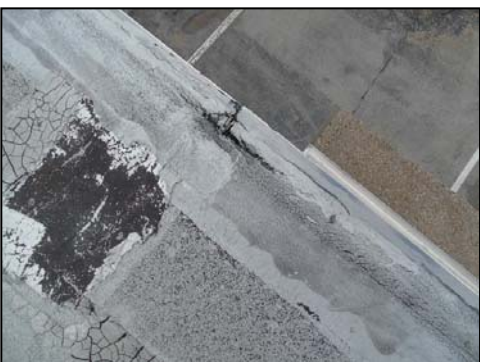
Defect Code:	46	Quantity:	Widespread	Priority:	First Year
Description: Split in flashing					
Repair: Cut away loose flashing and clean and prime repair area. Apply strip in of like material centered over split extending a minimum of 4" in all directions past prepared area.

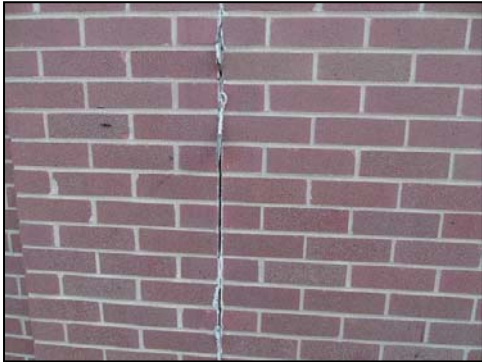
Defect Code:	1	Quantity:	Widespread	Priority:	First Year
Description: Deteriorated or missing sealant at counterflashing, termination bar, sealant lip, metal flashing, expansion joint, etc.					
Repair: Clean loose sealant and dirt from all surfaces. Apply new polyurethane sealant and tool to shed water.

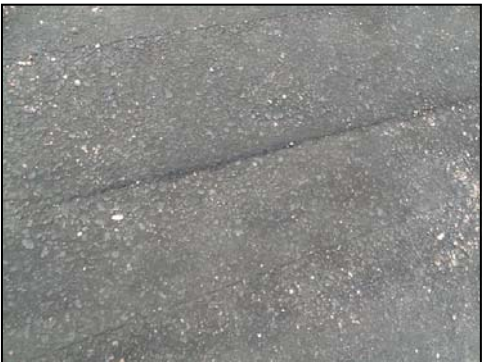
Defect Code:	5	Quantity:	Random	Priority:	Monitor
Description: Buckling or ridging of membrane.					
Repair: Cut out deteriorated buckles and ridges and repair membrane with similar membrane material. Extend repair material a minimum of 6" in all directions past repair areas.

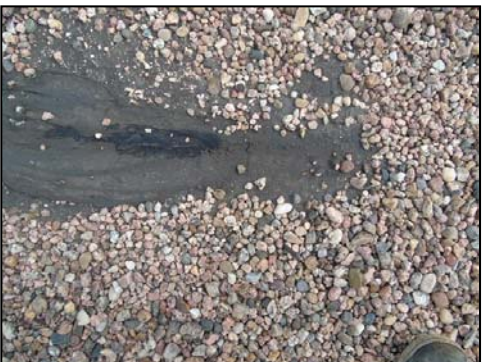
Defect Code:	6	Quantity:	Under 10 SF	Priority:	First Year
Description: Split in membrane.					
Repair: Cut out splits and repair membrane with similar membrane material. Extend repair material a minimum of 6" in all directions past repair areas.

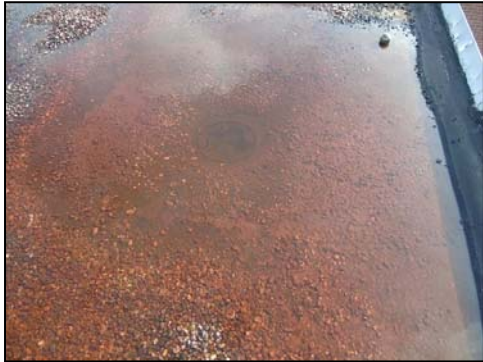
Defect Code:	16	Quantity:	1	Priority:	Urgent
Description: Blocked drain, scupper, or downspout.					
Repair: Remove all debris from drainage system and ensure drain or scupper is free flowing without restrictions at strainer or piping.

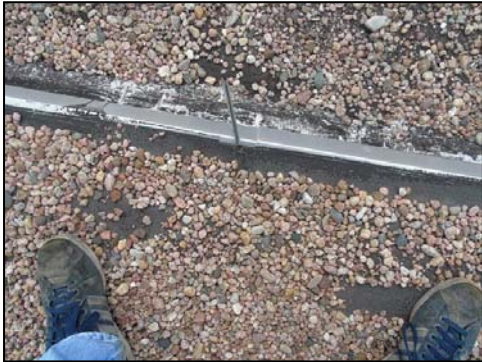
Defect Code:	45	Quantity:	Widespread	Priority:	First Year
Description: Open flashing lap					
Repair: Open loose lap area and clean thoroughly. Prime and reseam or reweld lap per the manufacturer's requirements. Strip-in defective lap with mimum 6" wide membrane on single ply systems or 6" wide fabric and mastic three-course application on asphalt systems. Regranulate or coat flashing repairs.

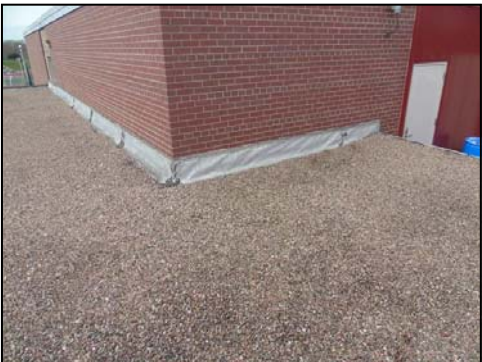
Defect Code:	47	Quantity:	Random	Priority:	Monitor
Description: Racked flashings					
Repair: Monitor flashings and repair when identified as deteriorated.

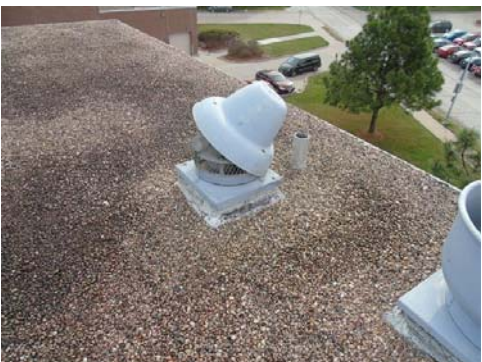
Defect Code:	52	Quantity:	1	Priority:	First Year
Description: Missing rain cap, rain collar, or hood.					
Repair: Install rain cap, hood, or collar and secure and seal to pipe.

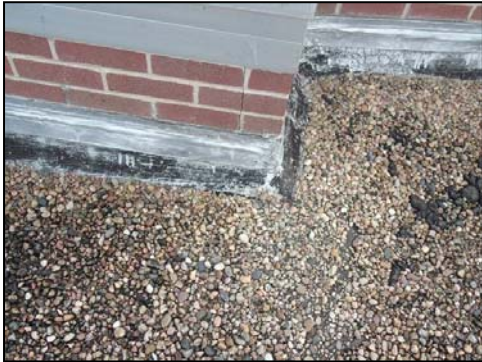
Defect Code:	79	Quantity:	Random	Priority:	First Year
Description: Cracks in walls.					
Repair: Investigate and repair cracks in walls. Apply elastomeric coating or membrane waterproofing to seal wall surface.

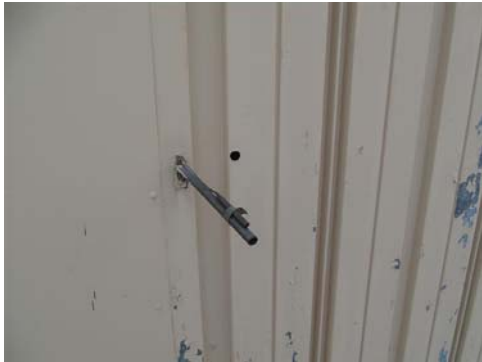
Defect Code:	89	Quantity:	Random	Priority:	First Year
Description: Missing wall covering/cladding.					
Repair: Replace cladding/wall covering with matching materials and methods. Reattach and reseal all joints, seams, laps, etc.

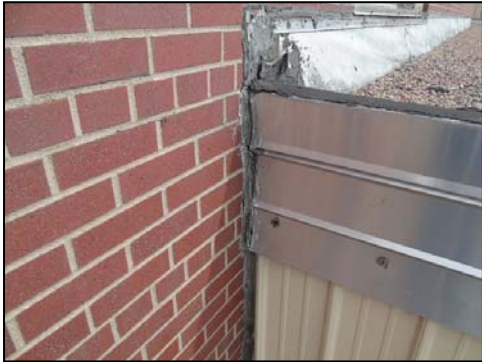
Defect Code:	1	Quantity:	Under 10 LF	Priority:	Monitor
Description: Deteriorated or missing sealant at counterflashing, termination bar, sealant lip, metal flashing, expansion joint, etc.					
Repair: Clean loose sealant and dirt from all surfaces. Apply new polyurethane sealant and tool to shed water.

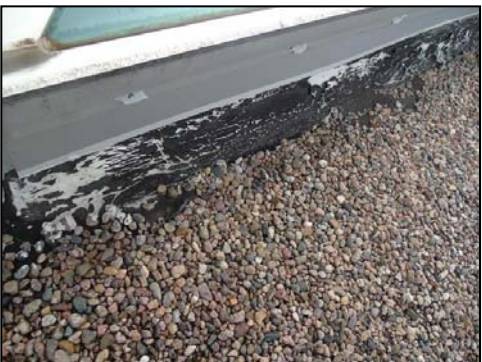
Defect Code:	43	Quantity:	Widespread	Priority:	Monitor
Description: Weathered and deteriorated flashing					
Repair: Clean and prepare surfaces by removing loose granules, dirt, and other debris. Apply two coats of elastomeric coating compatible with the flashing materials.

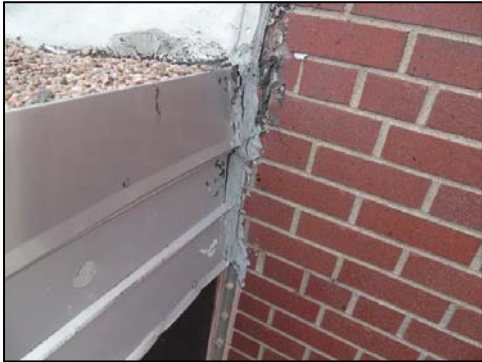
Defect Code:	1	Quantity:	Under 10 LF	Priority:	First Year
Description: Deteriorated or missing sealant at counterflashing, termination bar, sealant lip, metal flashing, expansion joint, etc.					
Repair: Clean loose sealant and dirt from all surfaces. Apply new polyurethane sealant and tool to shed water.

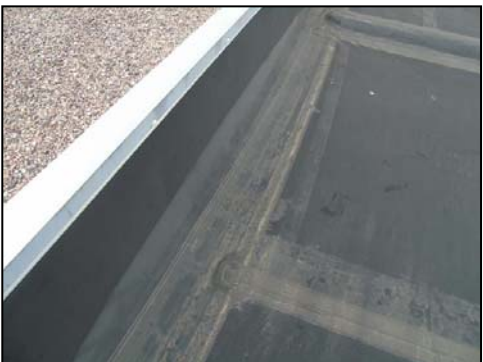
Defect Code:	44	Quantity:	Numerous	Priority:	Monitor
Description: Bridged flashing					
Repair: Cut out all bridged flashings. Clean area thoroughly and apply new flashings. Apply corner flashings and overlay all T-laps, flashings laps, and splice intersections.

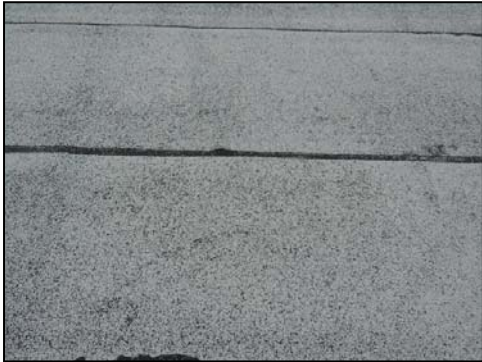
Defect Code:	2	Quantity:	Under 10 LF	Priority:	First Year
Description: Fishmouth in field or flashing seam.					
Repair: Cut away fishmouth and lay material flat. Apply repair of like material and extend onto existing roof surface a minimum of 4". Complete laps per manufacturer's requirements. On asphalt systems, apply three-course of mastic and fabric over lap. Resurface membrane with ballast, gravel, or granules.

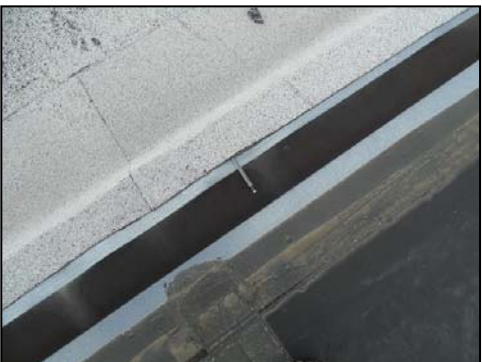
Defect Code:	45	Quantity:	150 LF	Priority:	First Year
Description: Open flashing lap					
Repair: Open loose lap area and clean thoroughly. Prime and reseam or reweld lap per the manufacturer's requirements. Strip-in defective lap with mimum 6" wide membrane on single ply systems or 6" wide fabric and mastic three-course application on asphalt systems. Regranulate or coat flashing repairs.

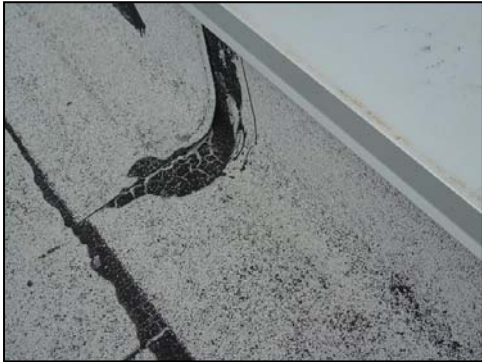
Defect Code:	45	Quantity:	Under 10 LF	Priority:	First Year
Description: Open flashing lap					
Repair: Open loose lap area and clean thoroughly. Prime and reseam or reweld lap per the manufacturer's requirements. Strip-in defective lap with minimum 6" wide membrane on single ply systems or 6" wide fabric and mastic three-course application on asphalt systems. Regranulate or coat flashing repairs.

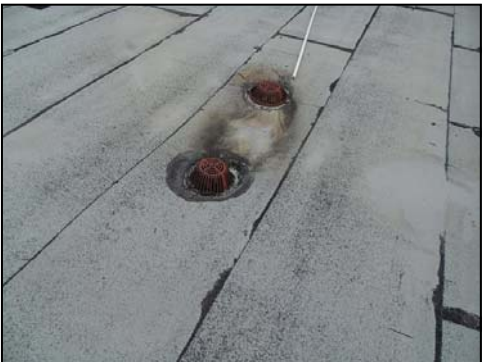
Defect Code:	58	Quantity:	4	Priority:	Monitor
Description: Inadequate, incomplete, nonconforming membrane flashings or flashing details.					
Repair: Complete membrane flashing repairs in accordance with NRCA recommendations and good roofing practices. Follow manufacturer requirements on warranted systems.

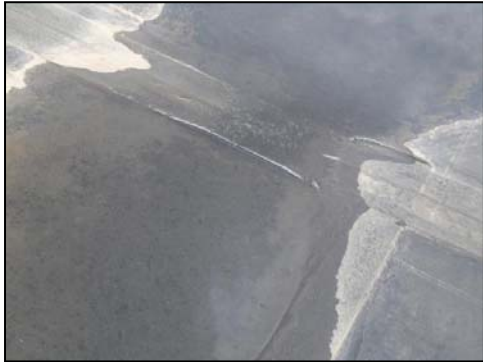
Defect Code:	3	Quantity:	10 LF	Priority:	Monitor
Description: Open lap in field membrane.					
Repair: Clean lap of all dirt and close seam. Overlay edge of affected seam with strip-in of new membrane of like material. Extend a minimum of 4" in all directions past seam edges and repair areas.

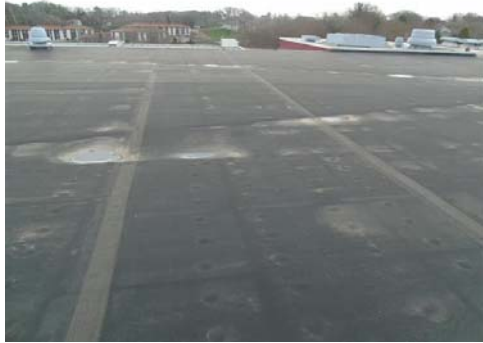
Defect Code:	24	Quantity:	Widespread	Priority:	Monitor
Description: Evidence of past problem and previous repair.					
Repair: Investigate for chronic leak problems and repair any areas that are suspect.

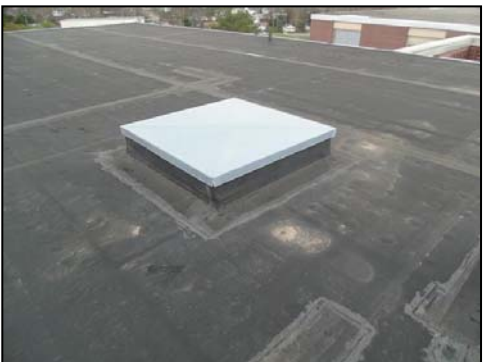
Defect Code:	56	Quantity:	2	Priority:	Monitor
Description: Abandoned and obsolete equipment.					
Repair: Monitor for leaks. Check systems are abandoned and disconnected and will not be used in the future. Remove abandoned equipment and repair deck at scheduled roof replacement.

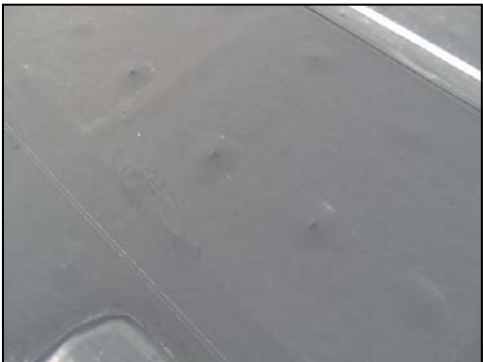
Defect Code:	10	Quantity:	Widespread	Priority:	Monitor
Description: Tented membrane at fastener.					
Repair: Remove fasteners that are loose or not flush with the substrate. Remove underlying substrate materials including insulation and coverboard and replace with matching materials of similar thicknesses to provide for a smooth flush surface.. Install new fasteners and plates per manufacturer's recommendations for system type and apply new membrane repair materials of similar type, gauge, and plies as existing roof system.

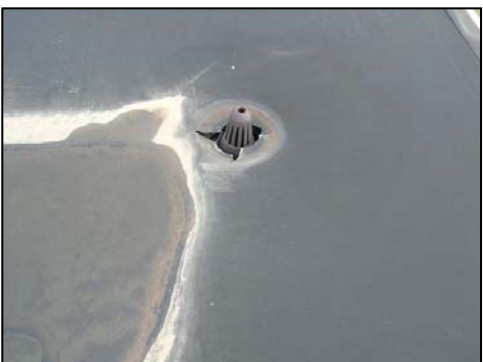
Defect Code:	18	Quantity:	100SF	Priority:	First Year
Description: Unadhered membrane or inadequate membrane attachment.					
Repair: At unadhered areas, cut open membrane and readhere to substrate with manufacturer's approved adhesive. At areas with missing securement, provide securement in the form of screws and plates installed a maximum of 12" O.C. Overlay repaired areas with new membrane of similar gauge, type, and plies and extend repairs a minimum of 4" past cut areas or edges of plates.

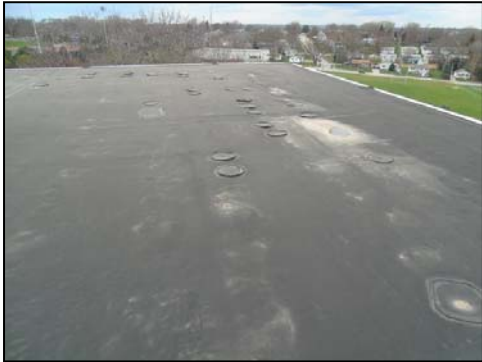
Defect Code:	23	Quantity:	Random	Priority:	Monitor
Description: Physical damage to membrane including cuts, holes, tears, scrapes, scuffs, or abrasions.					
Repair: Apply repair membrane over damaged area, extending repair material a minimum 6" past damage.

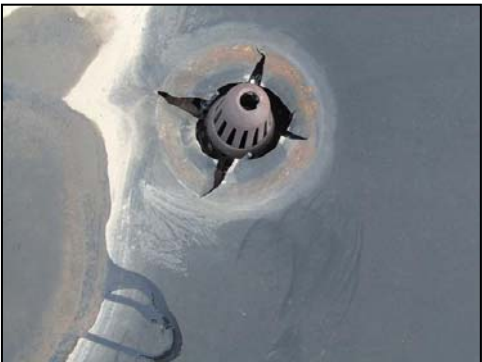
Defect Code:	58	Quantity:	1	Priority:	First Year
Description: Inadequate, incomplete, nonconforming membrane flashings or flashing details.					
Repair: Complete membrane flashing repairs in accordance with NRCA recommendations and good roofing practices. Follow manufacturer requirements on warranted systems.

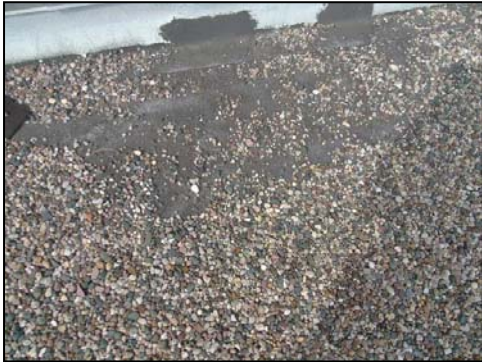
Defect Code:	8	Quantity:	Random	Priority:	Monitor
Description: Surface erosion.					
Repair: Prepare membrane surface by thoroughly cleaning and priming. Apply new surfacing of like materials to eroded areas. On gravel surfaced systems apply gravel in hot asphalt or recommended cold adhesive. Apply granulated fiberglass cap sheet or modified bitumen membrane on like systems. Apply coating system on smooth asphalt surfaces. Transition surfacing to provide for a smooth and neat finished appearance to match the existing surfacing.

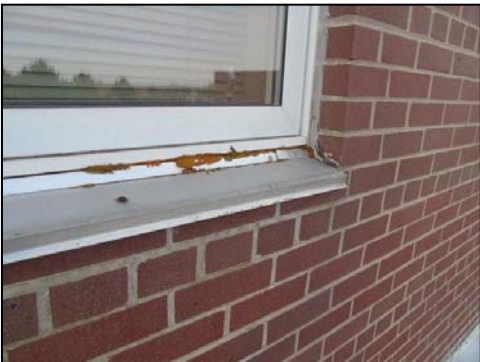
Defect Code:	24	Quantity:	Random	Priority:	Monitor
Description: Evidence of past problem and previous repair.					
Repair: Investigate for chronic leak problems and repair any areas that are suspect.

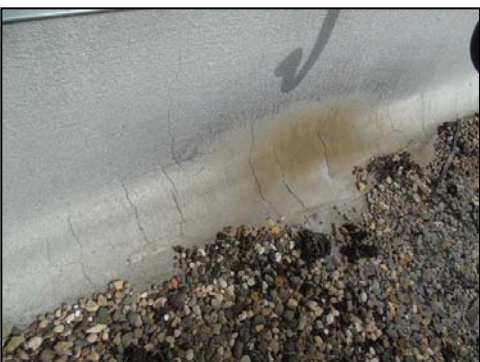
Defect Code:	43	Quantity:	Widespread	Priority:	Monitor
Description: Weathered and deteriorated flashing					
Repair: Clean and prepare surfaces by removing loose granules, dirt, and other debris. Apply two coats of elastomeric coating compatible with the flashing materials.

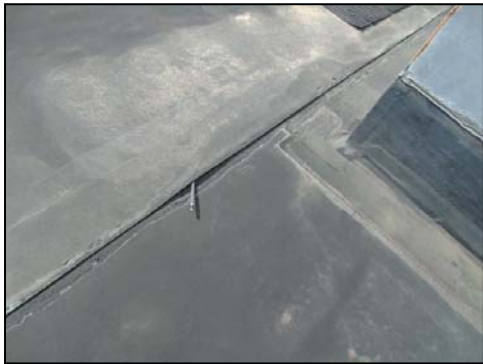
Defect Code:	3	Quantity:	Random	Priority:	First Year
Description: Open lap in field membrane.					
Repair: Clean lap of all dirt and close seam. Overlay edge of affected seam with strip-in of new membrane of like material. Extend a minimum of 4" in all directions past seam edges and repair areas.

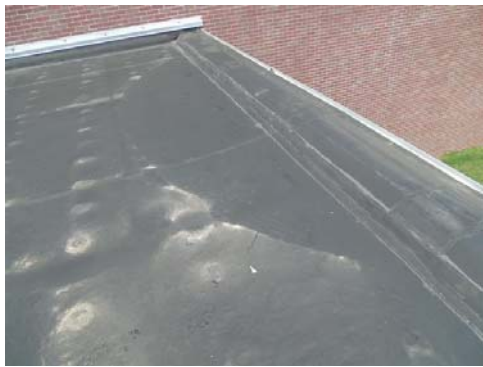
Defect Code:	18	Quantity:	50 SF	Priority:	Monitor
Description: Unadhered membrane or inadequate membrane attachment.					
Repair: At unadhered areas, cut open membrane and readhere to substrate with manufacturer's approved adhesive. At areas with missing securement, provide securement in the form of screws and plates installed a maximum of 12" O.C. Overlay repaired areas with new membrane of similar gauge, type, and plies and extend repairs a minimum of 4" past cut areas or edges of plates.

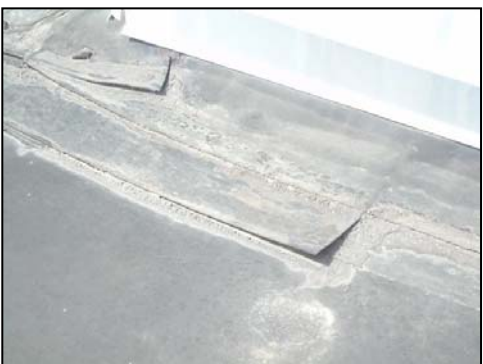
Defect Code:	45	Quantity:	Widespread	Priority:	First Year
Description: Open flashing lap					
Repair: Open loose lap area and clean thoroughly. Prime and reseam or reweld lap per the manufacturer's requirements. Strip-in defective lap with mimum 6" wide membrane on single ply systems or 6" wide fabric and mastic three-course application on asphalt systems. Regranulate or coat flashing repairs.

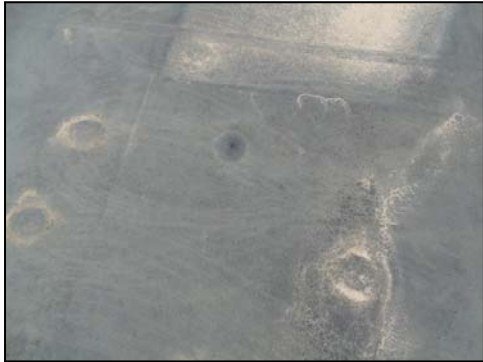
Defect Code:	10	Quantity:	3	Priority:	Monitor
Description: Tented membrane at fastener.					
Repair: Remove fasteners that are loose or not flush with the substrate. Remove underlying substrate materials including insulation and coverboard and replace with matching materials of similar thicknesses to provide for a smooth flush surface.. Install new fasteners and plates per manufacturer's recommendations for system type and apply new membrane repair materials of similar type, gauge, and plies as existing roof system.

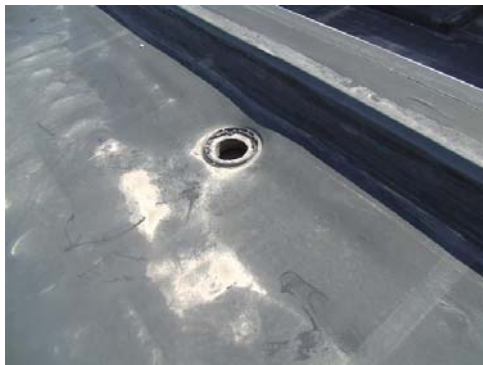
Defect Code:	17	Quantity:	1	Priority:	First Year
Description: Missing or damaged drain/scupper strainer					
Repair: Replace damaged or missing strainer with a new cast iron strainer sized to fit the drain assembly or scupper opening. Lock in place to prevent loss.

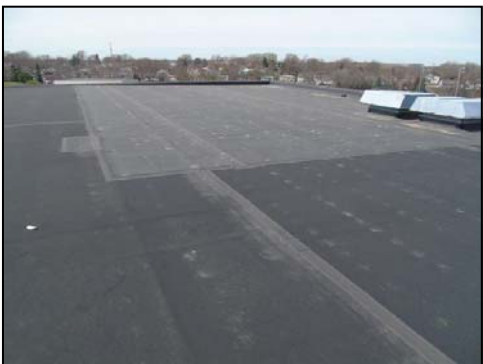
Defect Code:	24	Quantity:	Widespread	Priority:	Monitor
Description: Evidence of past problem and previous repair.					
Repair: Investigate for chronic leak problems and repair any areas that are suspect.

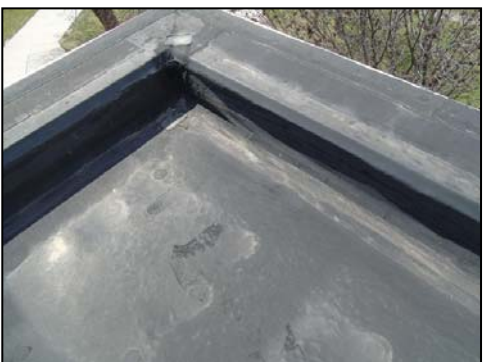
Defect Code:	41	Quantity:	Under 10 LF	Priority:	Monitor
Description: Missing or inadequate flashing attachment.					
Repair: Mechanically attach flashings a maximum of 6" O.C using screws and plates or 1" cap nails. Terminate with metal flashings or compression bar.

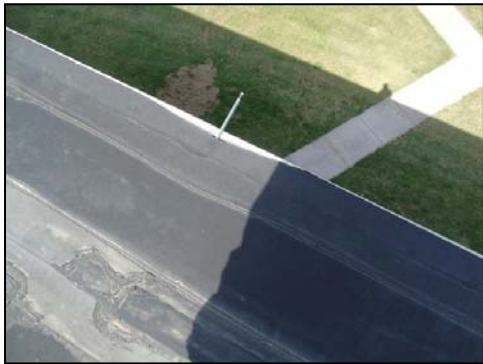
Defect Code:	45	Quantity:	Random	Priority:	First Year
Description: Open flashing lap					
Repair: Open loose lap area and clean thoroughly. Prime and reseam or reweld lap per the manufacturer's requirements. Strip-in defective lap with mimum 6" wide membrane on single ply systems or 6" wide fabric and mastic three-course application on asphalt systems. Regranulate or coat flashing repairs.

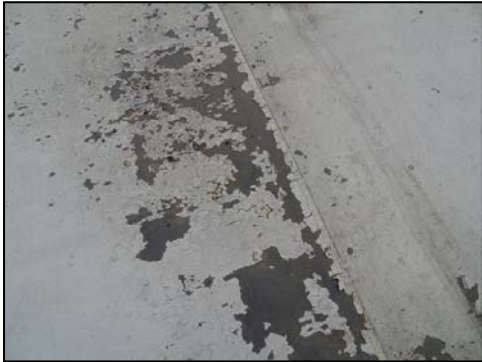
Defect Code:	8	Quantity:	Random	Priority:	Monitor
Description: Surface erosion.					
Repair: Prepare membrane surface by thoroughly cleaning and priming. Apply new surfacing of like materials to eroded areas. On gravel surfaced systems apply gravel in hot asphalt or recommended cold adhesive. Apply granulated fiberglass cap sheet or modified bitumen membrane on like systems. Apply coating system on smooth asphalt surfaces. Transition surfacing to provide for a smooth and neat finished appearance to match the existing surfacing.

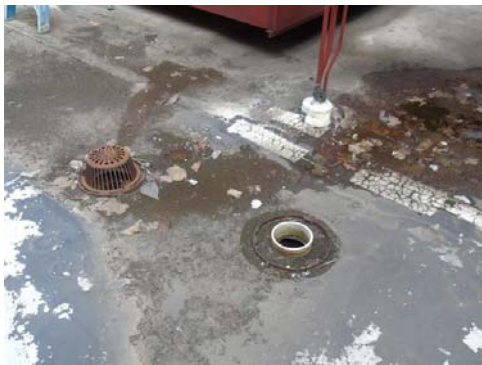
Defect Code:	17	Quantity:	1	Priority:	First Year
Description: Missing or damaged drain/scupper strainer					
Repair: Replace damaged or missing strainer with a new cast iron strainer sized to fit the drain assembly or scupper opening. Lock in place to prevent loss.

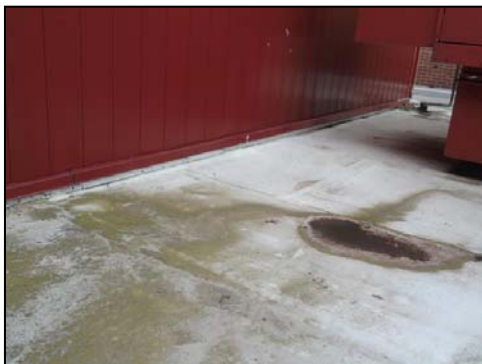
Defect Code:	40	Quantity:	Widespread	Priority:	Monitor
Description: Low flashing height.					
Repair: Raise flashing height to a minimum of 8" above finished roof surface. Provide appropriate termination of flashings with metal copings or counterflashings. Provide a compression bar termination of flashings to concrete or block surface if flashings cannot be maintained at 8" minimum height.

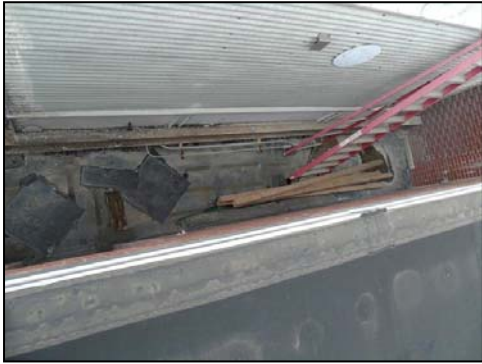
Defect Code:	22	Quantity:	Random	Priority:	Monitor
Description: Debris, trash, construction materials, HVAC equipment, filters, motors, etc. on roof surface.					
Repair: Remove all trash and debris from roof. Clean and inspect surfaces and repair any damages to the membrane or flashings.

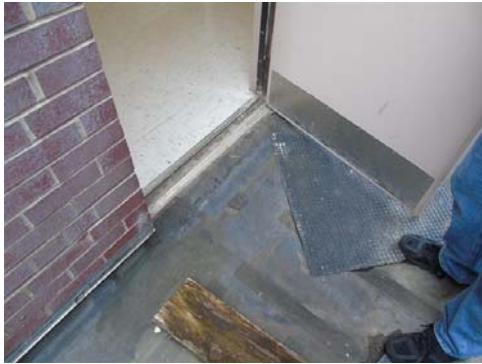
Defect Code:	40	Quantity:	Under 10 LF	Priority:	Monitor
Description: Low flashing height.					
Repair: Raise flashing height to a minimum of 8" above finished roof surface. Provide appropriate termination of flashings with metal copings or counterflashings. Provide a compression bar termination of flashings to concrete or block surface if flashings cannot be maintained at 8" minimum height.

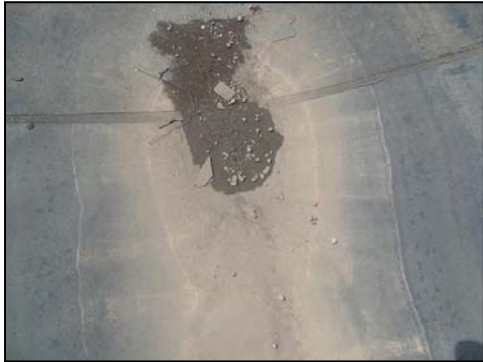
Defect Code:	16	Quantity:	2	Priority:	Urgent
Description: Blocked drain, scupper, or downspout.					
Repair: Remove all debris from drainage system and ensure drain or scupper is free flowing without restrictions at strainer or piping.

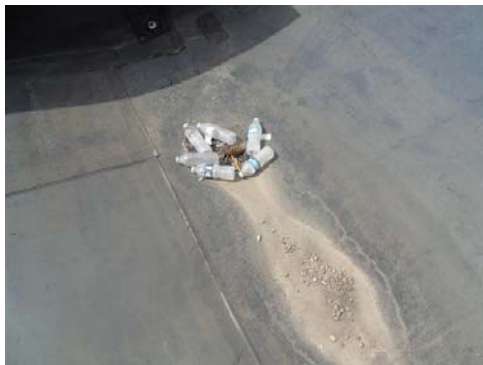
Defect Code:	22	Quantity:	Random	Priority:	First Year
Description: Debris, trash, construction materials, HVAC equipment, filters, motors, etc. on roof surface.					
Repair: Remove all trash and debris from roof. Clean and inspect surfaces and repair any damages to the membrane or flashings.

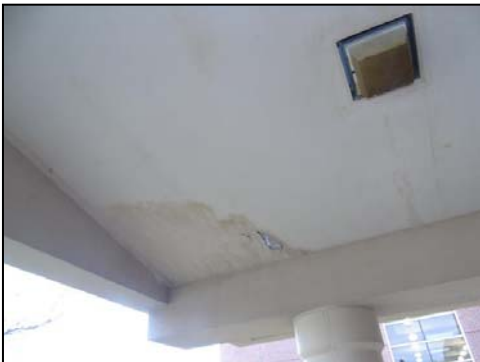
Defect Code:	28	Quantity:	Random	Priority:	Monitor
Description: Reported leak location					
Repair: Investigate leak and determine source. Repair areas with like materials of appropriate gauge and plies.
