Roof Inspection Report

East High School
1401 High School Drive
Bellevue, NE 68005

Date of Last Inspection: Apr 03, 2017

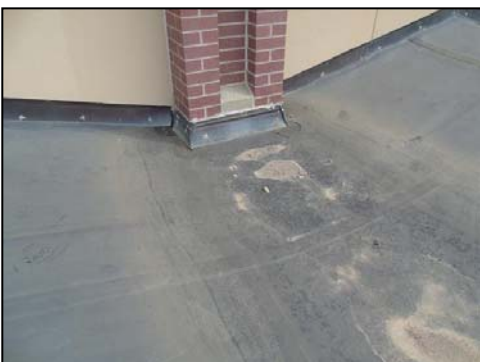
Defect Code:	40	Quantity:	4	Priority:	Monitor
Description: Low flashing height.					
Repair: Raise flashing height to a minimum of 8" above finished roof surface. Provide appropriate termination of flashings with metal copings or counterflashings. Provide a compression bar termination of flashings to concrete or block surface if flashings cannot be maintained at 8" minimum height.

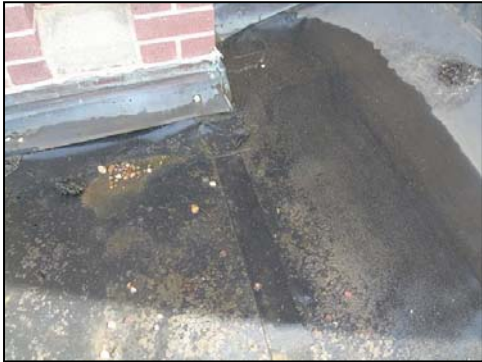
Defect Code:	45	Quantity:	Random	Priority:	First Year
Description: Open flashing lap					
Repair: Open loose lap area and clean thoroughly. Prime and reseam or reweld lap per the manufacturer's requirements. Strip-in defective lap with mimum 6" wide membrane on single ply systems or 6" wide fabric and mastic three-course application on asphalt systems. Regranulate or coat flashing repairs.

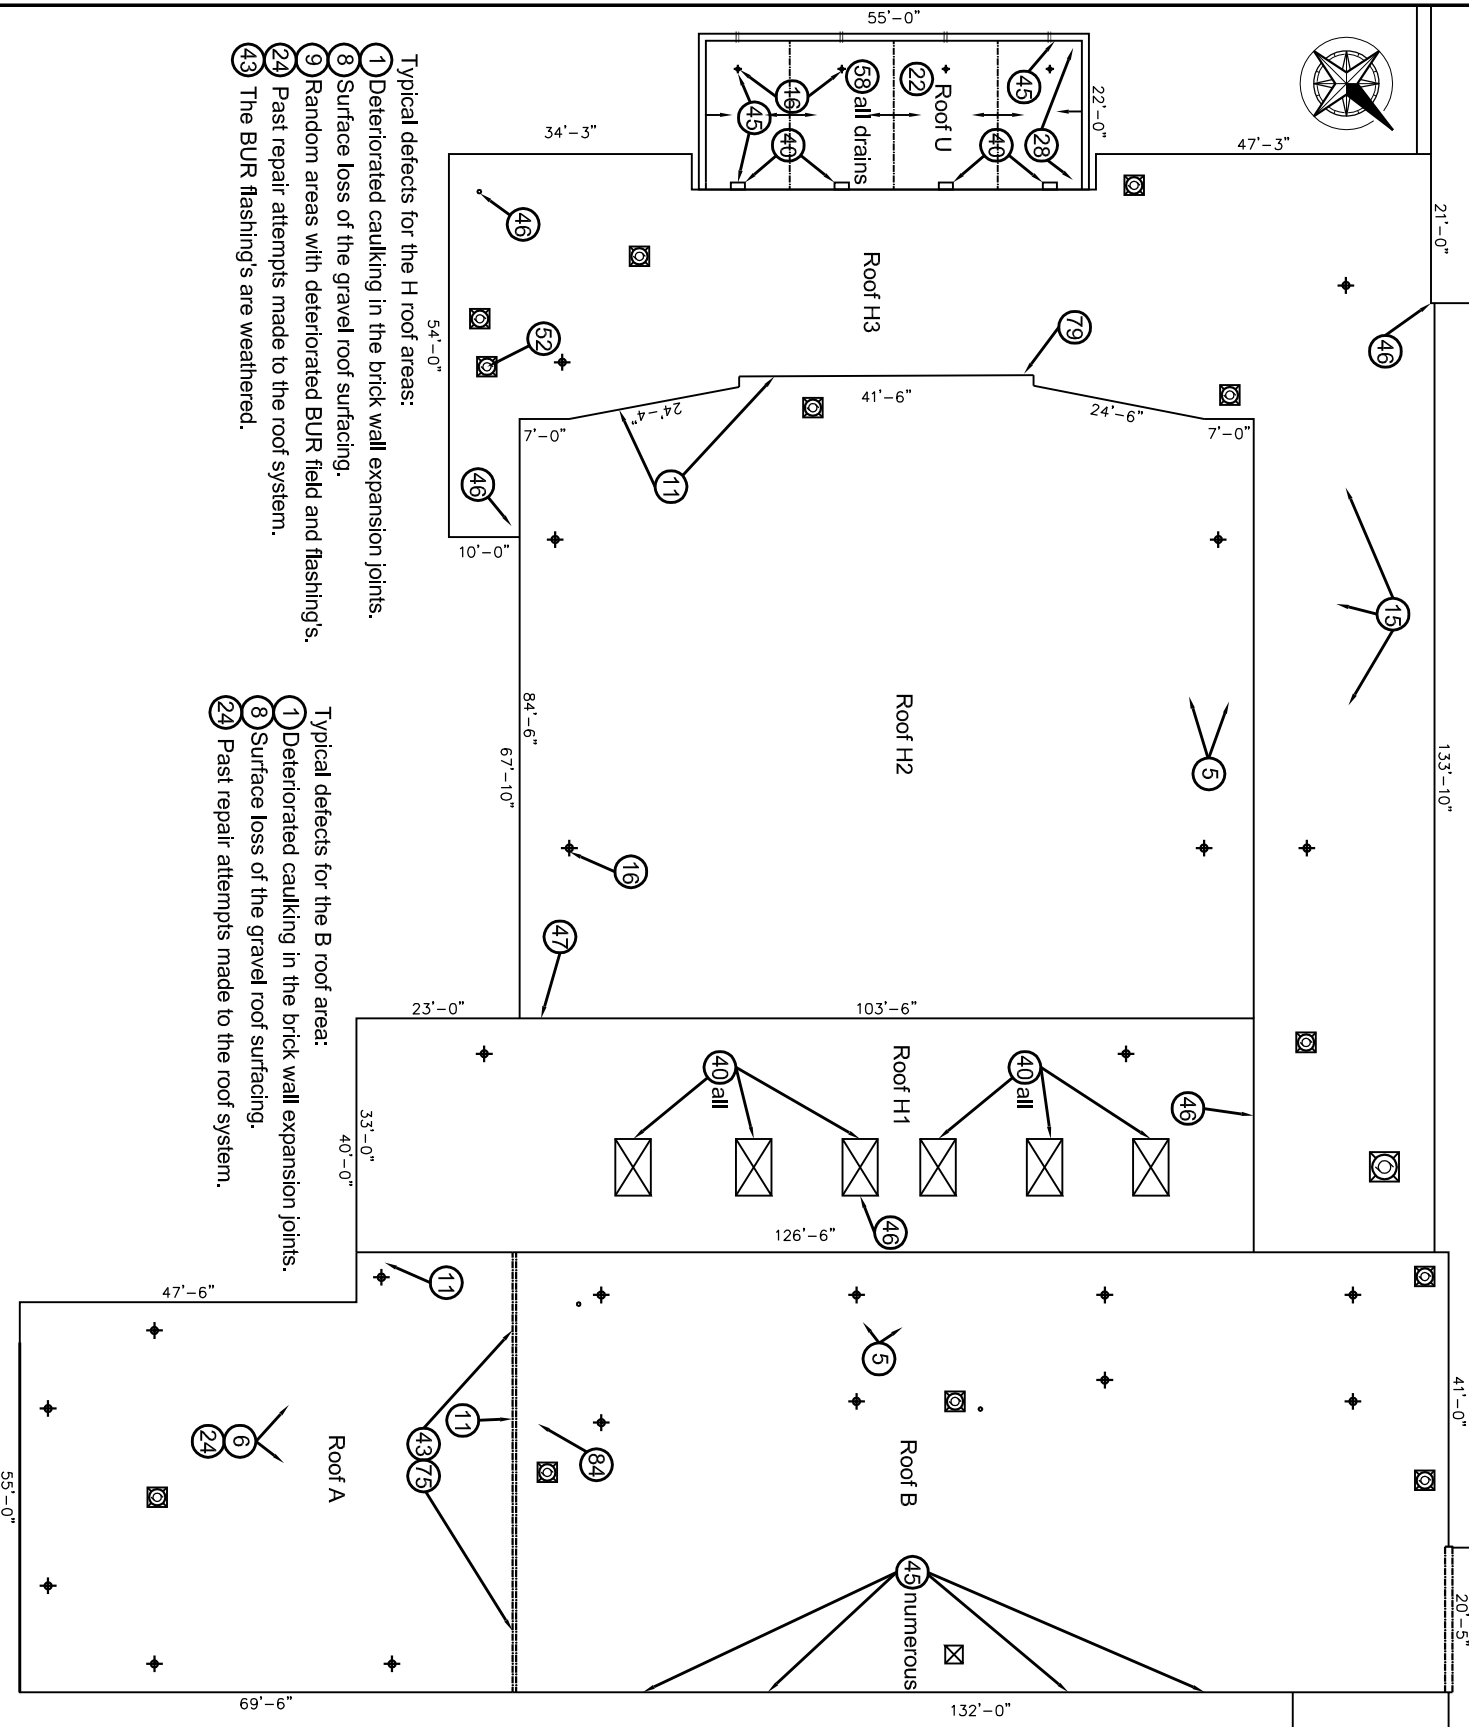
Typical defects for the H roof areas:

- 1 Deteriorated caulking in the brick wall expansion joints.
- 8 Surface loss of the gravel roof surfacing.
- 9 Random areas with deteriorated BUR field and flashings.
- 24 Past repair attempts made to the roof system.
- 43 The BUR flashings are weathered.

Typical defects for the B roof area:

- 1 Deteriorated caulking in the brick wall expansion joints.
- 8 Surface loss of the gravel roof surfacing.
- 24 Past repair attempts made to the roof system.

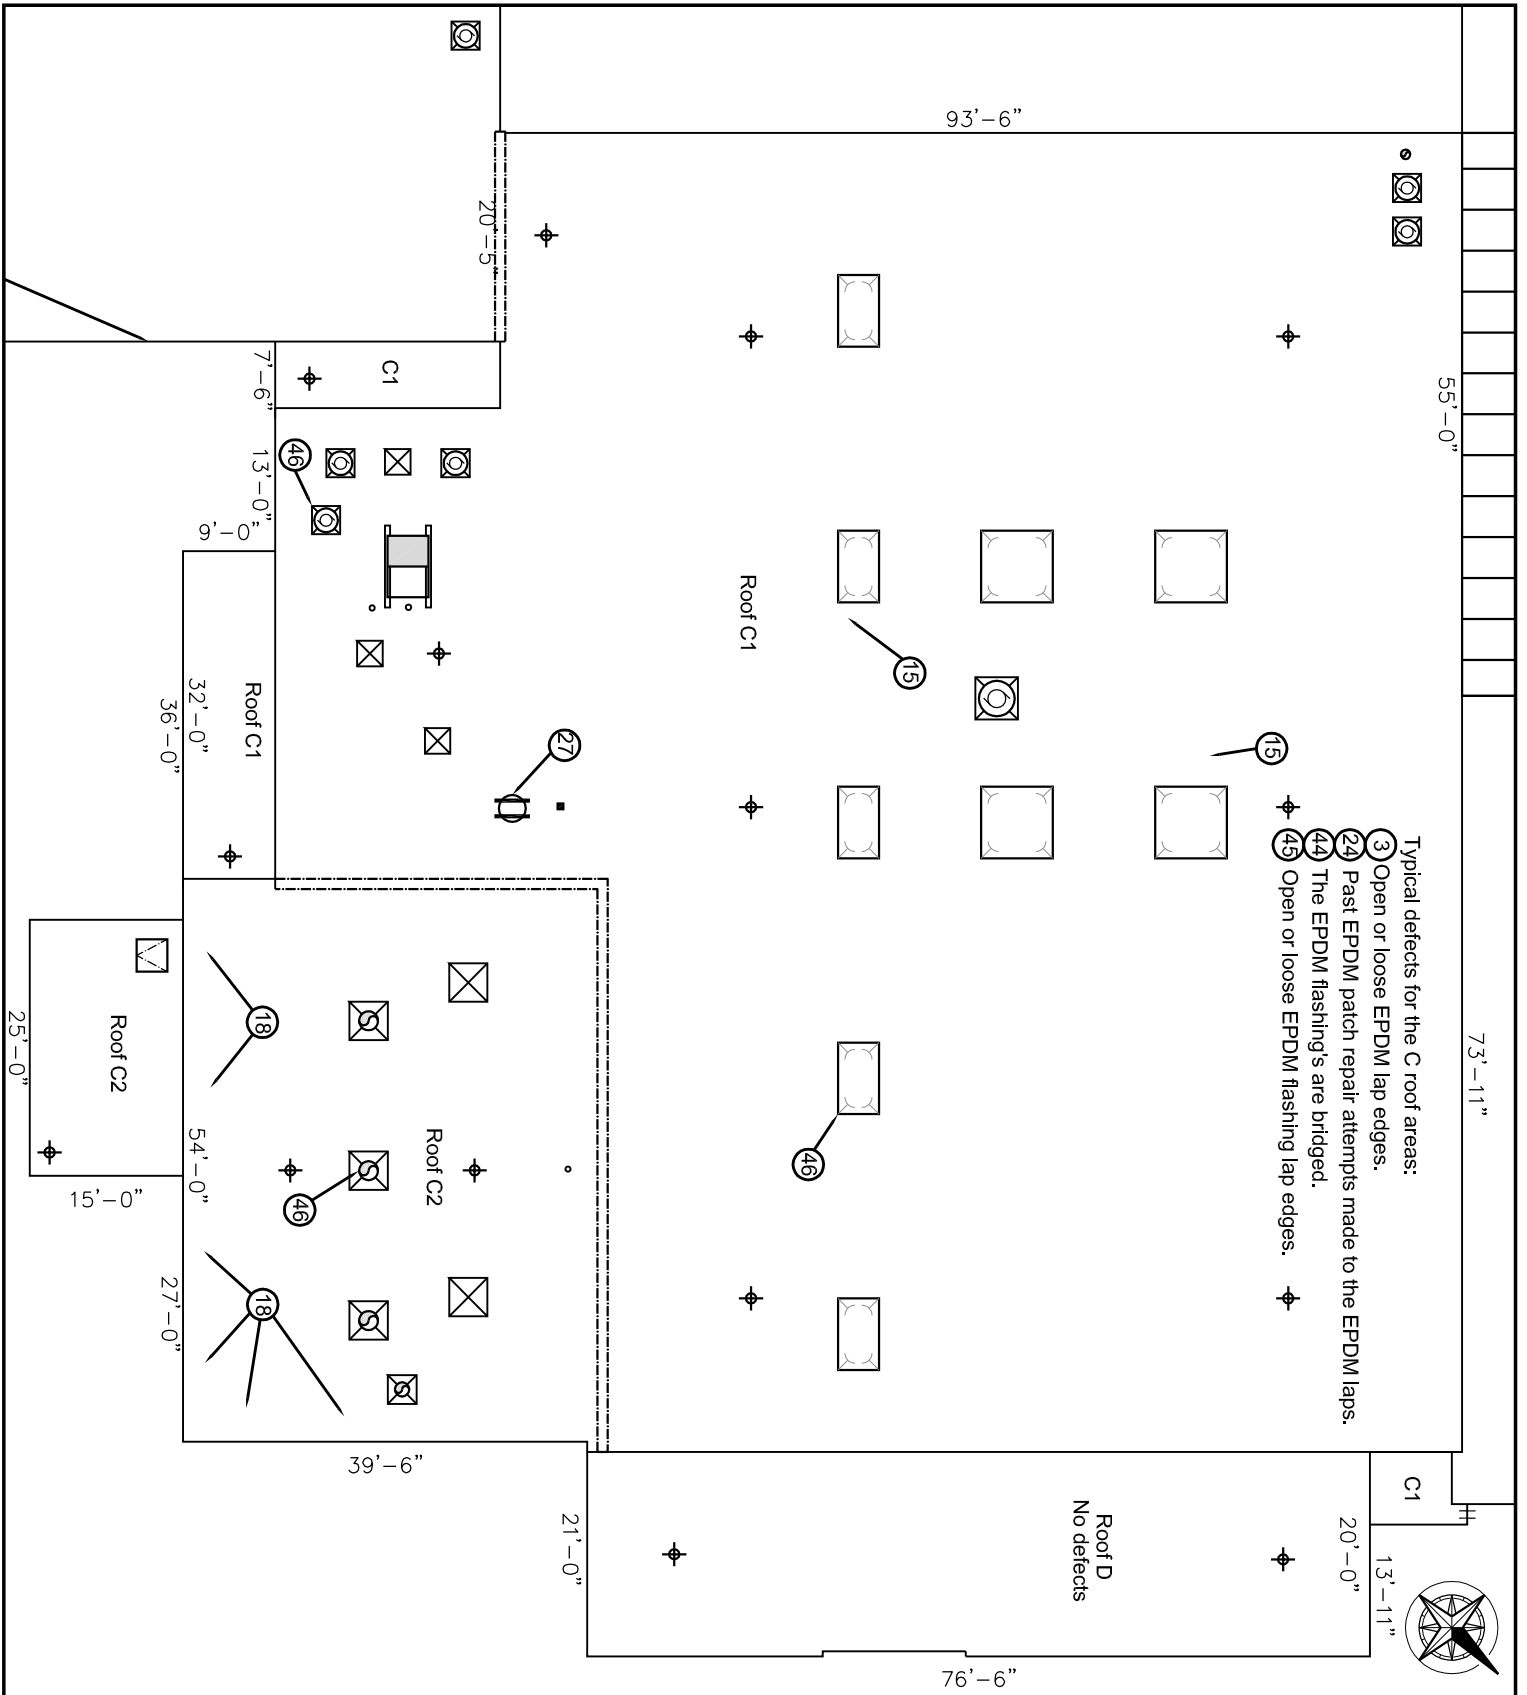
- Typical defects for the C roof areas:
- ③ Open or loose EPDM lap edges.
 - ② Past EPDM patch repair attempts made to the EPDM laps.
 - ④ The EPDM flashings are bridged.
 - ④ Open or loose EPDM flashing lap edges.

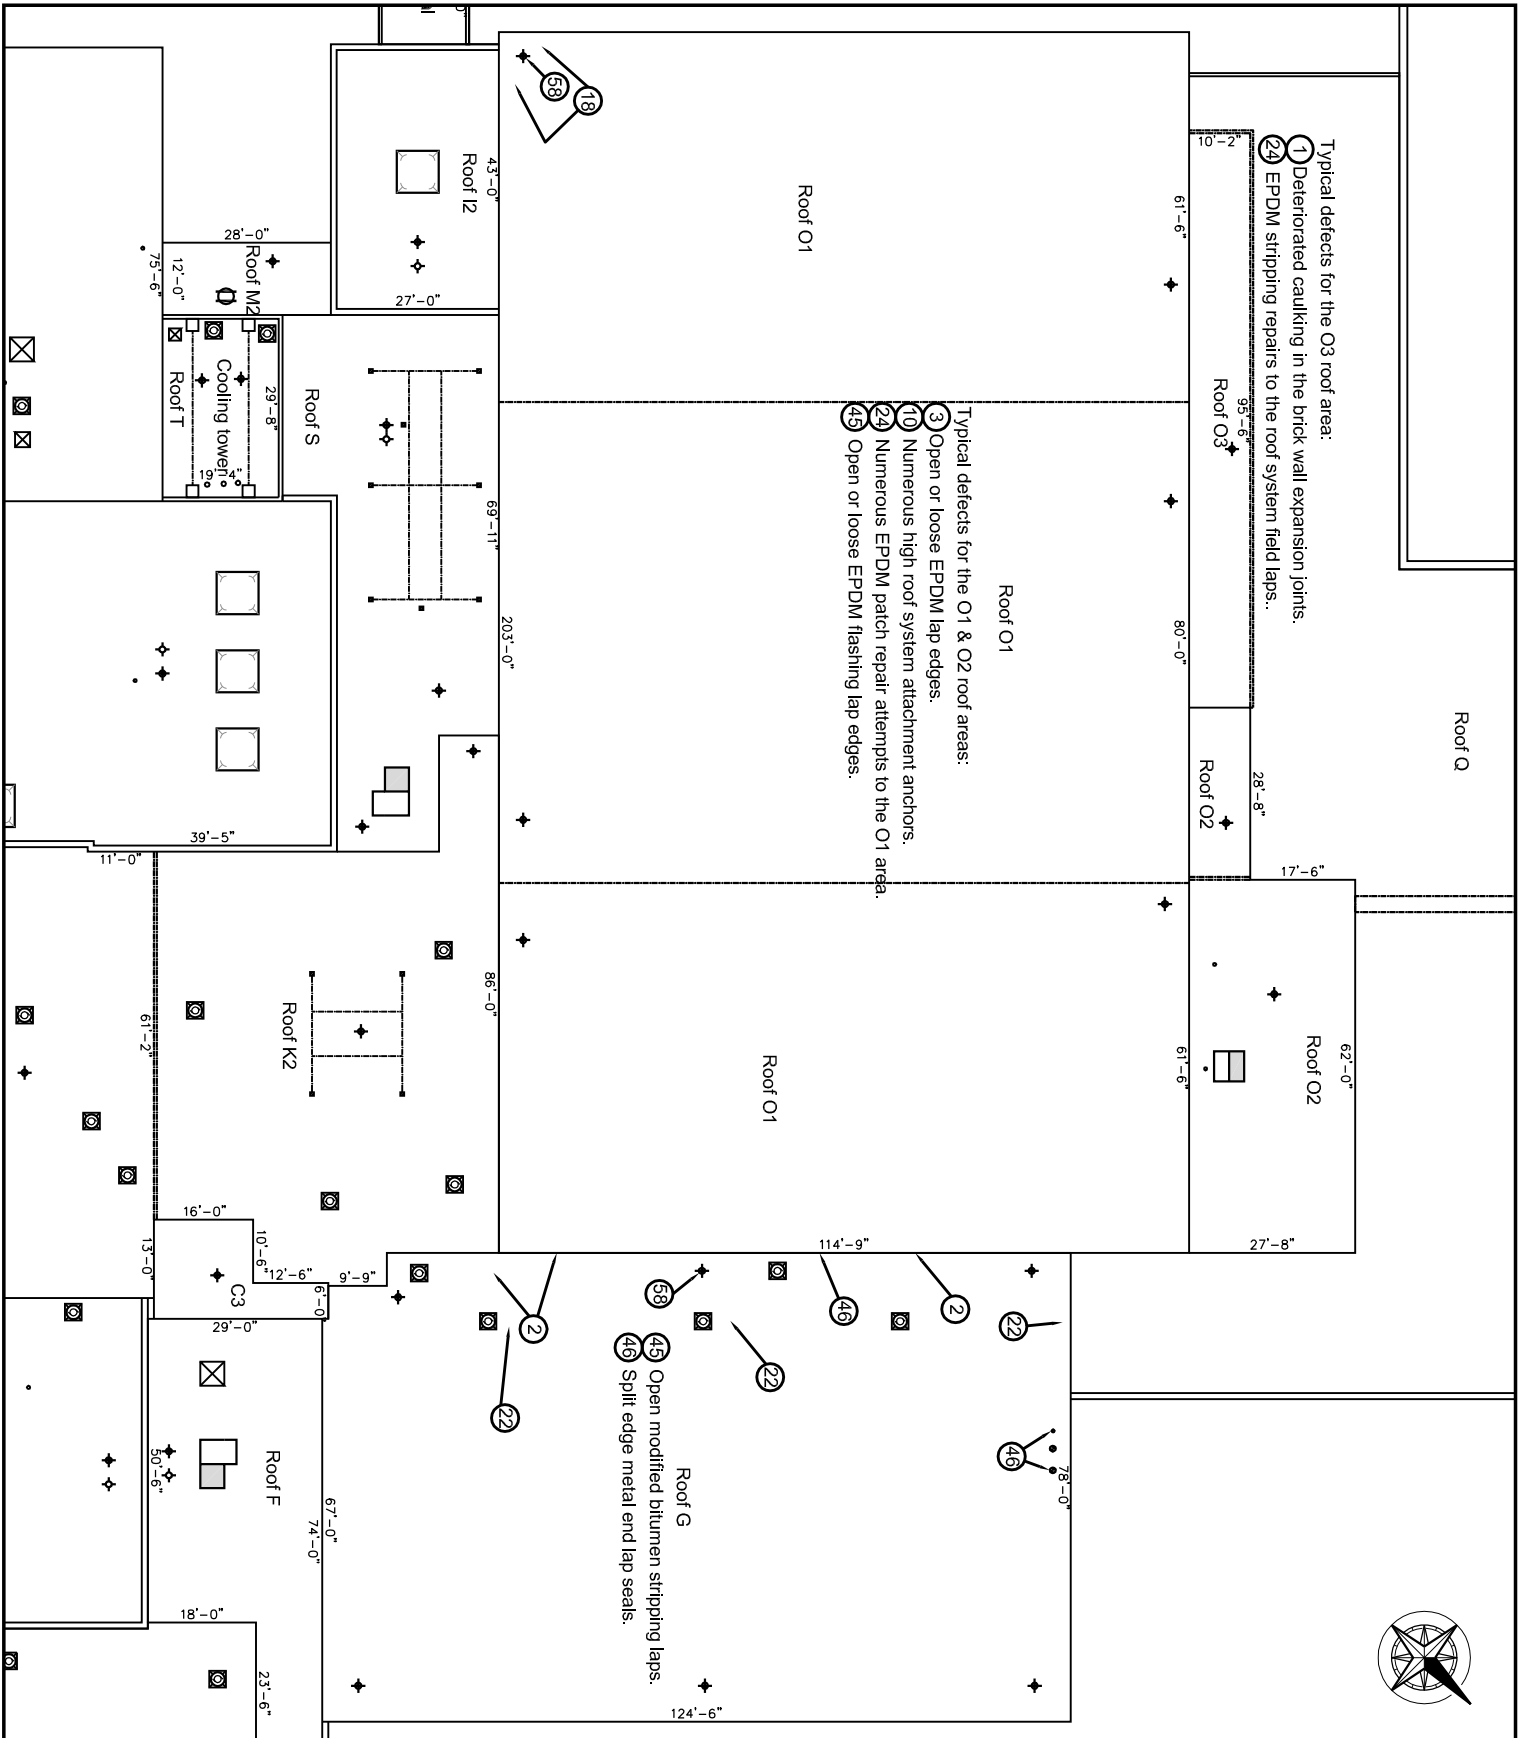
Sheet Title:
E,F,C3,K1&L-Roof Plan

Typical defects for the O3 roof area:
 ① Deteriorated caulking in the brick wall expansion joints.
 ② EPDM stripping repairs to the roof system field laps.

Typical defects for the O1 & O2 roof areas:
 ③ Open or loose EPDM lap edges.
 ⑩ Numerous high roof system attachment anchors.
 ②④ Numerous EPDM patch repair attempts to the O1 area.
 ④⑨ Open or loose EPDM flashing lap edges.

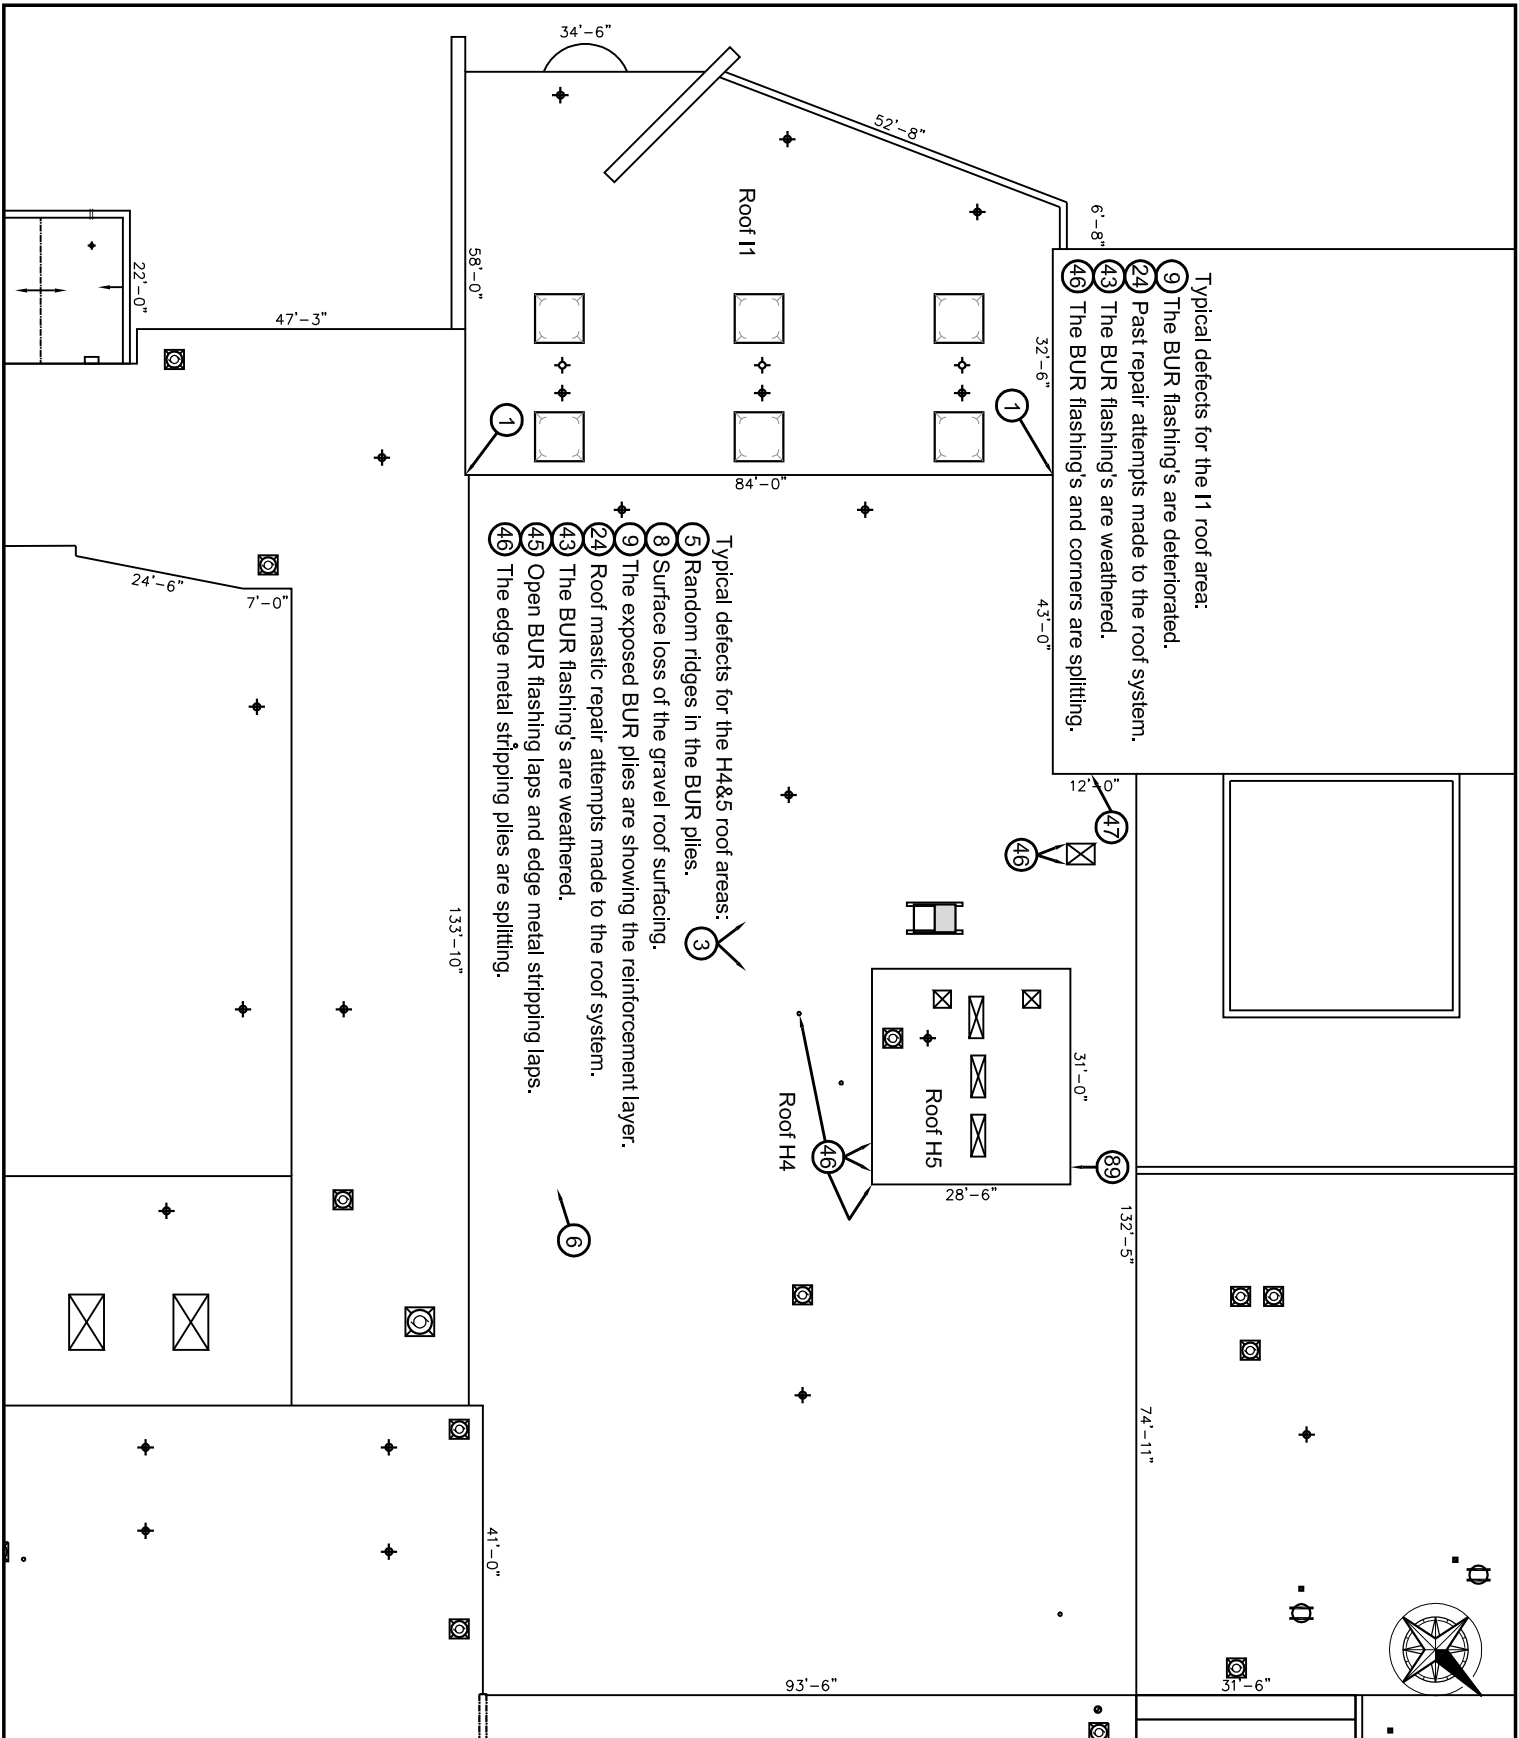
Sheet Title:
G&O-Roof Plan

Typical defects for the I1 roof area:

- ⑨ The BUR flashings are deteriorated.
- ②④ Past repair attempts made to the roof system.
- ④③ The BUR flashings are weathered.
- ④⑥ The BUR flashings and corners are splitting.

Typical defects for the H4&5 roof areas:

- ⑤ Random ridges in the BUR plies.
- ⑧ Surface loss of the gravel roof surfacing.
- ⑨ The exposed BUR plies are showing the reinforcement layer.
- ②④ Roof mastic repair attempts made to the roof system.
- ④③ The BUR flashings are weathered.
- ④⑤ Open BUR flashing laps and edge metal stripping plies.
- ④⑥ The edge metal stripping plies are splitting.
