Roof Inspection Report

Logan Fontenelle Middle School
701 Kayleen Drive
Bellevue, NE 68005

Date of Last Inspection: Mar 21, 2017

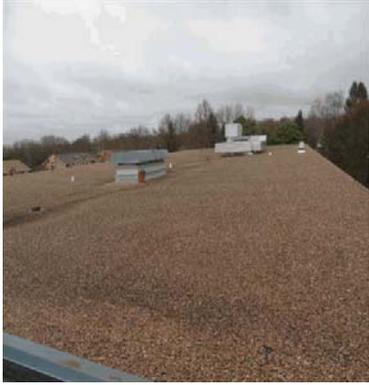
Roof A A 1995	12,097 sq. ft. 28 ft.	Built-Up Asphalt Roofing	Poor 40 1(Yrs)	\$145,164.00

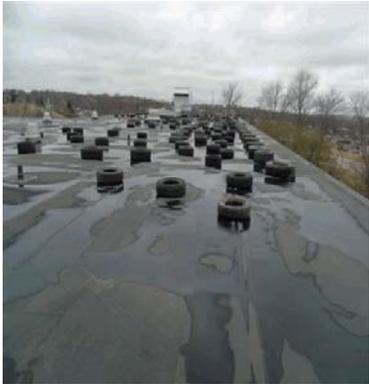
Roof B B 1987	14,581 sq. ft. 28 ft.	(EPDM) Ethylene-Propyl ene-Diene-Mon omer Roofing	Urgent 20 0(Yrs)	\$160,391.00

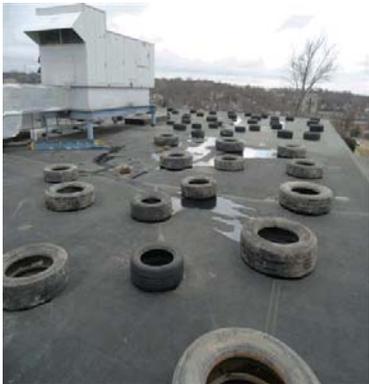
Roof C C 1997	6,084 sq. ft. 28 ft.	(EPDM) Ethylene-Propyl ene-Diene-Mon omer Roofing	Urgent 20 0(Yrs)	\$91,260.00

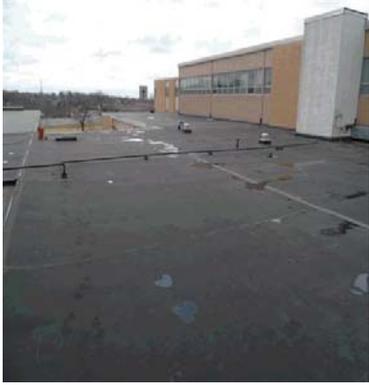
Roof D D 1987	25,449 sq. ft. 12 ft.	(EPDM) Ethylene-Propyl ene-Diene-Mon omer Roofing	Poor 33 0(Yrs)	\$381,735.00

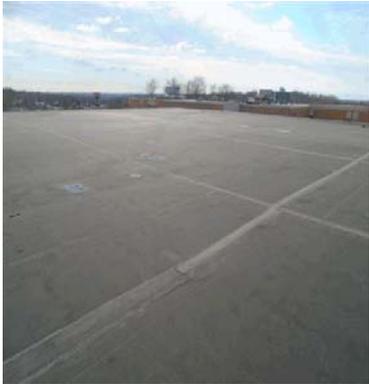
Roof E E 1997	11,350 sq. ft. 28 ft.	(EPDM) Ethylene-Propyl ene-Diene-Mon omer Roofing	Poor 33 1(Yrs)	\$170,250.00

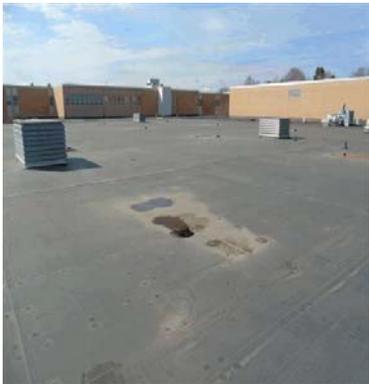
Roof F F 2012	16,558 sq. ft. 12 ft.	(EPDM) Ethylene-Propyl ene-Diene-Mon omer Roofing	Good 75 15(Yrs)	\$198,696.00

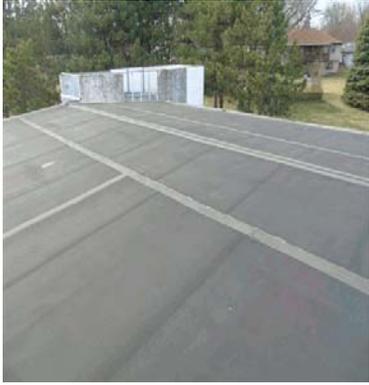
Roof G G 1987	1,015 sq. ft. 12 ft.	(EPDM) Ethylene-Propyl ene-Diene-Mon omer Roofing	Poor 33 0(Yrs)	\$15,225.00
87,134					\$1,162,721.00
*RCI Rating 0 -100 where 100 is excellent

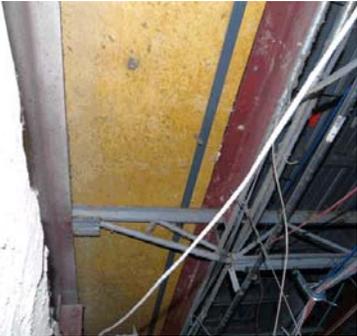
Mar 21, 2017	Deck Underside

One (1) core cut revealed a poured in place gypsum decking. The insulation consists of one (1) layer of 1.5" and one (1) layer of 1" extruded polystyrene insulation board with one (1) layer of 1/2" wood fiber cover board. The membrane is a fully-adhered, .060 mil Firestone EPDM. Note that the wood fiber cover board was deteriorated at the core cut location. Most of the EPDM membrane is no longer adhered on this roof section.

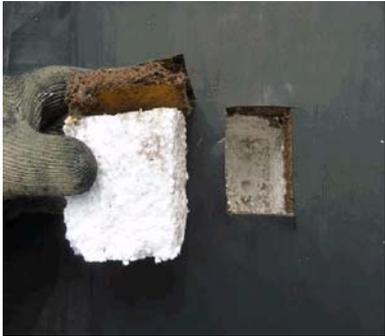
Mar 21, 2017	Core cut #1

Core cuts were performed on the D-1, D-3 & D-4 roof areas to verify the roofing layers in place. All three (3) core samples revealed the same type of roofing layers in place. The deck is poured in place gypsum. The insulation is an air expanded polystyrene insulation board, which appears to be part of a tapered insulation system, with one (1) layer of 1/2" wood fiber cover board. The membrane is a fully-adhered, .060 mil Firestone EPDM. The wood fiber cover board was deteriorated at all three (3) core cut locations. An under view of the D-2 roof area revealed a fiberglass form board with what appears to be toggle bolt attachment of the roof system.

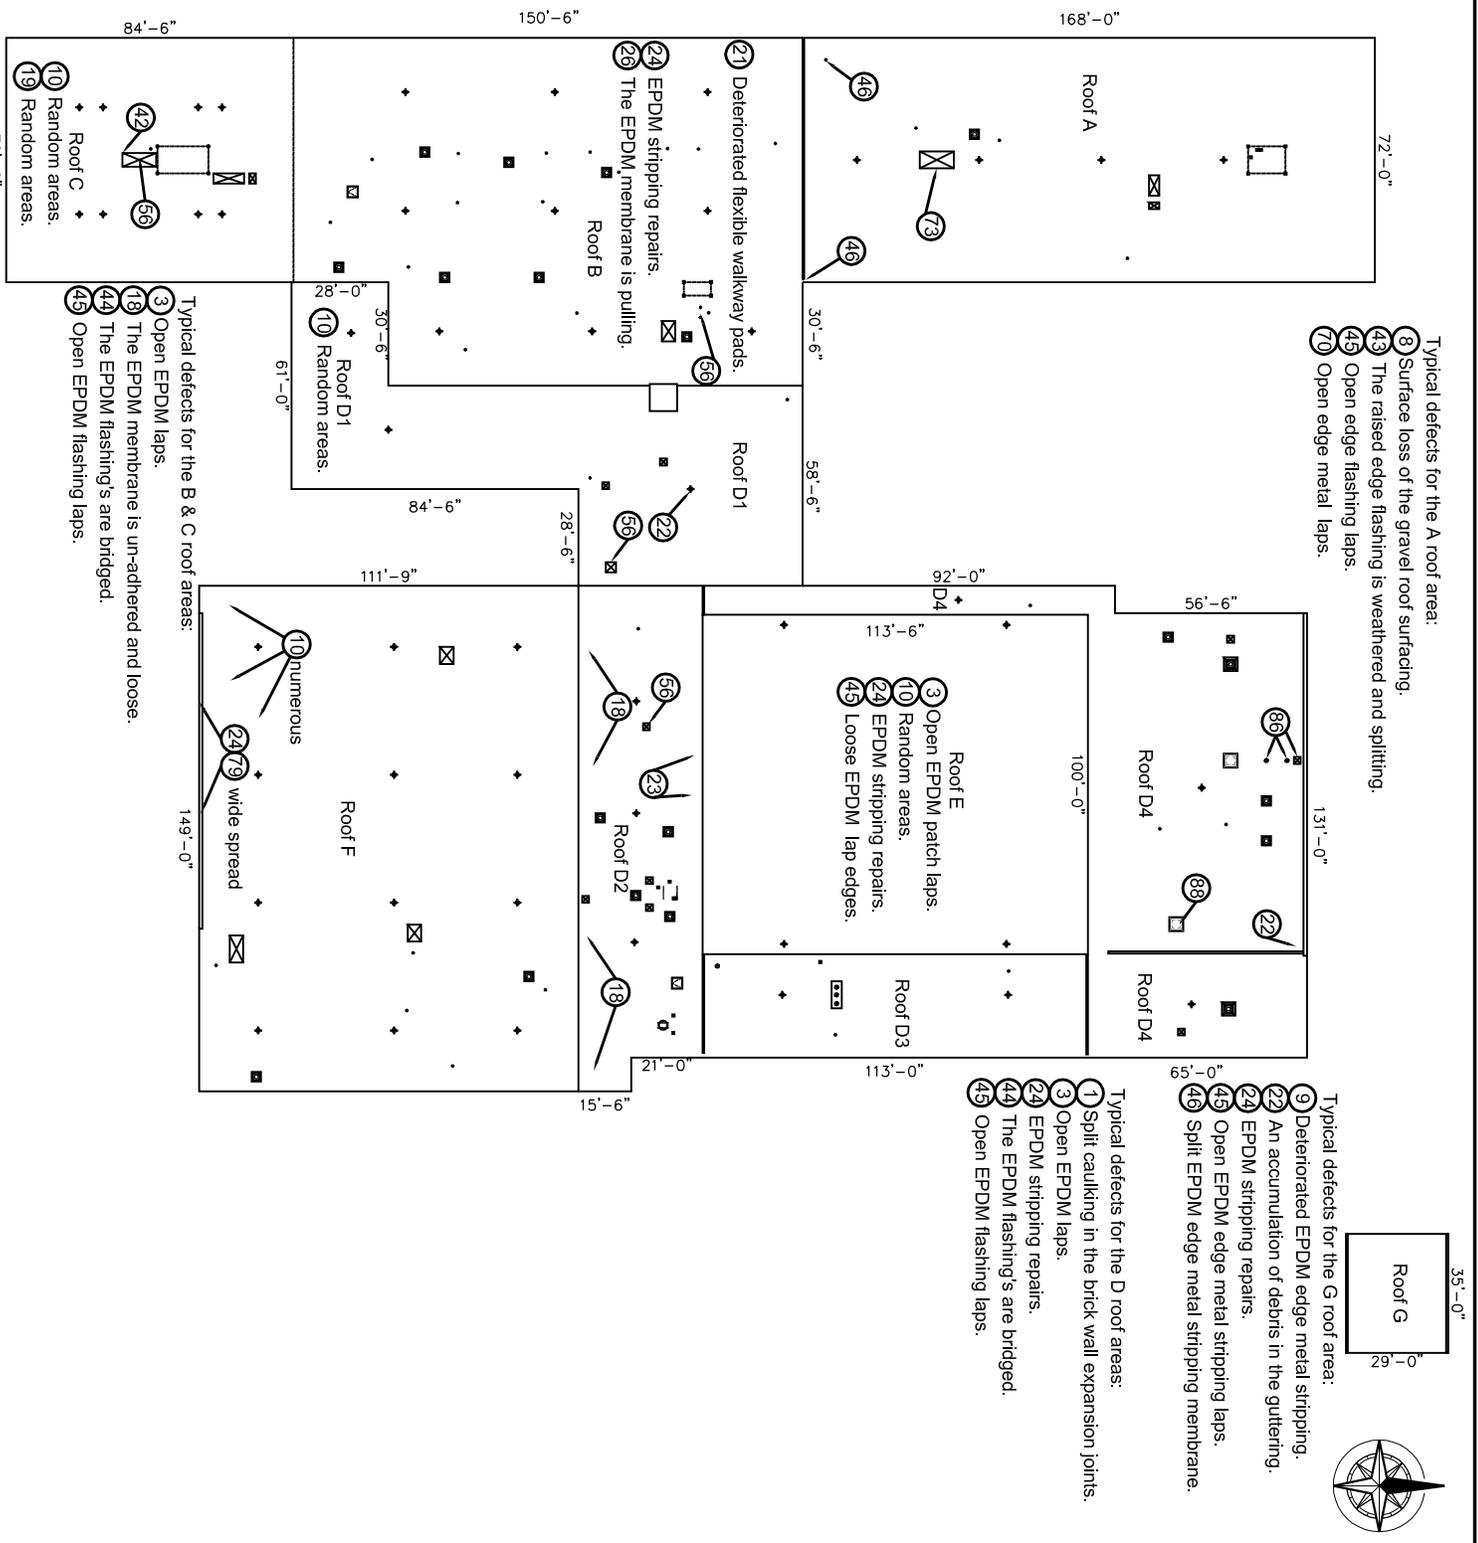
- Typical defects for the D roof areas:
- 1 Split caulking in the brick wall expansion joints.
 - 3 Open EPDM laps.
 - 24 EPDM stripping repairs.
 - 44 The EPDM flashing's are bridged.
 - 45 Open EPDM flashing laps.

- Typical defects for the B & C roof areas:
- 3 Open EPDM laps.
 - 18 The EPDM membrane is un-adhered and loose.
 - 44 The EPDM flashing's are bridged.
 - 49 Open EPDM flashing laps.

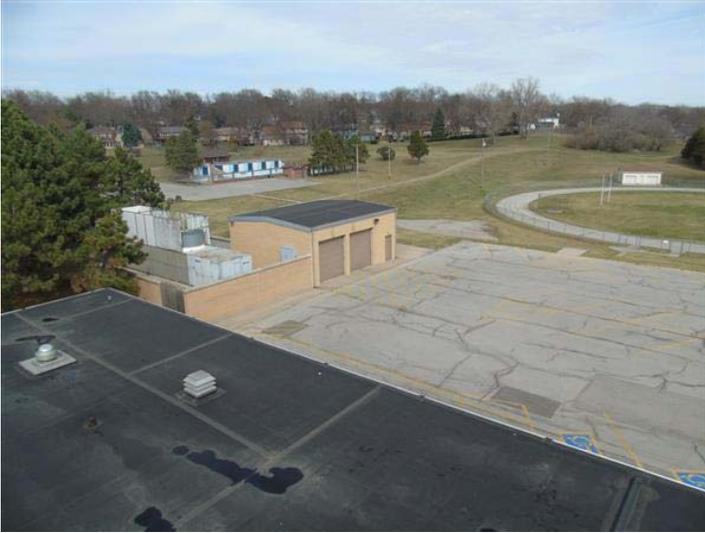
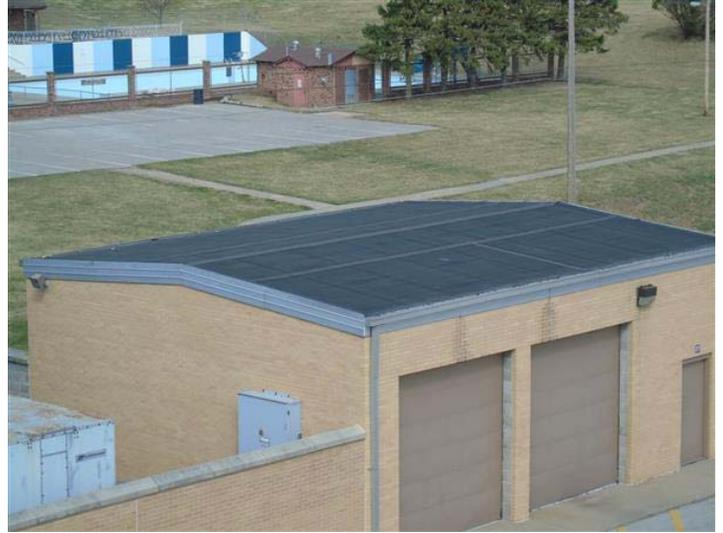
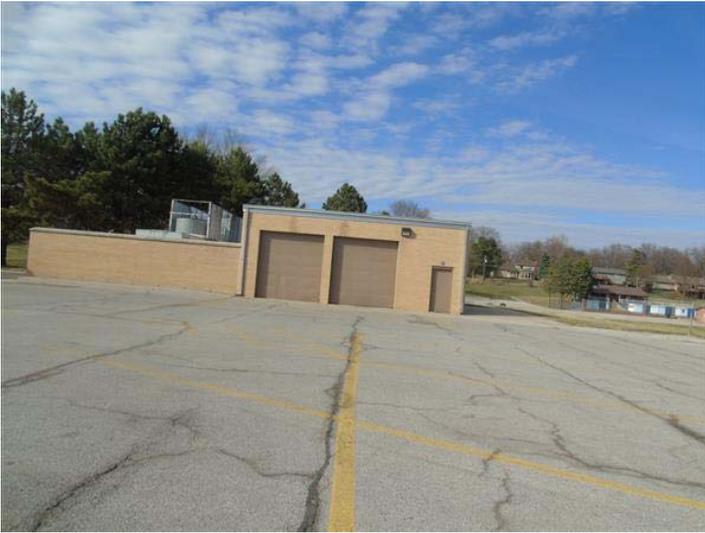
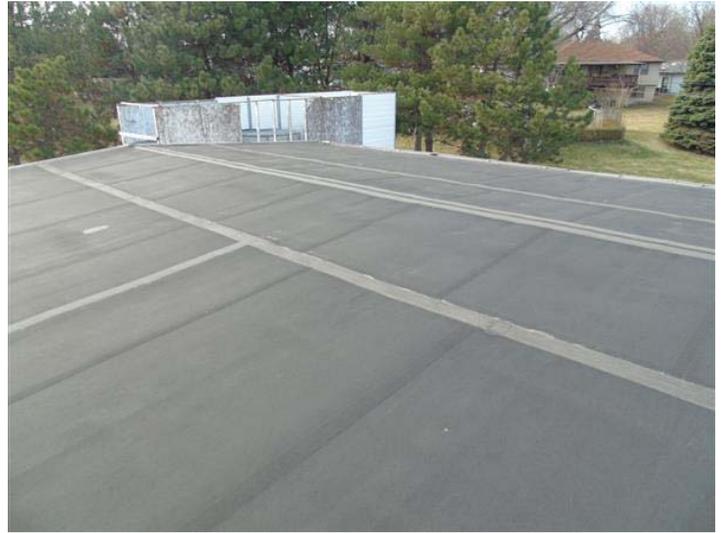
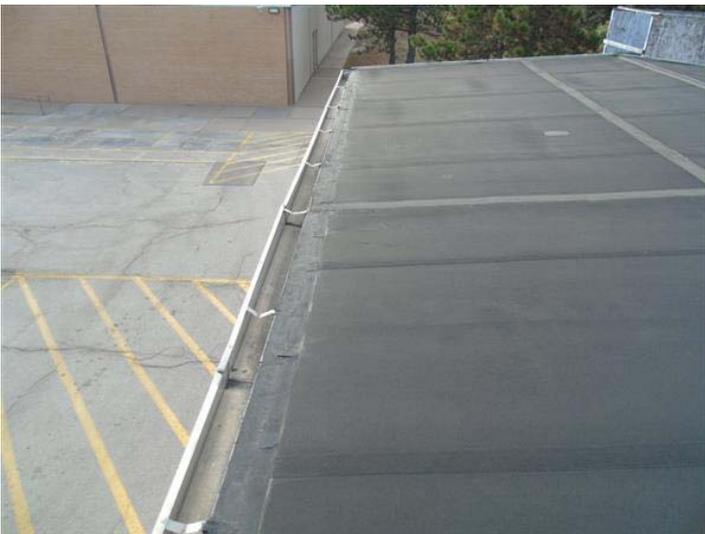
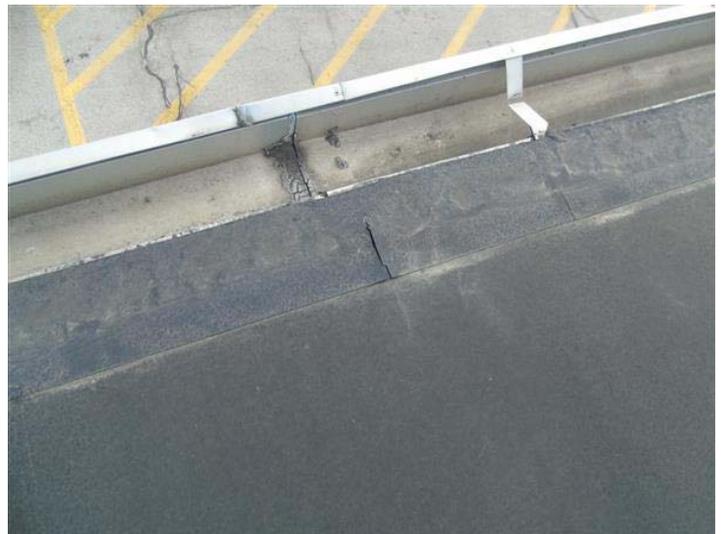
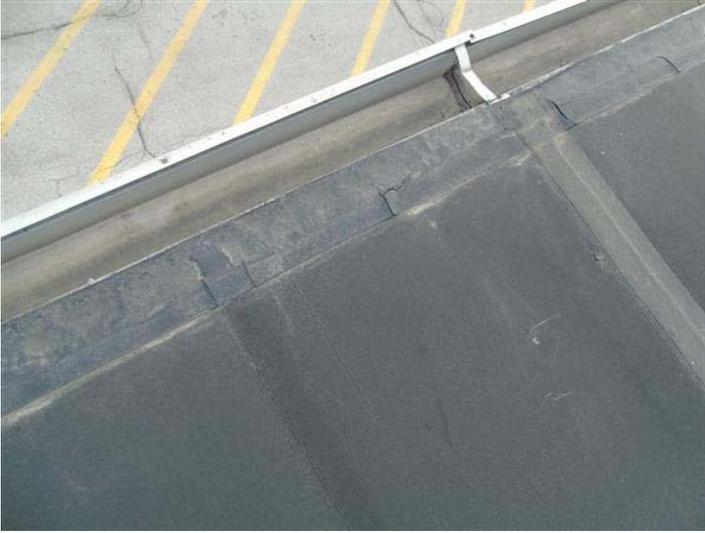
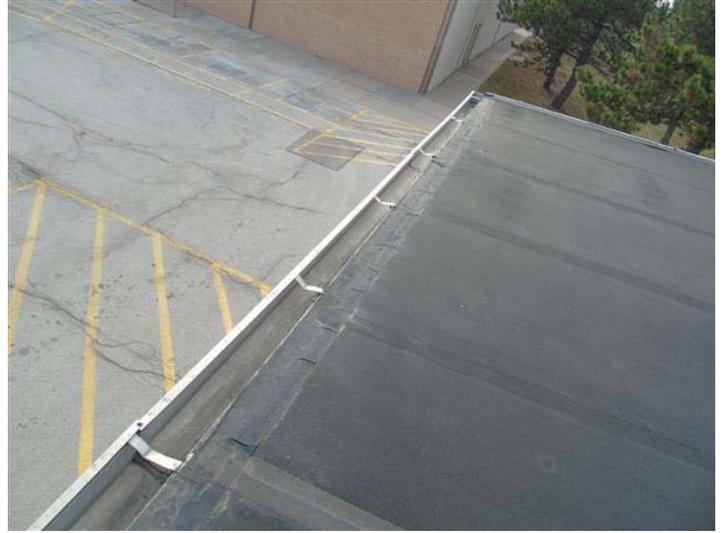
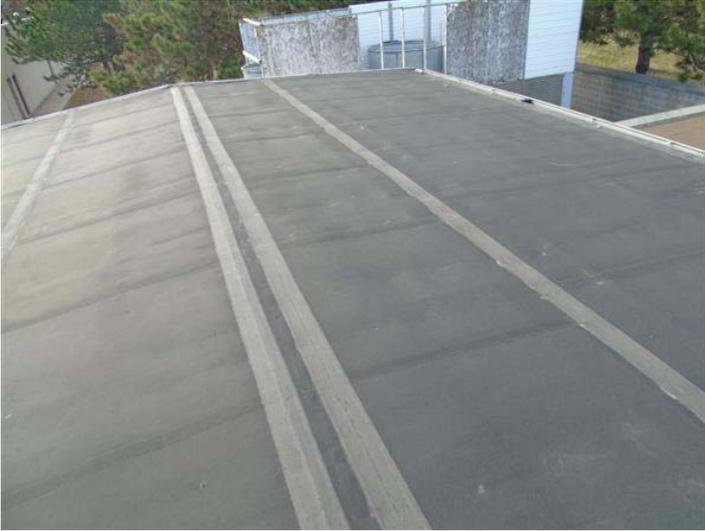
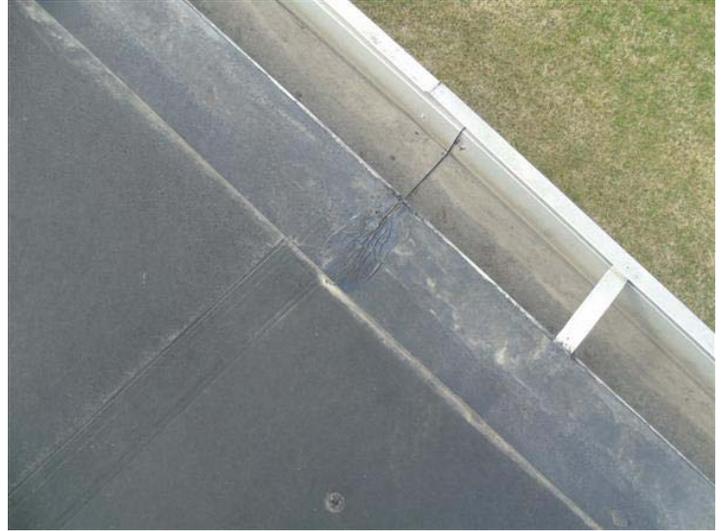
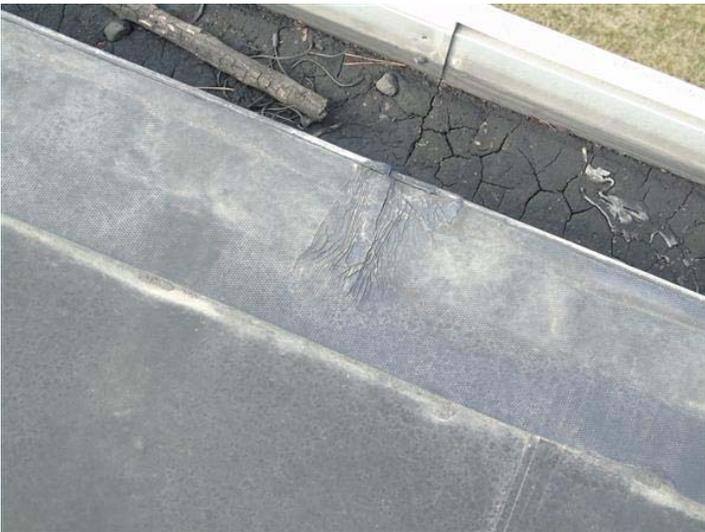
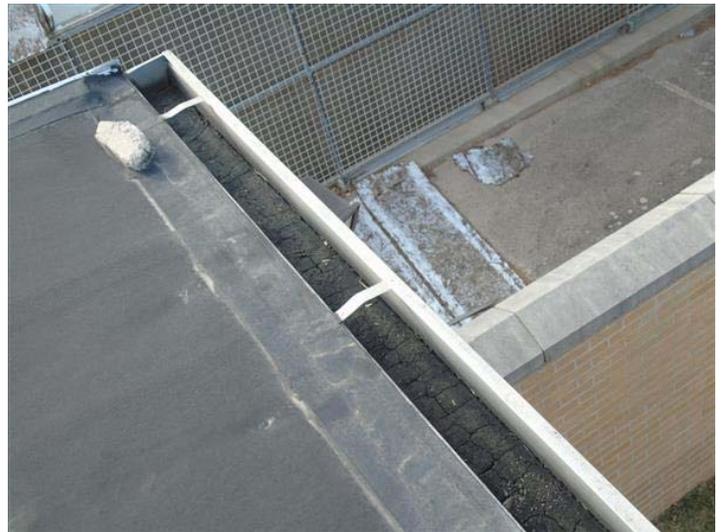
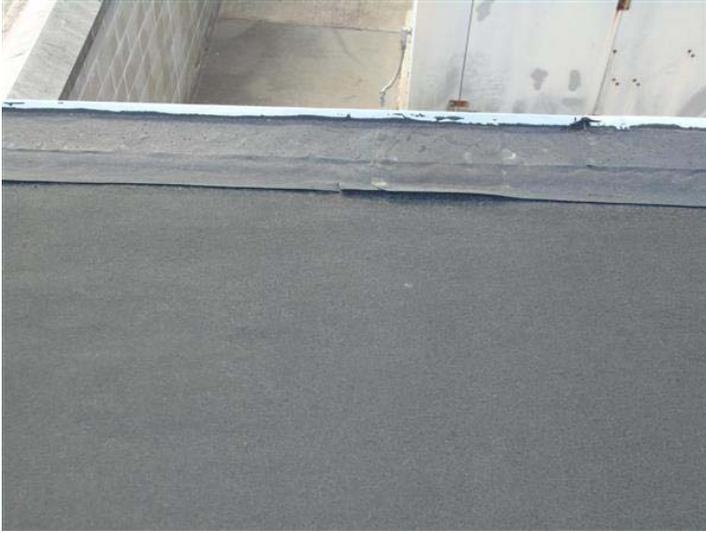
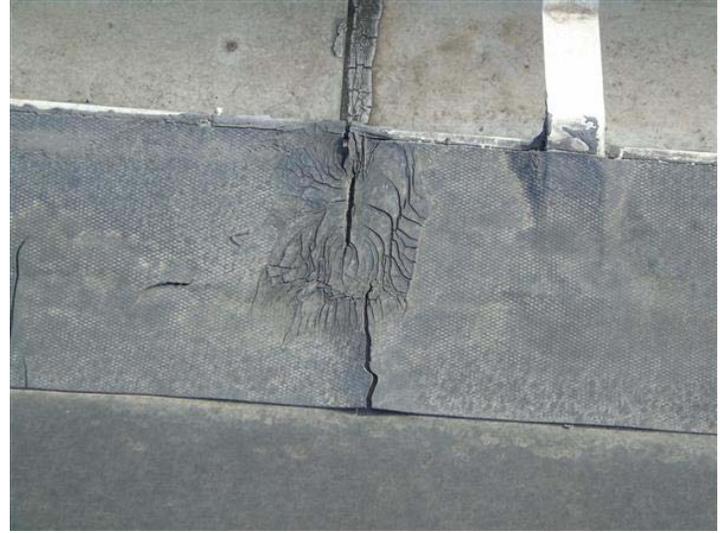
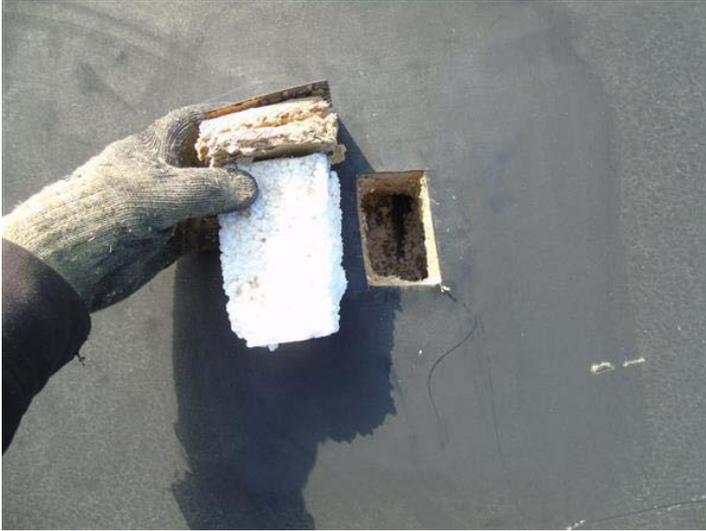
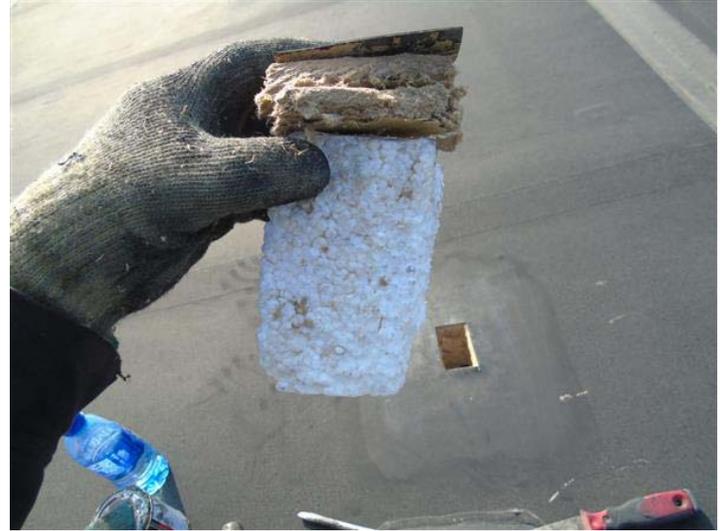
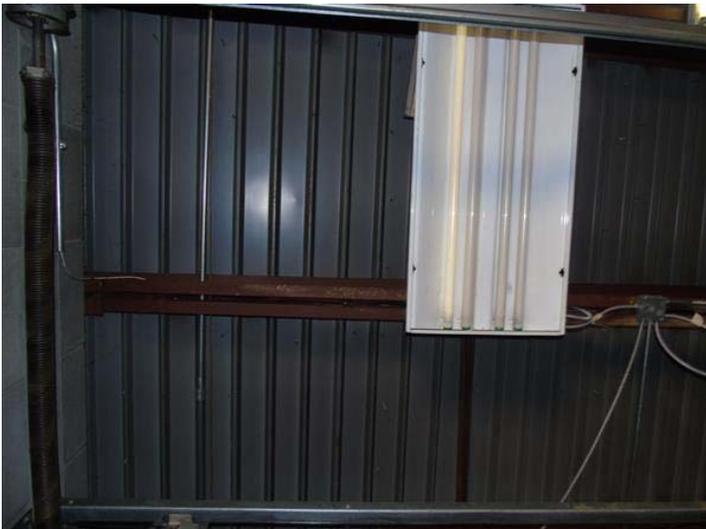
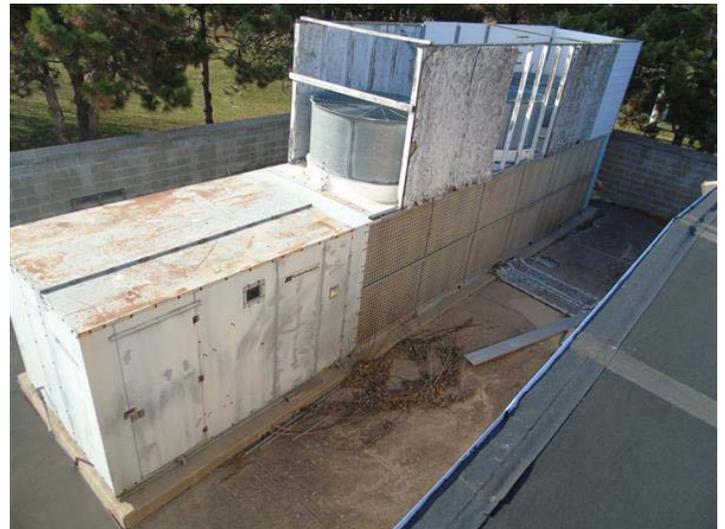
Logan Fontenelle Middle School_Bellevue, NE
Ph 1 Roof Inspection_Roof G_2017-03-21

- Typical defects for the G roof area:
- 9 Deteriorated EPDM edge metal stripping.
 - 22 An accumulation of debris in the guttering.
 - 24 EPDM stripping repairs.
 - 45 Open EPDM edge metal stripping laps.
 - 49 Split EPDM edge metal stripping membrane.
