# Roof Inspection Report

Central Elementary School  
510 W. 22<sup>nd</sup> Avenue  
Bellevue, NE 68005

Date	Inspection Type	Inspecting Company	Inspector
Mar 22, 2017	Phase 1 Roof Inspection	Roofing Solutions, Inc.	Garry Hendrickson

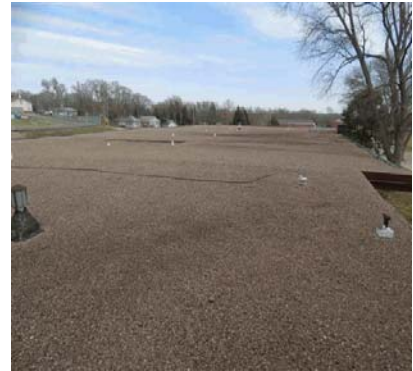
**Drainage and Leak Details:** The A roof areas slope to the interior and drain to primary roof drains. The A-3 roof area has two (2) overflow drains and the A-1 roof area has five (5) scuppers that go through the raised roof edge detail.

Facility personnel reported an ongoing leak issue around a roof drain on the A-1 roof area.

Budget Year	Activity Type	Action Item ?	Allocation	Urgency	Quotation \$
2017	Infrared Scan	Yes	Expense	High	\$2,500
RSI recommends an infrared scan be performed to locate any wet insulation present in the current roof system.					
2017	Retrofit	Yes	Capital	High	\$165,197
RSI recommends the installation of a new twenty (20) year design life roof system. We further recommend installation of new perimeter metal and projection details per the SMACNA Architectural Sheet Metal Manual.					
					<b>\$167,697</b>

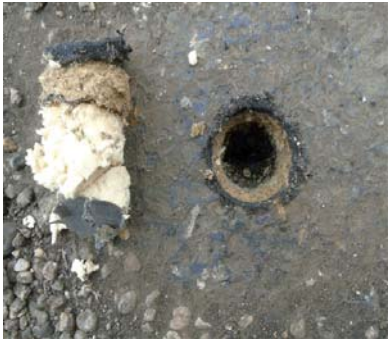
Mar 22, 2017	Core cut #1
 	Mar 22, 2017	Core cut #2

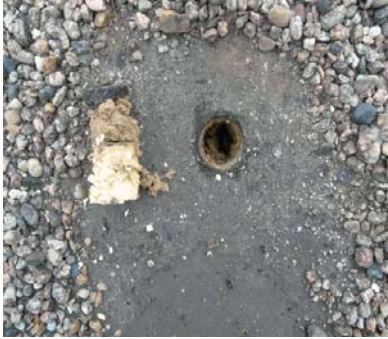
Mar 22, 2017	Core cut #3

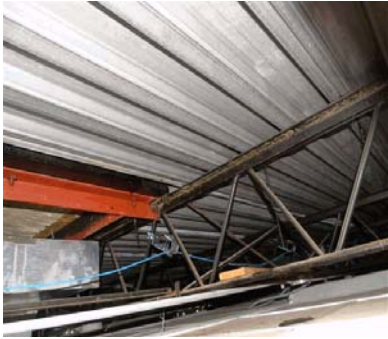
Mar 22, 2017	Deck Underside

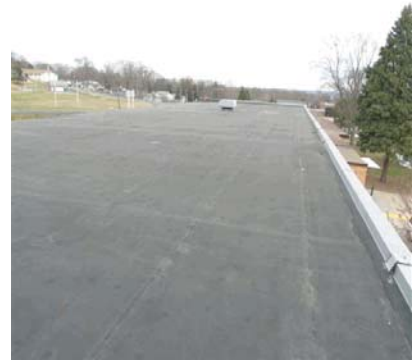
- EPDM stripping repairs observed to the field seams
- Random areas where the base flashing attachment has failed
- The EPDM flashings are bridged
- The wall cap cover plates are loose along the south wall detail
- The edge metal and guttering are rusted

Overall, the roof system is in poor condition due to its age and the deteriorated nature of the roof system. Given the observed conditions, it is our opinion comprehensive repairs in an effort to extend the life of the system would be neither feasible nor cost effective. We recommend the roof be replaced. There was no warranty information available for this roof section at the time of inspection.

RSI recommends a complete tear-off of existing roof system and the installation of a new twenty (20) year design life roof system. We further recommend the replacement of all perimeter coping cap and projection details per SMACNA Architectural Sheet Metal Manual.

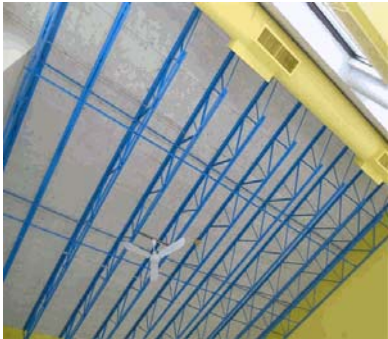
Mar 22, 2017	Deck Underside

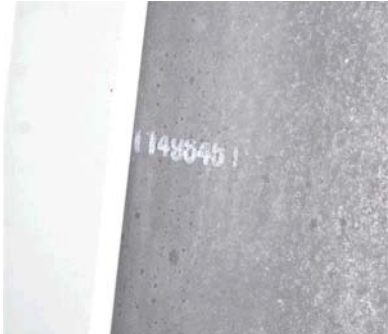
Mar 22, 2017	Membrane stamp

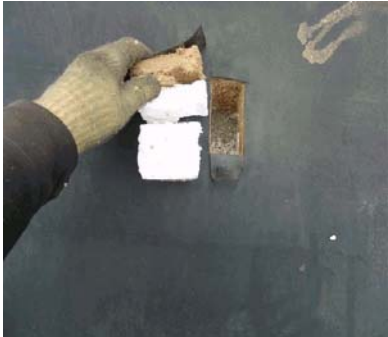
Mar 22, 2017	Roof System Core
