# Roof Inspection Report

Fort Crook Elementary  
12501 S. 25<sup>th</sup> Street  
Bellevue, NE 68123

Date	Inspection Type	Inspecting Company	Inspector
Mar 09, 2017	Phase 1 Roof Inspection	Roofing Solutions, Inc.	Garry Hendrickson

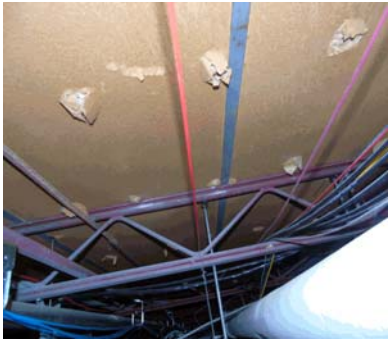
Mar 09, 2017	Deck Underside

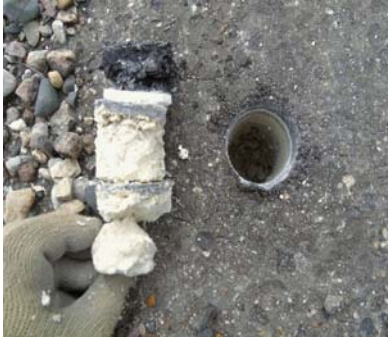
Mar 09, 2017	Roof System Core

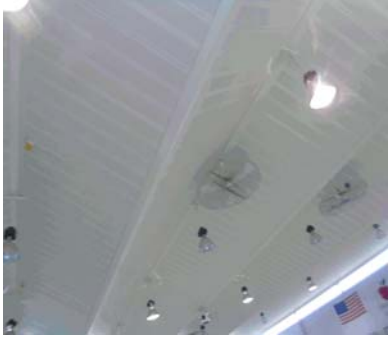
Mar 09, 2017	Deck Underside
